Flawed Reactor Pressure Vessels in Belgian Nuclear Plants Doel-3 and Tihange-2

Some Comments

Ilse Tweer

January 2013

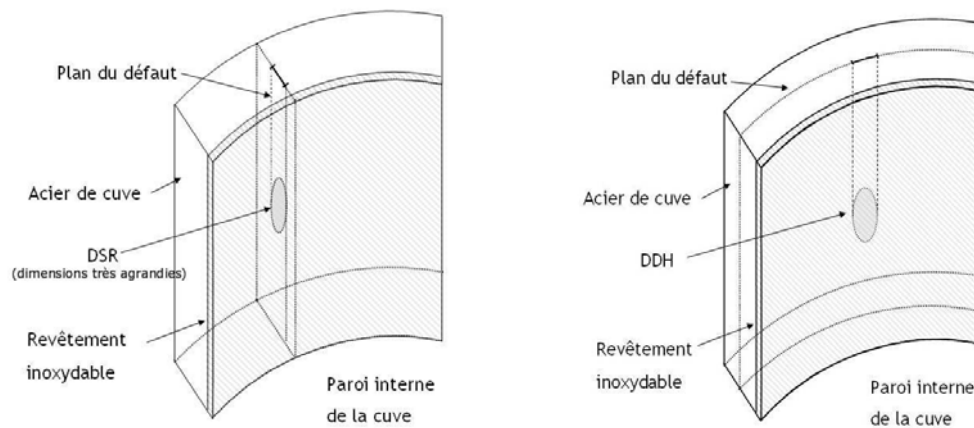
While underclad cracks are directly under the stainless steel cladding oriented normal to the inside surface of the RPV wall, the observed flaws are parallel to the wall surface (see the following figures⁹; DSR¹⁰ are underclad cracks, DDH¹¹ the hydrogen-induced flaws).

Figures 2a and 2b: Underclad cracks (a) and hydrogen-induced flaws (b)
