Dry Cask Storage Characterization Project—Phase 1: CASTOR V/21 Cask Opening and Examination

Idaho National Engineering and Environmental Laboratory

NUREG/CR-6745 INEEL/EXT-01-00183

Prepared by W.C. Bare, L.D. Torgerson

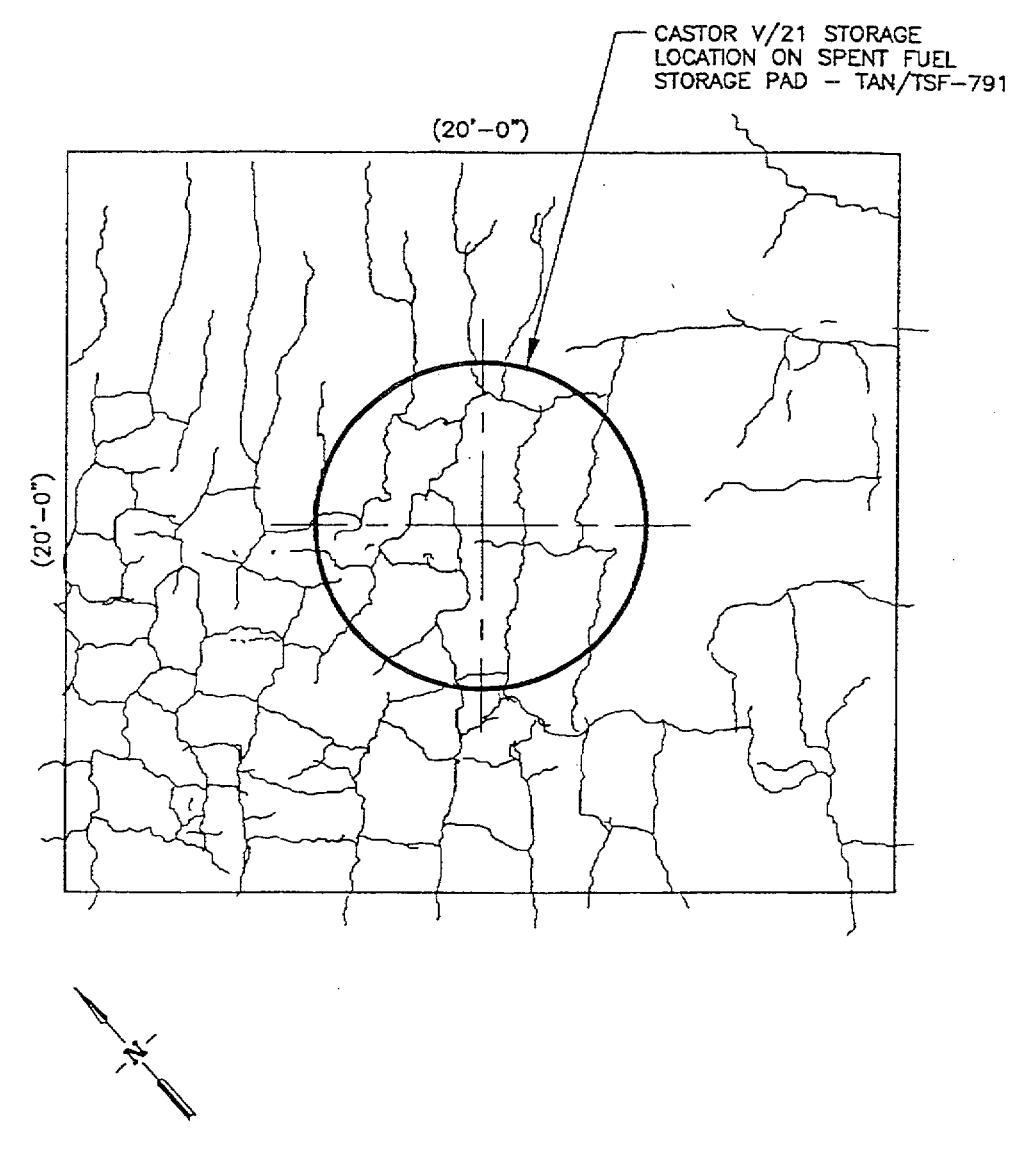
The pad was also visually inspected for evidence of degradation and structural failure. The surface of the whole pad did not exhibit any evidence of structural failure of the concrete, such as open cracks or cracks with displacements in elevation of the surface. The surface of the concrete did not exhibit any evidence of spallation of the surface, exposed aggregate, or aggregate pop-out from the surface. The surface was solid and exhibited only minor wear and environmental weathering, well within the extent of weathering expected for the cold and windy climate of Idaho. The broom-finished unpainted surface exhibited only a network of faint, fine surface shrinkage cracks (Figure 2-3), less than 0.8 mm (1/32 in.) wide and of superficial depth, and a few rust stains under the cask from lightly rusted bolts on the cask. Similar cracks were prevalent across the entire surface of the pad, and were not associated with the cask locations. Tests with a straight taught line across the 6.1 m × 6.1 m (20×20 ft) grid indicated that there was no sag or vertical displacement in the concrete associated with the crack network; measurements with a straight edge and the taught line indicated only localized variations in the elevation of the concrete that were less than 3.2 mm (1/8 in.). The localized variations in elevation were not associated with the location of the cask and were most likely an artifact of the screeding and finishing when the concrete was originally poured.

Figure 2-3. Shrink crack indication of CASTOR V/21 concrete pad storage area.

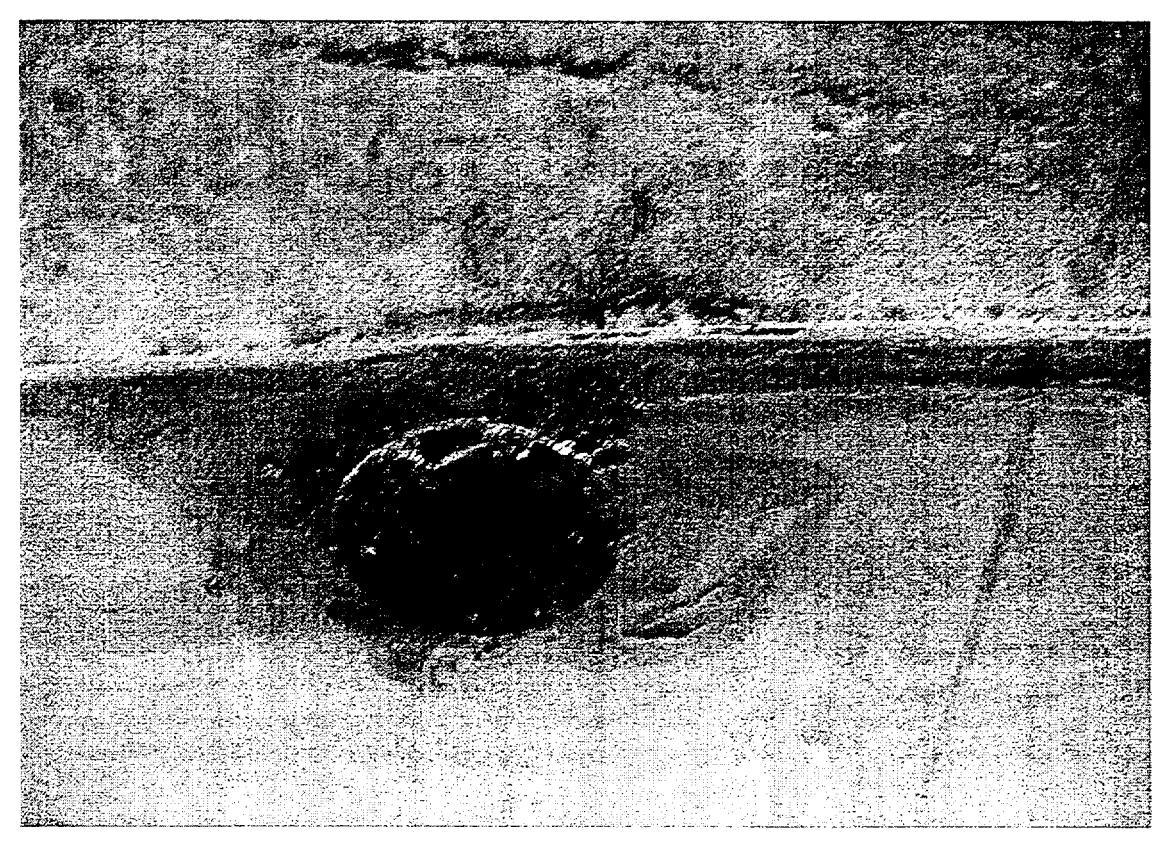
Figure 2-4. Cask bottom cover plate bolt corrosion.

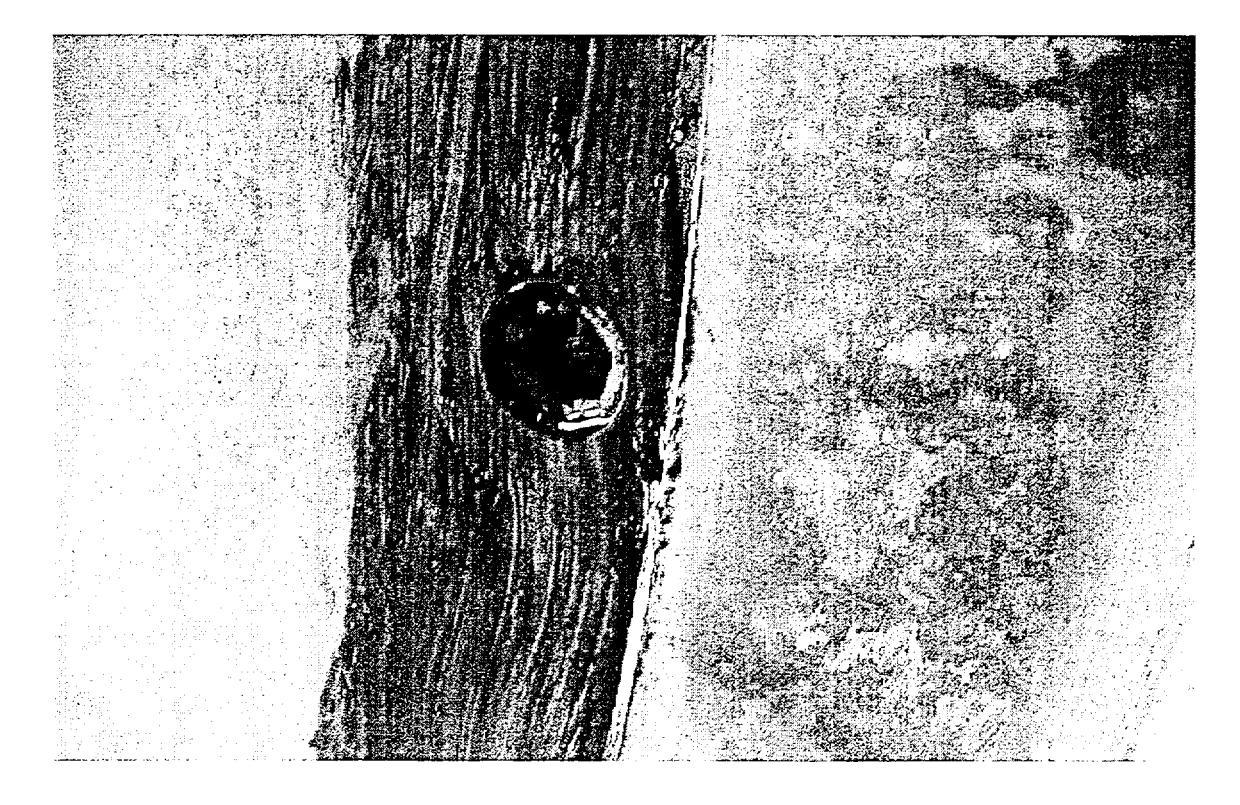
Figure 2-5. Cask bottom cover plate bolt after corrosion removal.

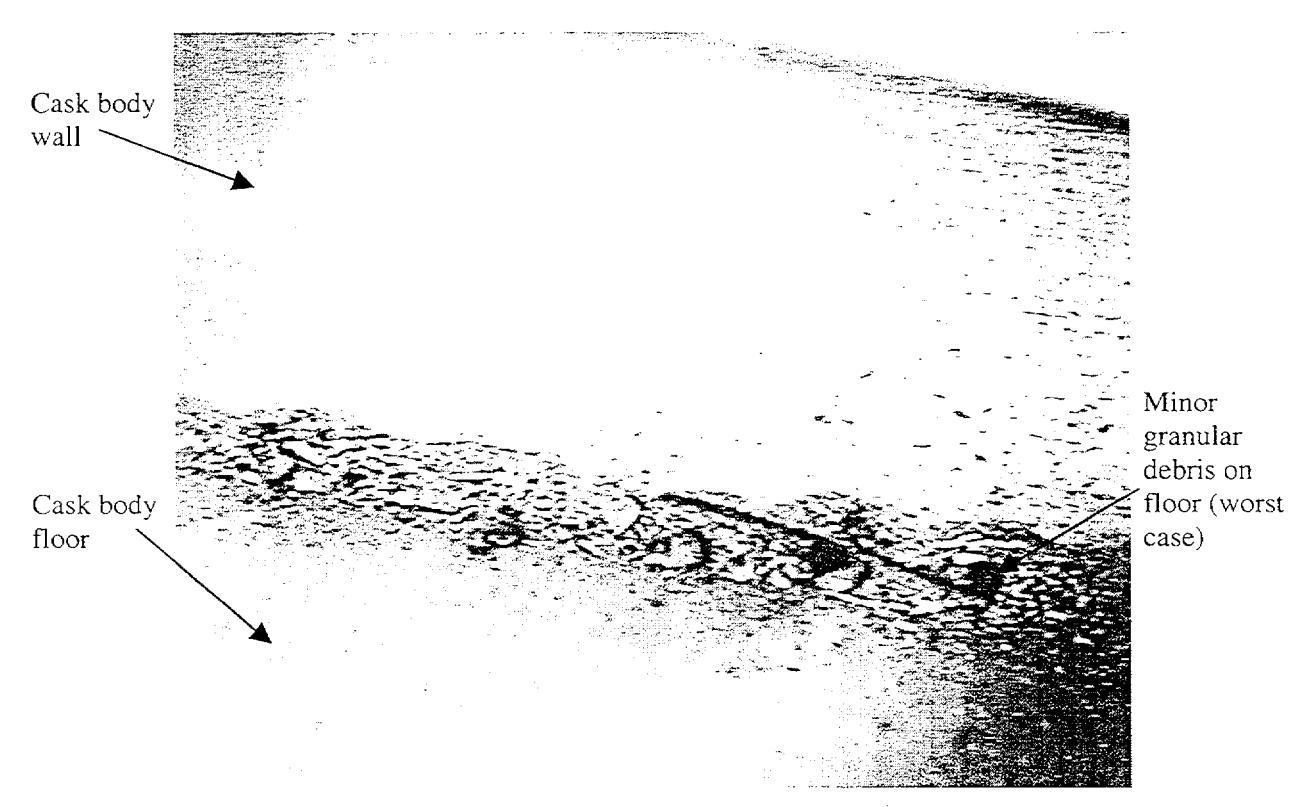
Small grains of debris were thinly scattered over most of the cask floor as shown in Figure 2-14 and Appendix F. The debris ranged from sandlike particles of submillimeter to several millimeter size to long slivers of material several millimeters in length. These generally appeared to have been deposited after the nickel plating of the surface, because the larger particles were dark in color and not reflective. Similar material had accumulated on the horizontal bars at the bottom of each fuel tube on which the fuel assemblies rested. Much of the sand-like debris probably consists of welding slag or grinding swarf from the basket. However, some of the debris appeared to consist of slivers of metal. The slivers may be slivers of stainless steel gouged from the fuel tube walls by insertion and extraction of the fuel assemblies, because the fuel tube walls exhibited much evidence of scraping by the fuel assemblies.

Figure 2-14. Cask floor and wall below fuel tube C8-reflective surfaces free of corrosion.

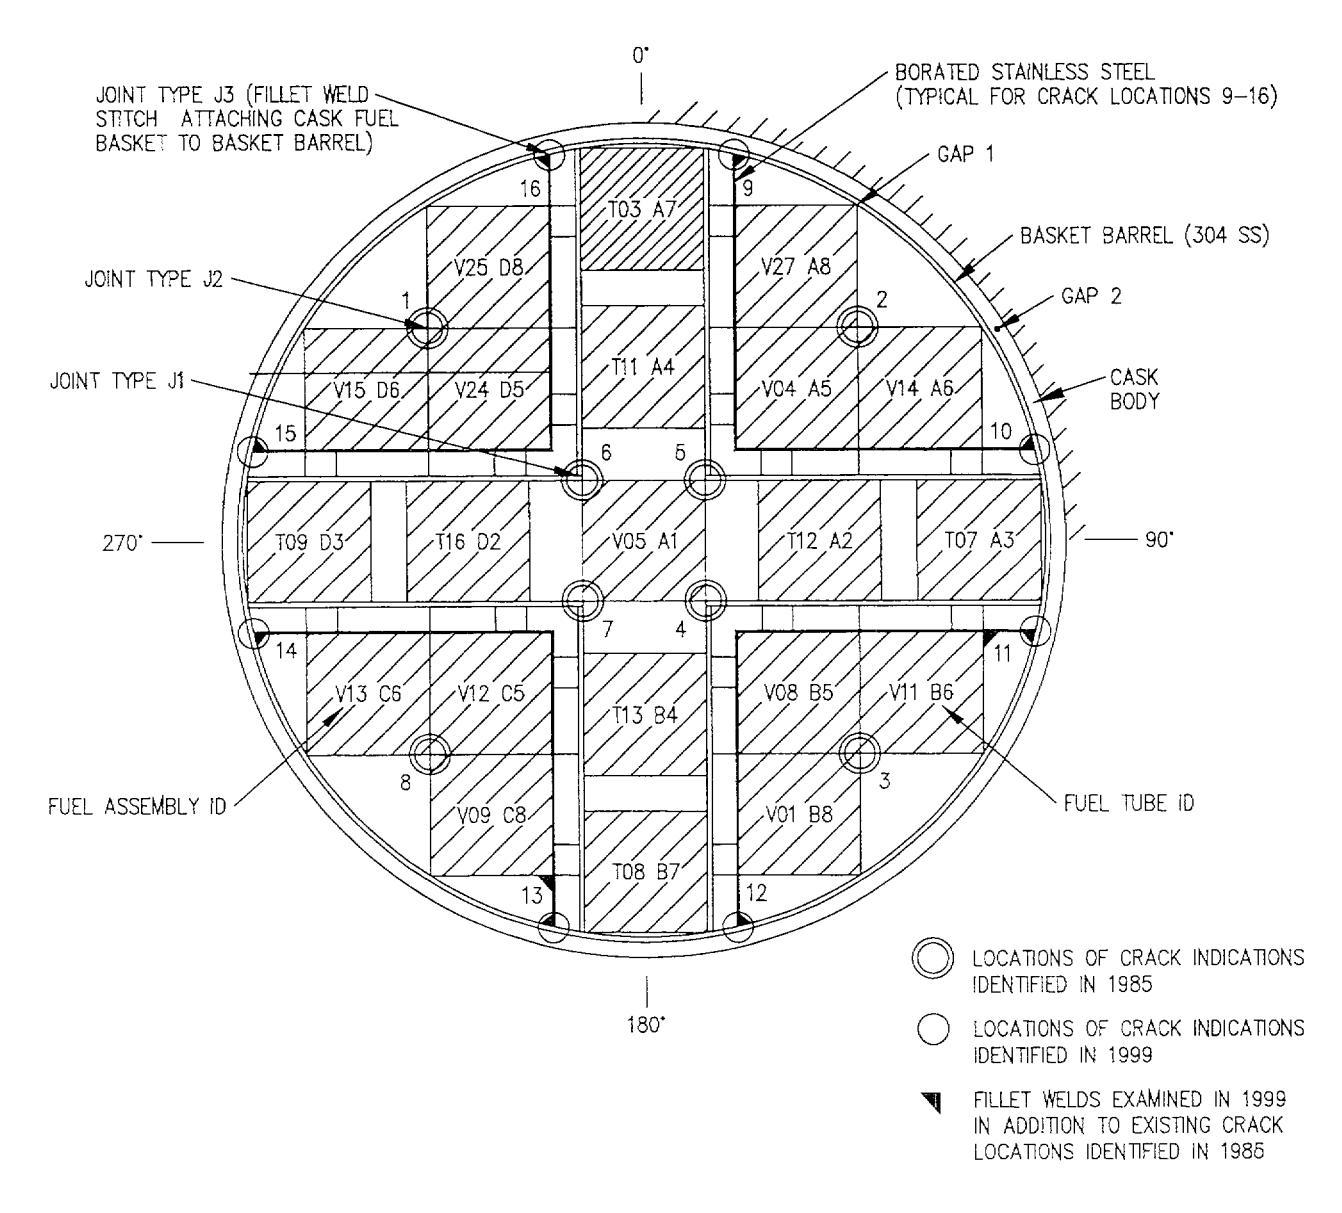
a. Cracks were formed in some of the basket welds during the initial thermal testing conducted in 1985 (prior to long-term storage). The intent here is to determine if new cracks may have formed during long-term storage.

Figure 2-16. CASTOR-V/21 basket crack indication locations and fuel tube arrangement.

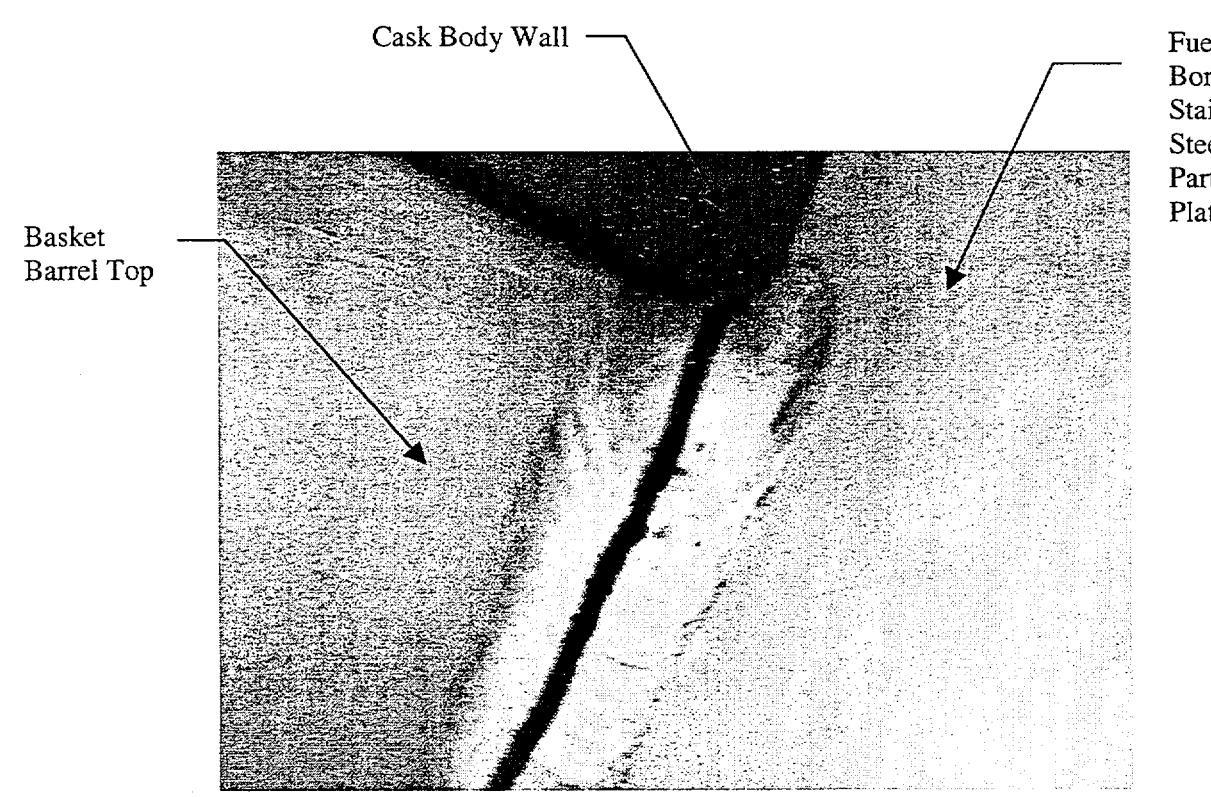
Figure 2-17. Typical top stitch weld crack at location 14 identified in Figure 2-16.

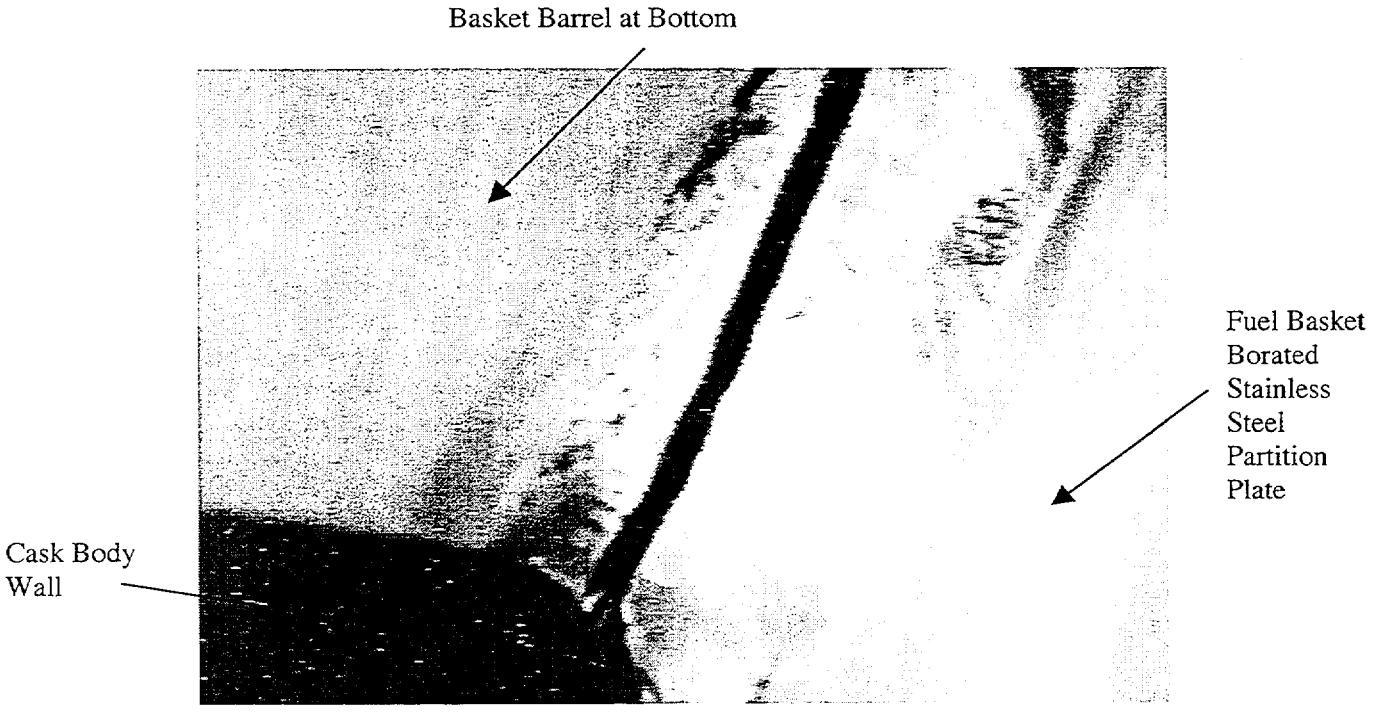
Figure 2-18. Typical bottom stitch weld crack at location 14 identified in Figure 2-16.

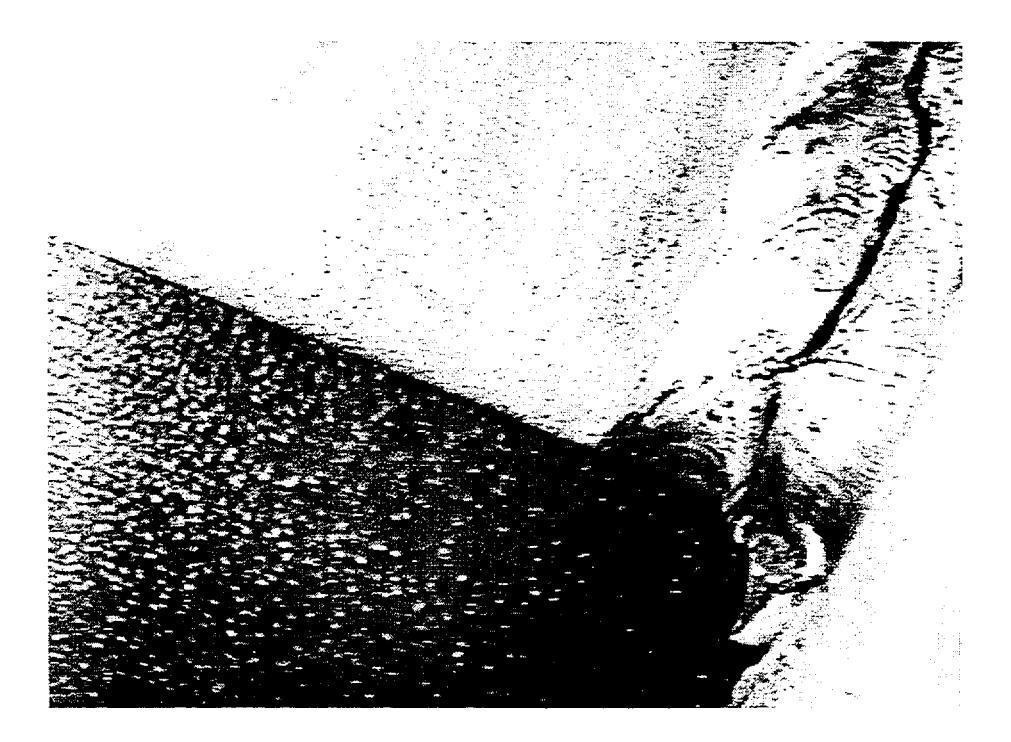
Figure B-4. Bottom weld crack at location 10 identified in Figure B-19. (Triangular air channel between fuel tube A3 & A6)

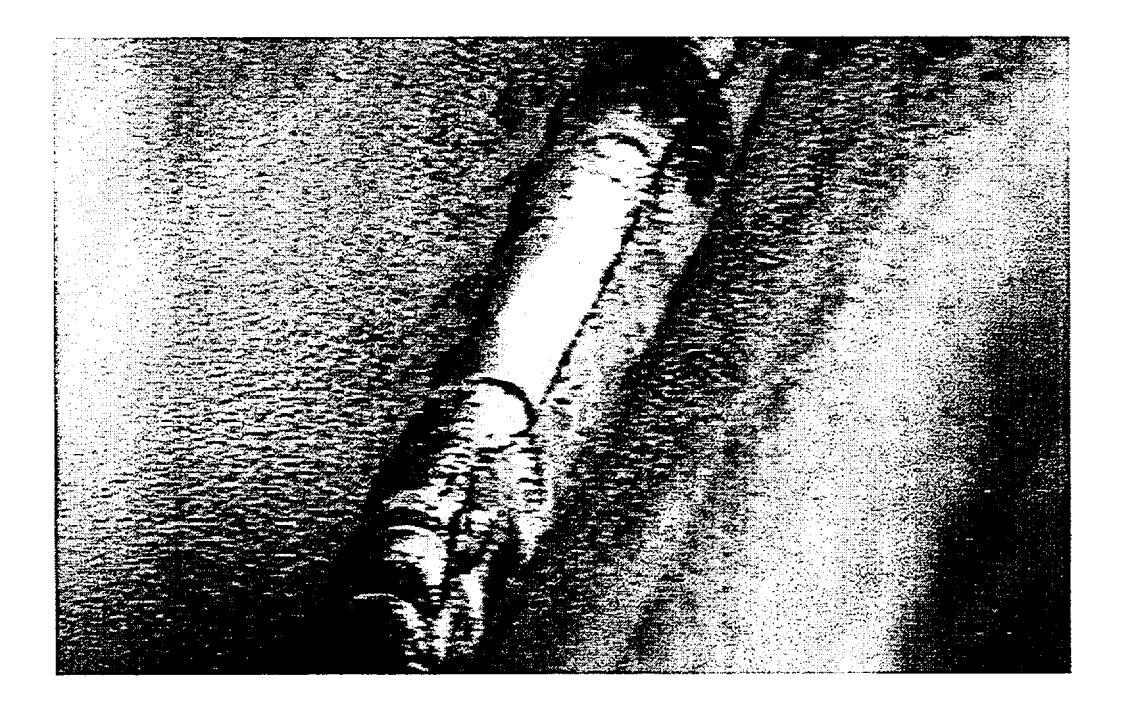
Figure B-16. Bottom weld crack at location 16 identified in Figure B-19. (Triangular air channel between fuel tube A7 & D8)

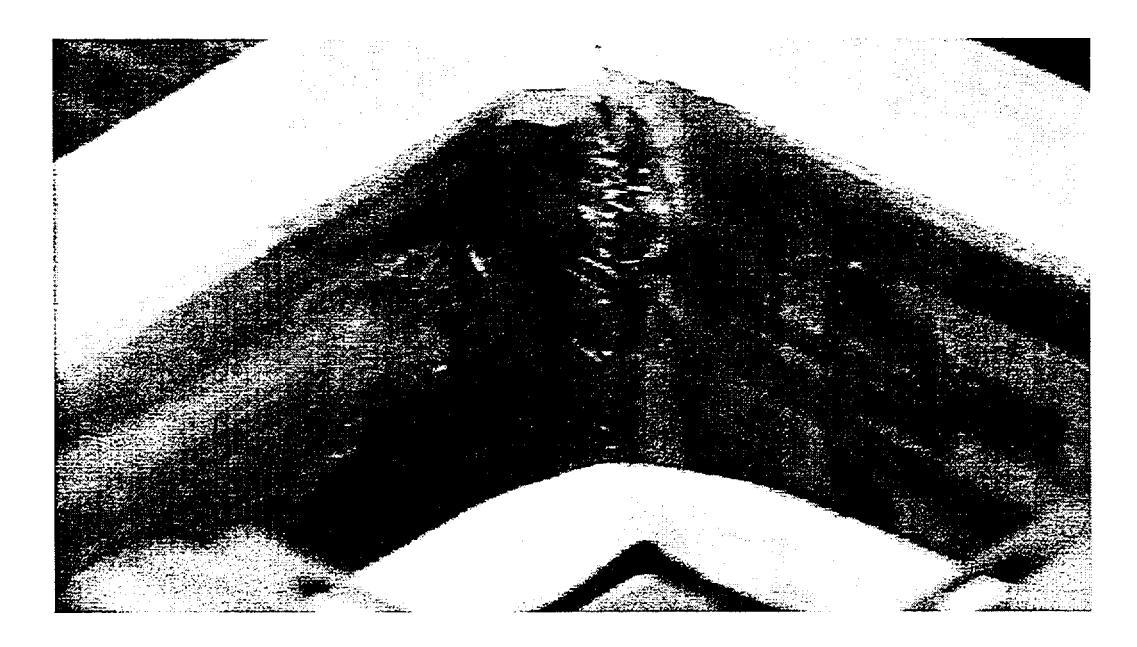
Figure B-17. Crack in basket weld below weld crack 4 (120°) identified in Figure B-19.

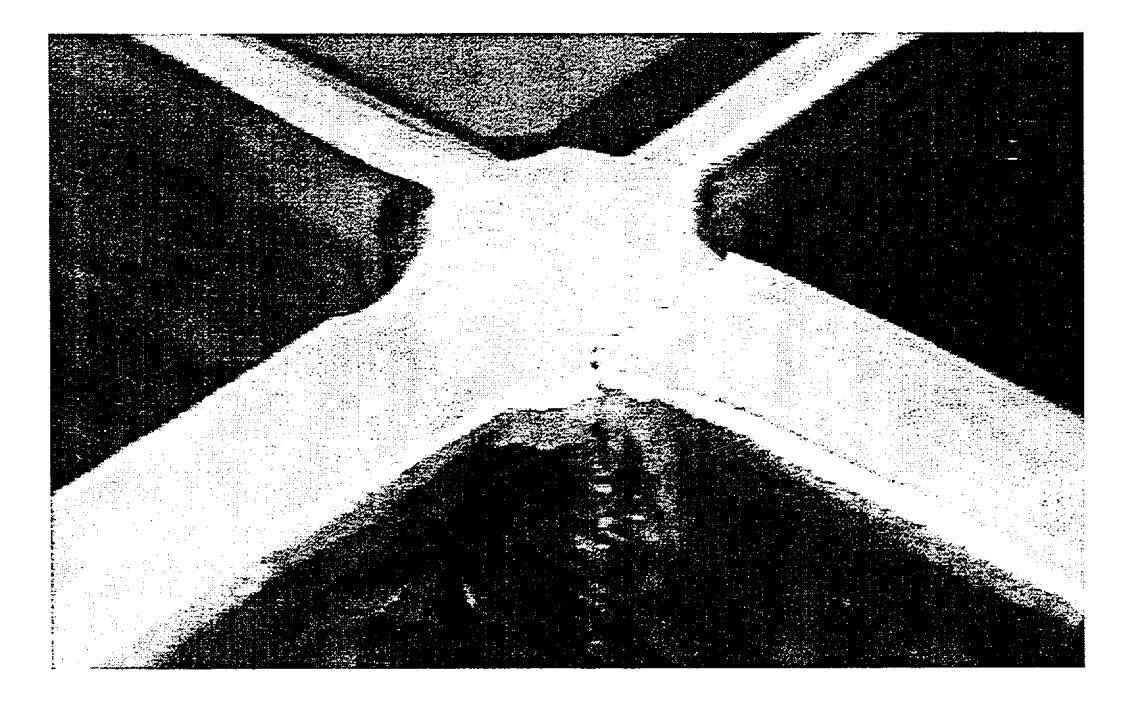
Figure B-18. Same as Figure B-17 with complete view of existing weld crack 4 identified in Figure B-19.

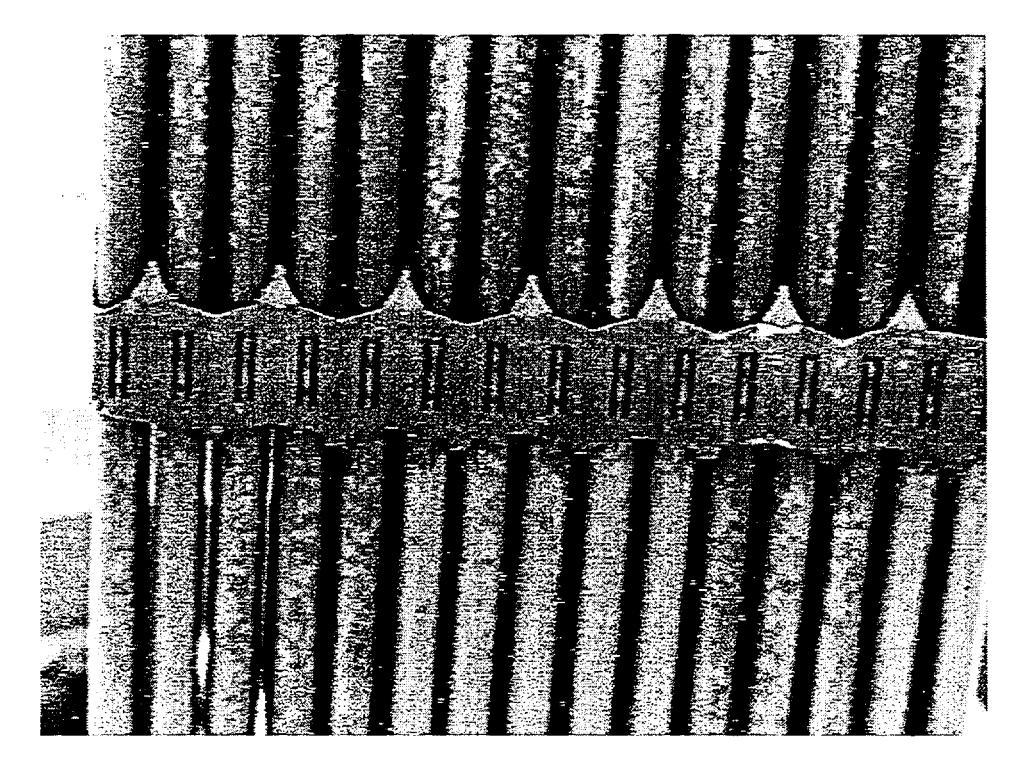
Figure C-3. Oxide mottling noted around spacer #5 on fuel assembly V-05.

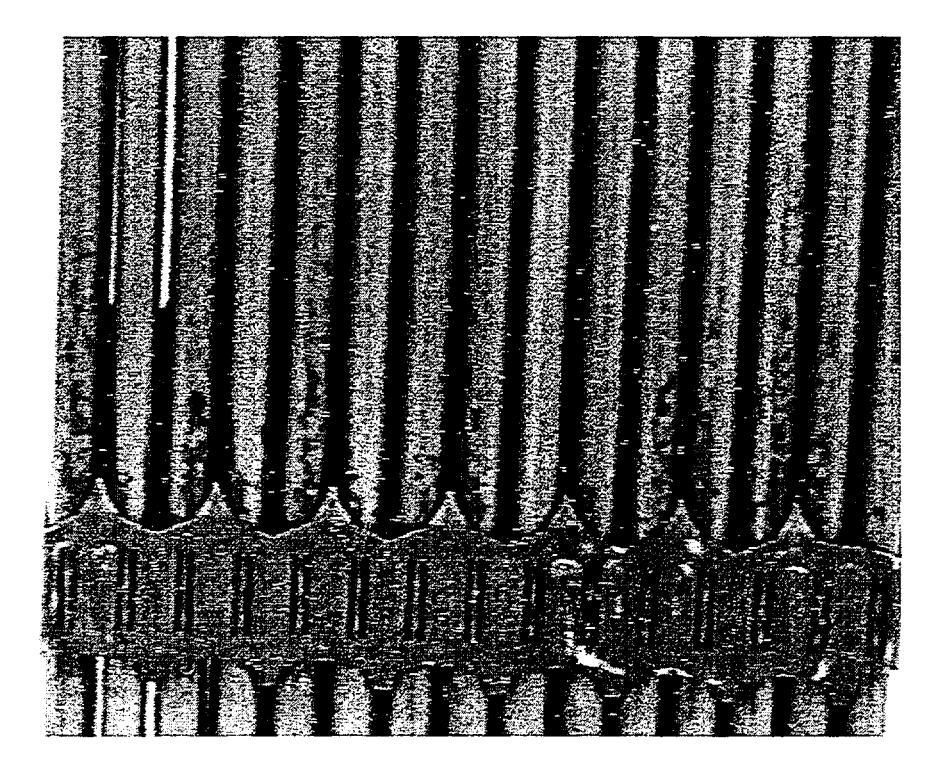
Figure C-4. Oxide mottling noted around grid spacer #6 on V-05.

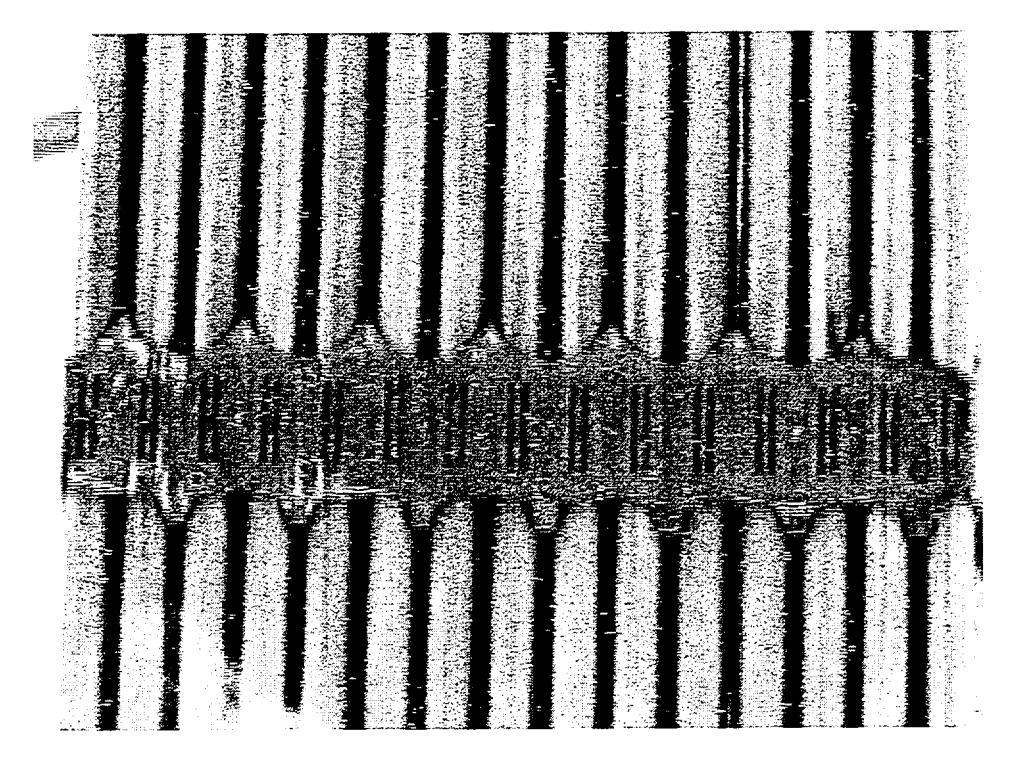
Figure C-6. Fuel assembly V-05 area around third grid spacer-noted light abrasion marking on spacer.

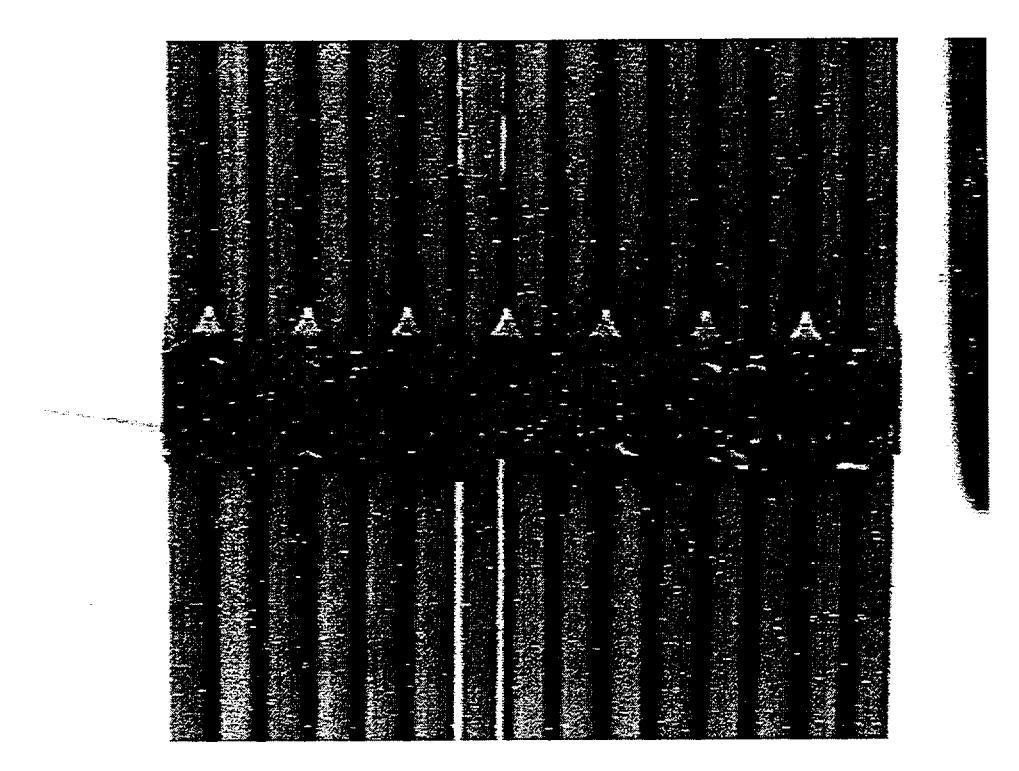
Figure C-11. Fuel assembly V-05 oxide mottling noted around grid spacer 5.

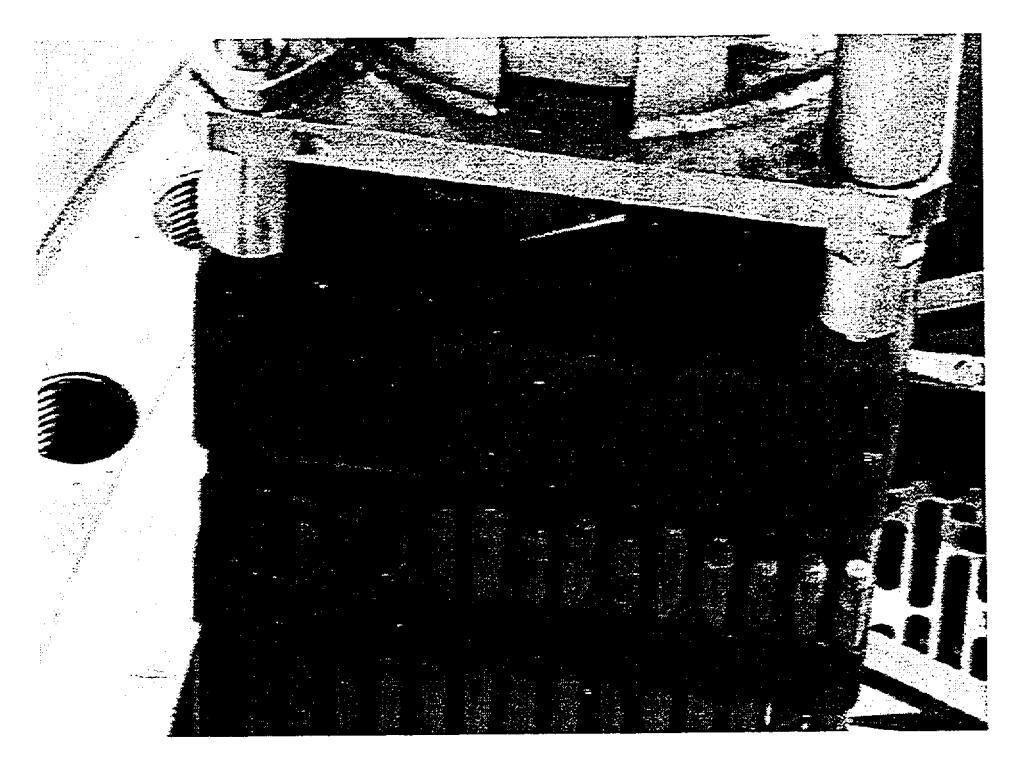
Figure C-14. Element T-03 being withdrawn-note fuel rod growth.

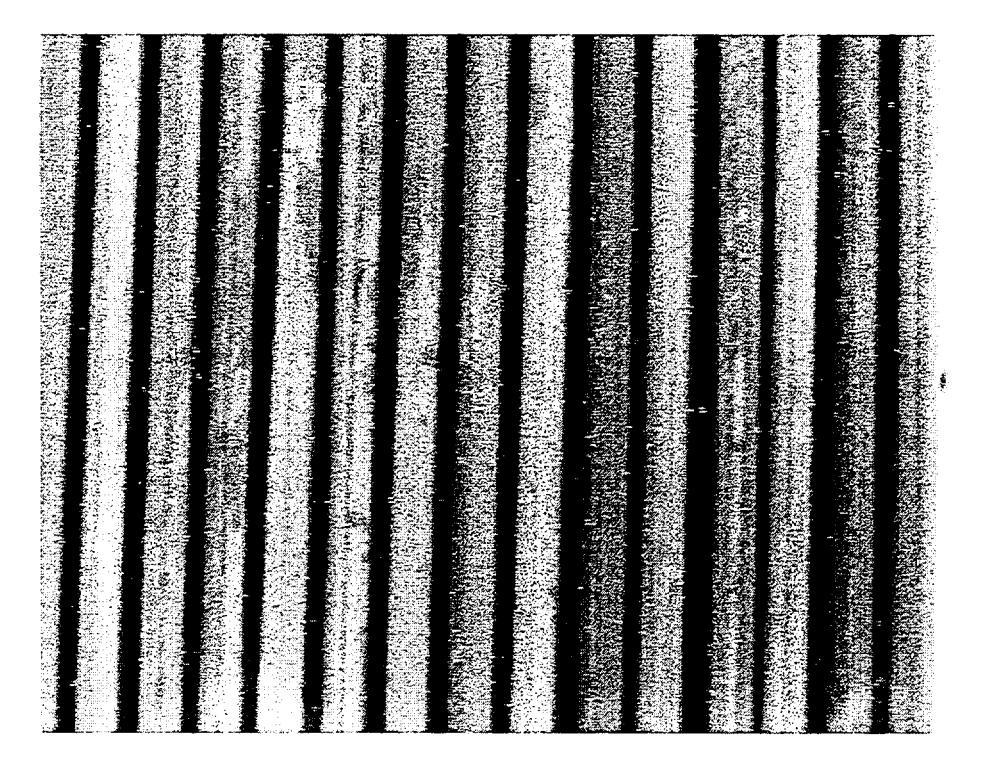
Figure C-16. Element T-03 midpoint of assembly noted oxide density increases as we go lower on the element.

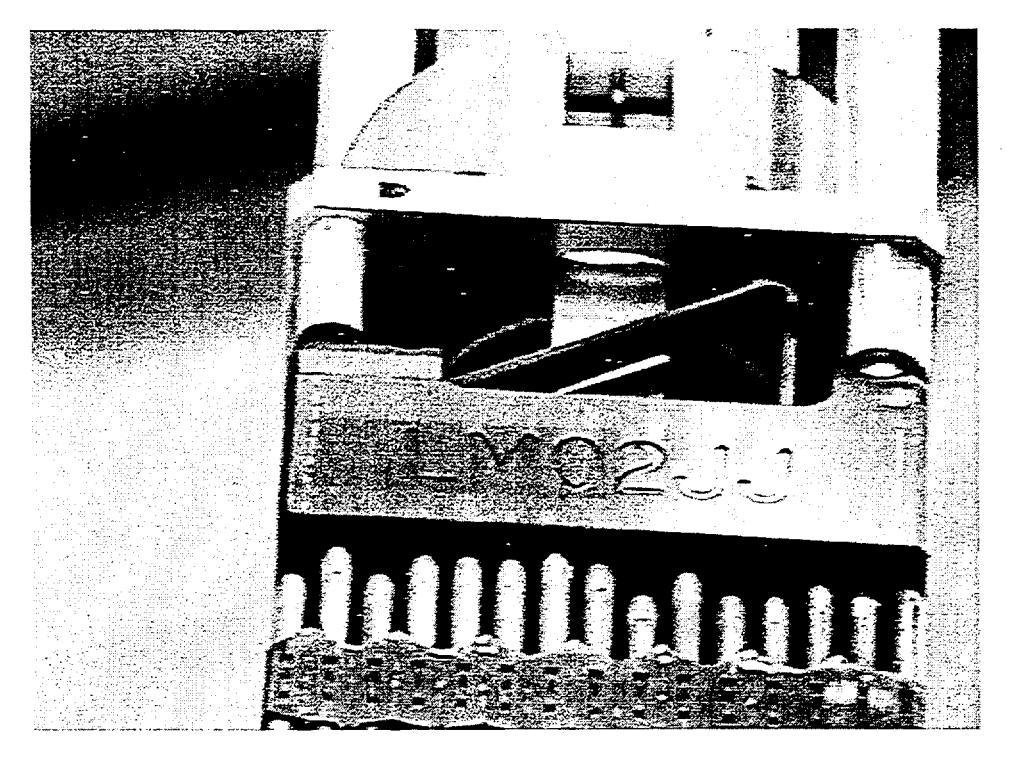
Figure C-19. Fuel element T-03-notes serial number-fuel rod growth evident.

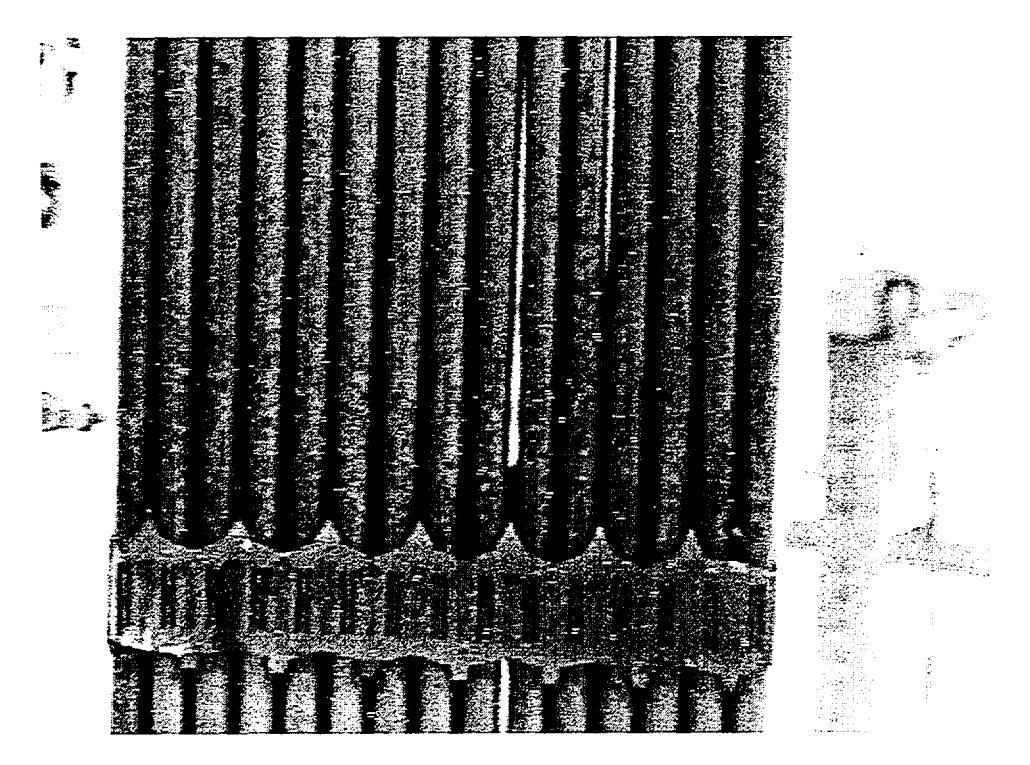
Figure C-22. Fuel assembly V-27 oxide mottling noted.

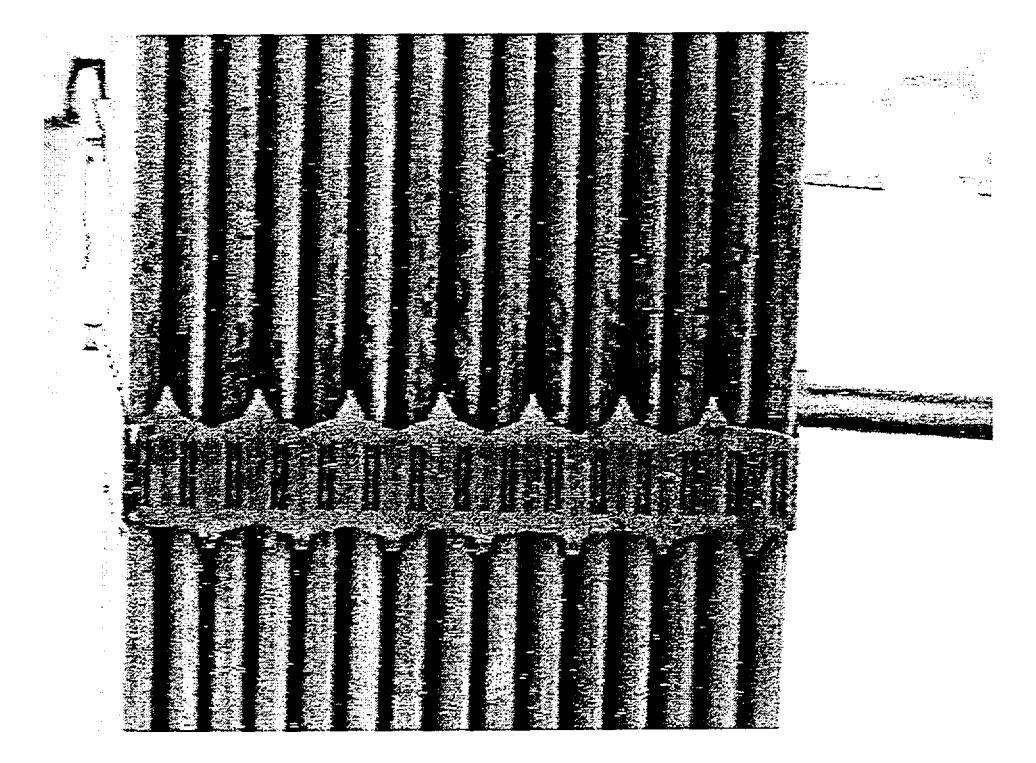
Figure C-66. Fuel assembly V-04 mottling at fifth grid spacer.

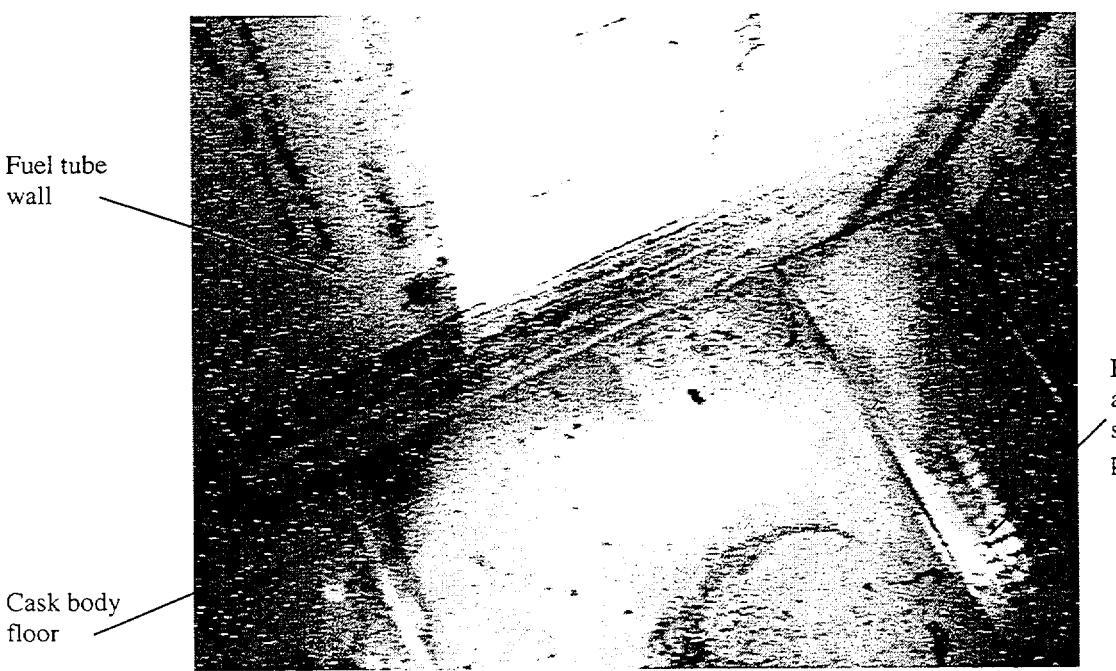
Figure D-2. Fuel Tube A-1 – Close up of bottom – minor debris noted.

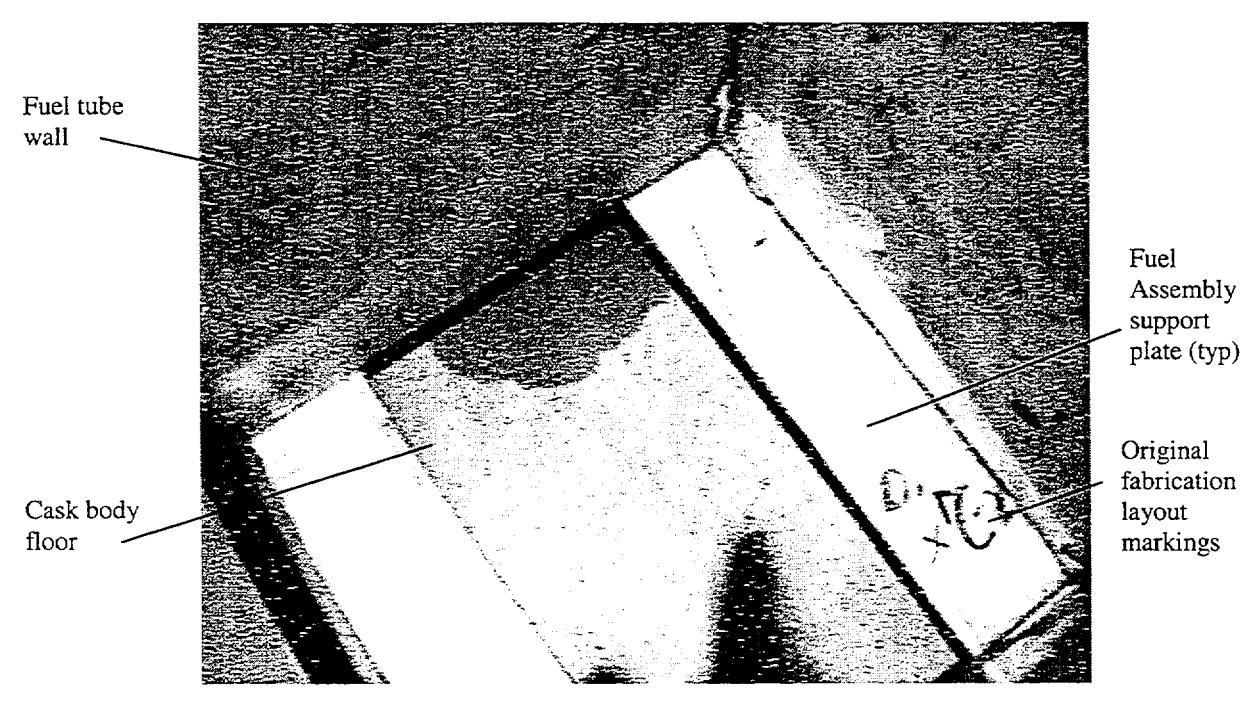
Figure D-3. Fuel tube A-7 – closeup of bottom – noted stain – no conclusion – surfaces are clean and bright. This view approximates condition viewed at the bottom of all fuel tubes.

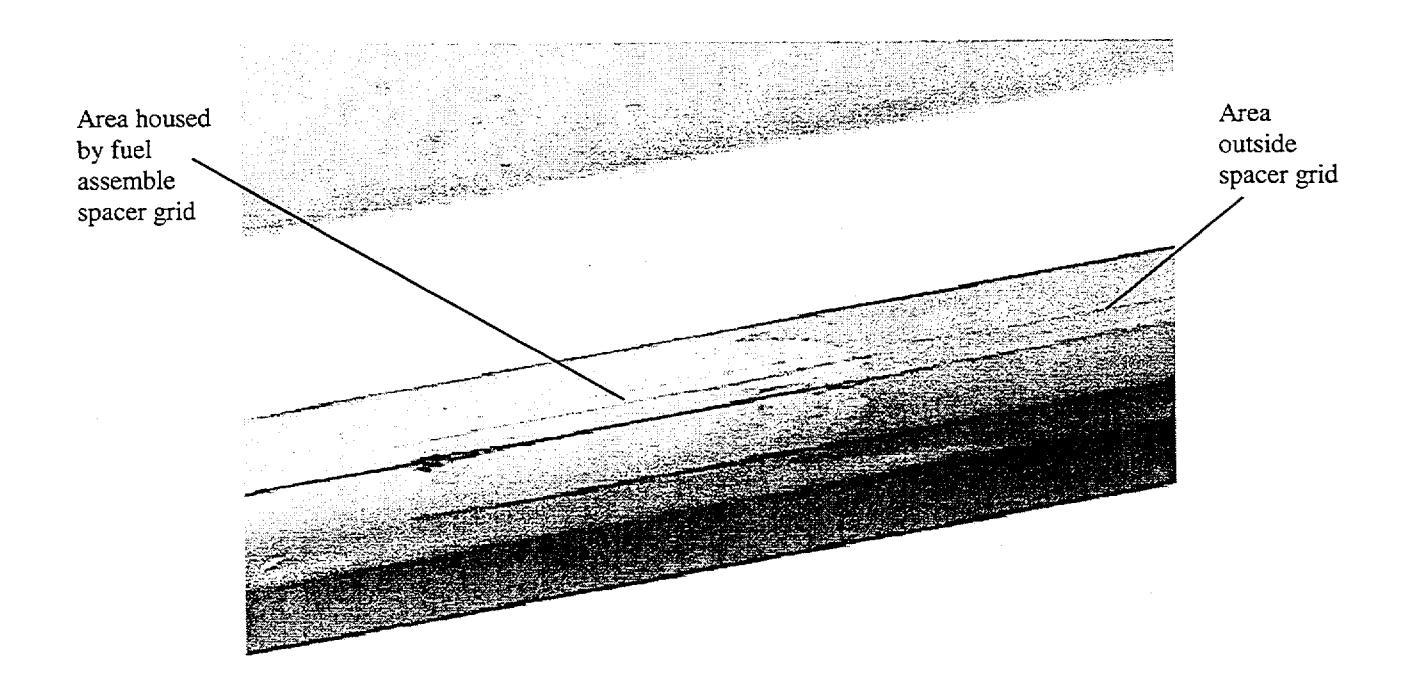
Figure E-7. Condition of fuel rod—light oxide coating minor—scratches believed from moving rod through spacer grids.

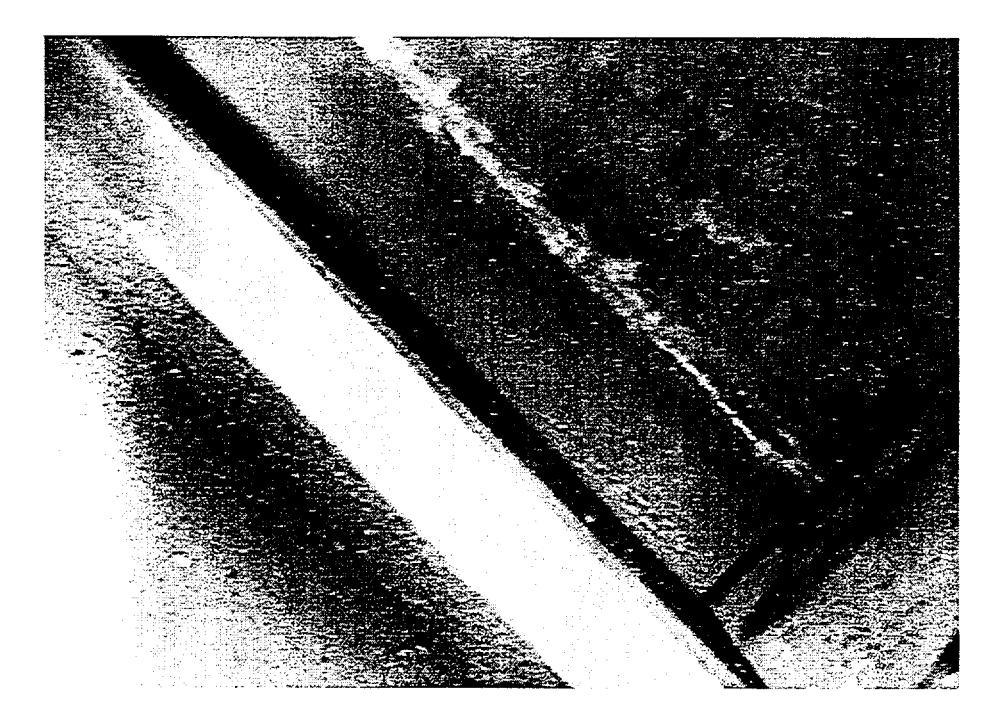
Figure F-7. Cask floor and wall below fuel tube A7—reflective surfaces free of corrosion—minor granular debris on floor.
