Dry Cask Storage Characterization Project—Phase 1: CASTOR V/21 Cask Opening and Examination

Idaho National Engineering and Environmental Laboratory

NUREG/CR-6745 INEEL/EXT-01-00183

Prepared by W.C. Bare, L.D. Torgerson

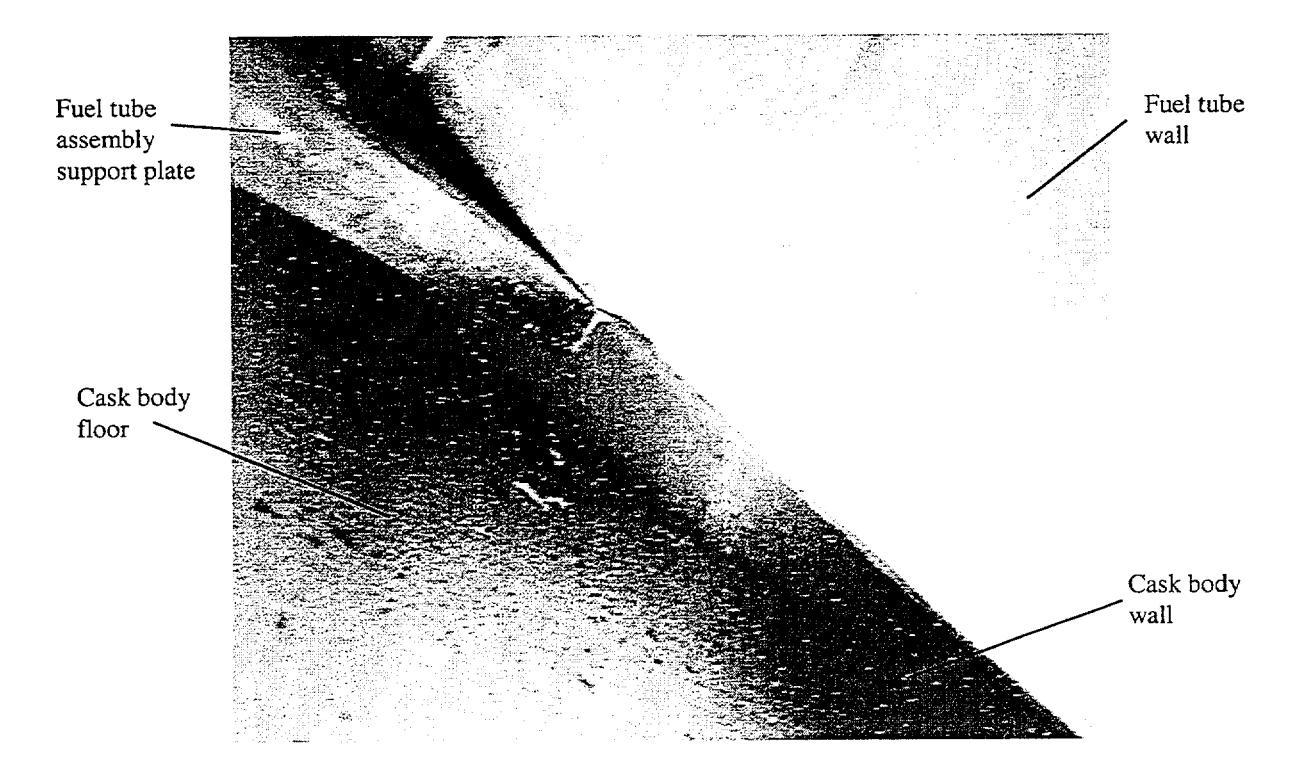
Figure F-9. Cask floor below fuel tube B6—reflective surfaces free of corrosion—minor granular debris on floor.
