Flawed Reactor Pressure Vessels in Belgian Nuclear Plants Doel-3 and Tihange-2

Some Comments

Ilse Tweer

January 2013

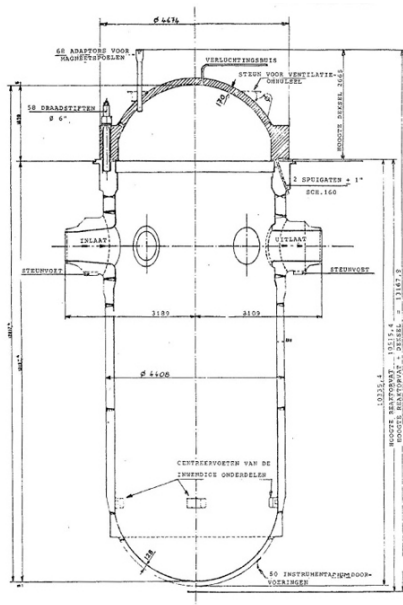
Figure 1: Reactor Pressure Vessel Doel 3

In the cases of Doel 3 and Tihange 2, the reactor pressure vessel consists of welded forged rings in the cylindrical part and a lower and upper head, the RPV has a height of about 13 m (incl. head), a diameter of about 4.4 m and a wall thickness of 20 mm (see figure 1)².
