Dry Cask Storage Characterization Project—Phase 1: CASTOR V/21 Cask Opening and Examination

Idaho National Engineering and Environmental Laboratory

NUREG/CR-6745 INEEL/EXT-01-00183

Prepared by W.C. Bare, L.D. Torgerson

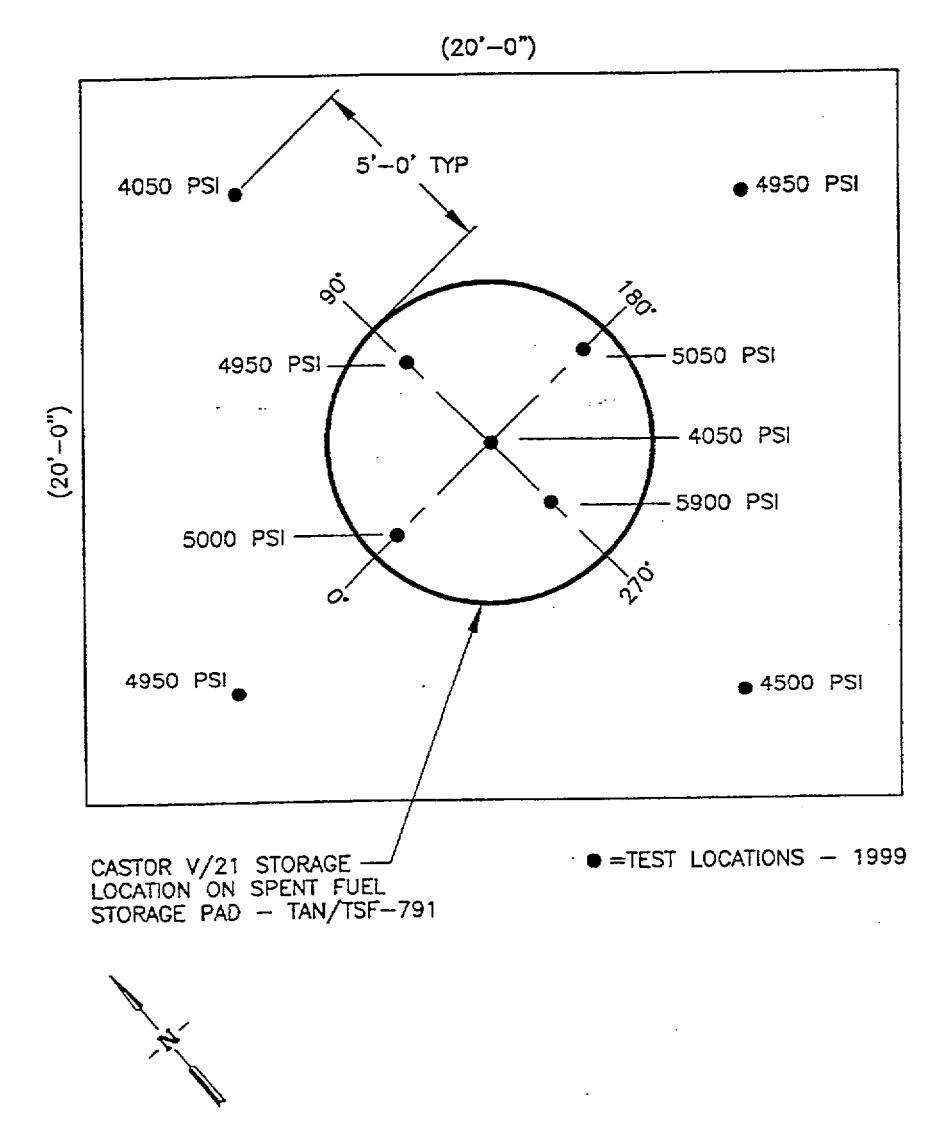
Figure 2-2. Rebound hammer test locations at CASTOR V/21 storage pad location.

The structural soundness of the concrete was determined by ASTM test standard C805-94 (Test Method for Rebound Number of Hardened Concrete, also known as the Swiss hammer test). The Swiss hammer test was performed on the concrete surface in 9 places in a 37.2 m (122 ft) area centered on the placement of the CASTOR V/21 cask, of which 5 places were selected in the area under the cask. The nine test results (Figure 2-2), which ranged from 28 MPa (4050 psi) to 41 MPa (5900 psi), averaged at 33 MPa (4800 psi) and demonstrated that the structural integrity of the concrete pad still meets or exceeds the 28 MPa (4050 psi) design strength of the concrete.

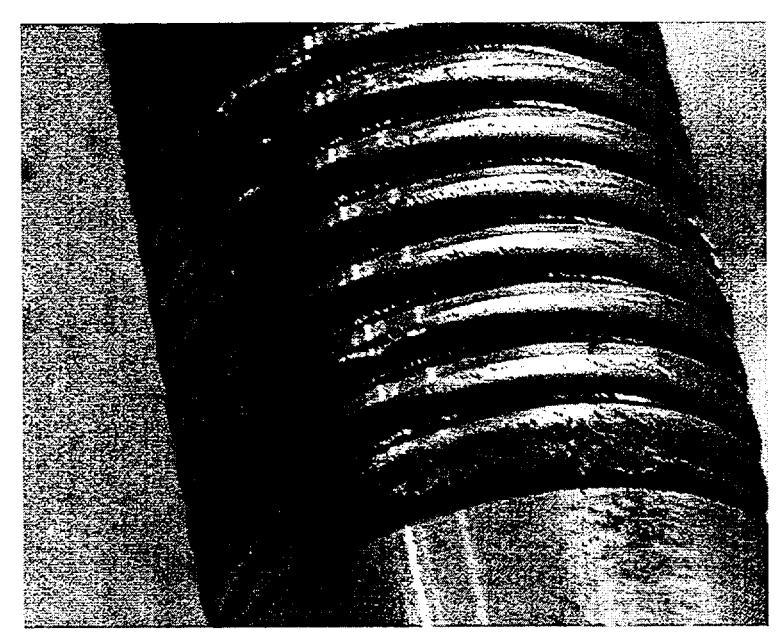
Figure 2-6. Typical cask primary lid bolt after removal.

All bolts were in satisfactory condition. The exposed portion of all bolt heads were found to be in very good condition. None of the primary lid bolts as shown in Figures 2-6 and 2-7 had any indications of

pitting or general corrosion, cracks, thread damage, discoloration, or any defects or indications of potential failure. All bolts had a deposit of graphitic thread lubrication over the threaded area of the shaft. Nine of the bolts also had a residue of a light gray/white material on the threads that resembled tape residue, and a residue of a red compound, probably a thread compound.

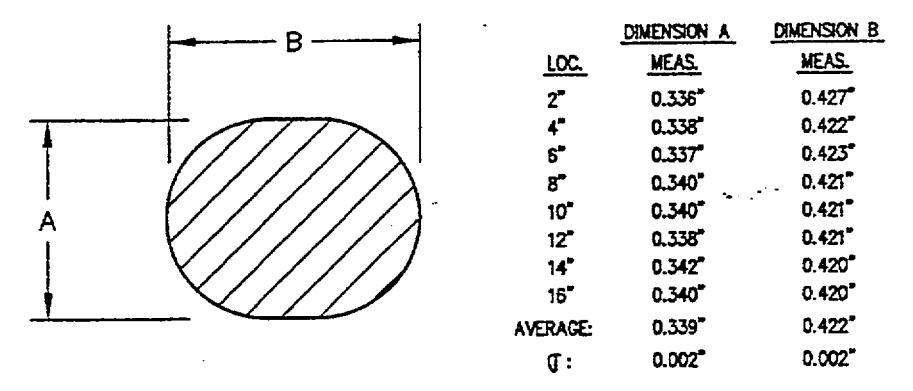
Figure 2-8. Primary lid elastomer O-ring crushed dimensional configuration.

The elastomer was still firmly resilient in consistency, flexible, and limber, with no evidence of embrittlement, stiffness, or depolymerization. Bending, pulling, twisting, and coiling the elastomer into a 30 cm (12 in.) diameter coil did not cause fracture or stress failure. There was no physical evidence of delamination or pullout of material, spallation, or chalking. The black elastomer surface exhibited a satin matte sheen and was free of breaks, cuts, scratches, cracks, or craze defects. There was no evidence of oxidation or physical degradation of the elastomer. The crushed dimensional configuration taken along a segment of the elastomer O-ring after removal (14 years of service) is presented in Figure 2-8.

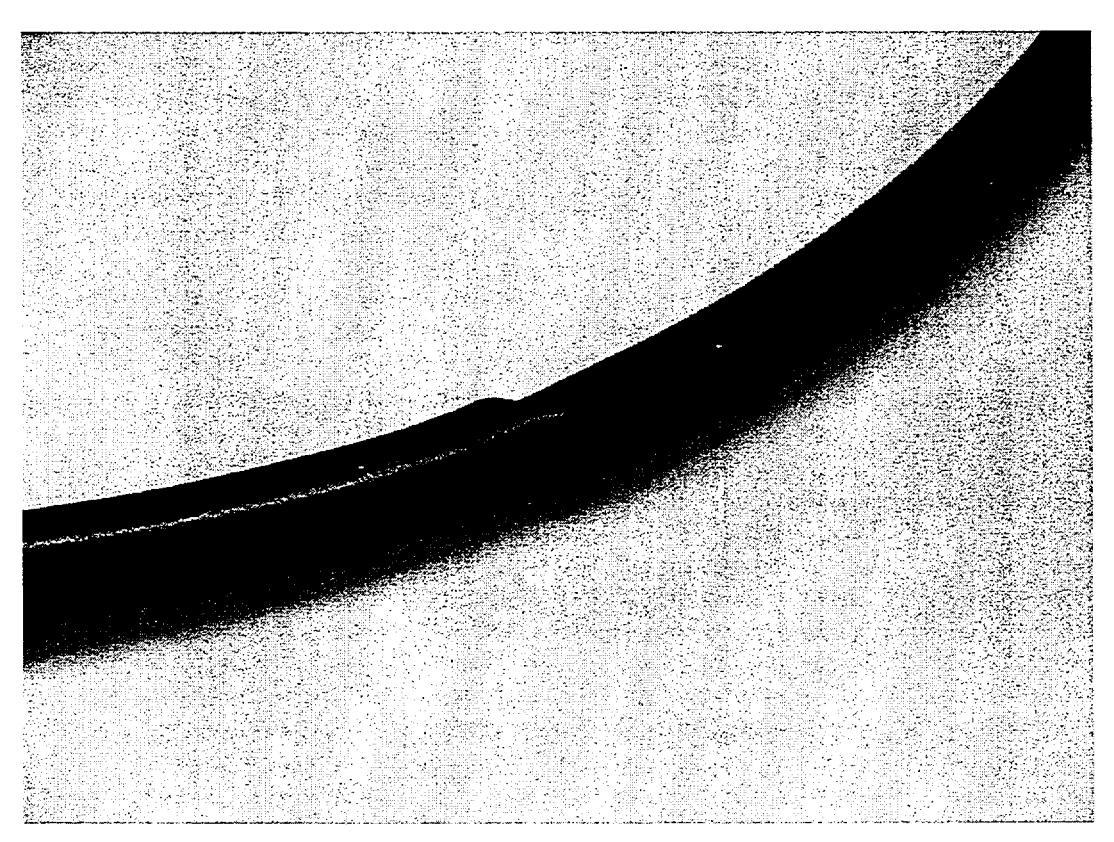
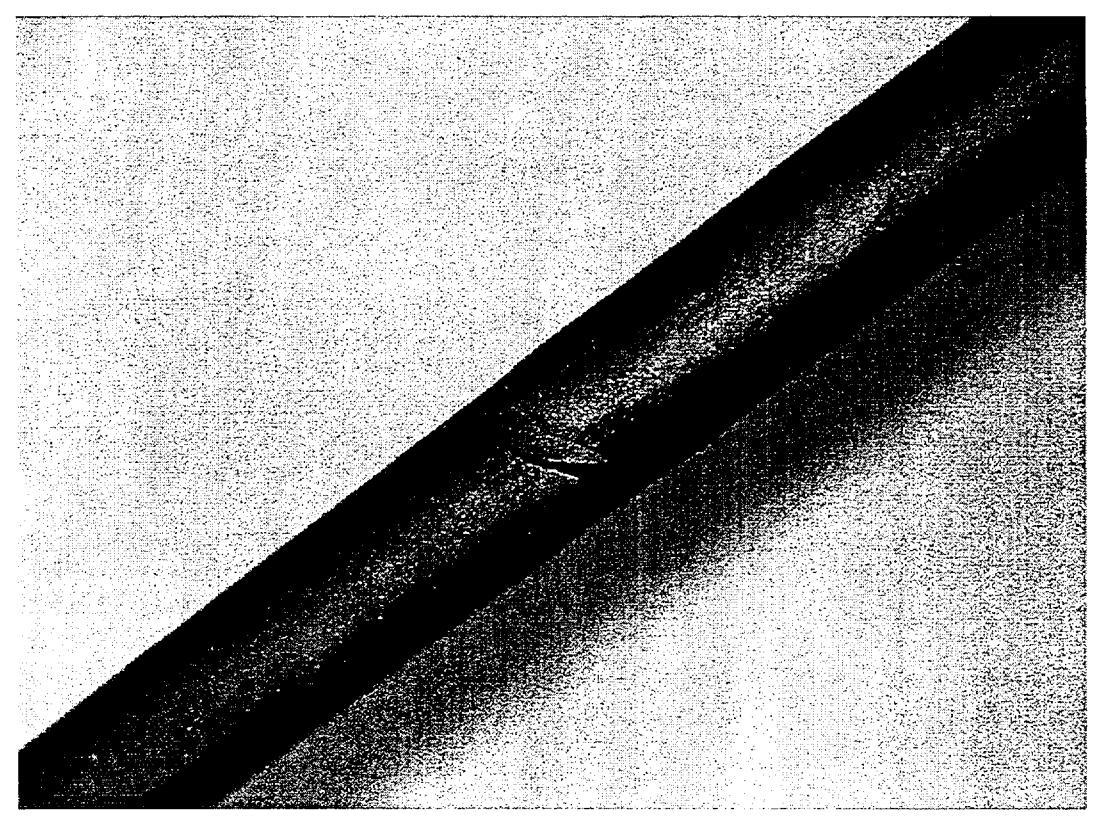
The elastomer O-ring was fabricated with a 45-degree scarf splice joint. As was noted in the remote camera inspections, the splice joint was slightly misaligned and partially open; the glue did not completely fill the gaps in the joint as shown in the Figures 2-9 and 2-10. However, the joint still had good strength and could not be pulled apart manually.

Figure 2-9. Elastomer O-ring splice joint configuration.

Figure 2-10. Elastomer O-ring splice joint configuration.

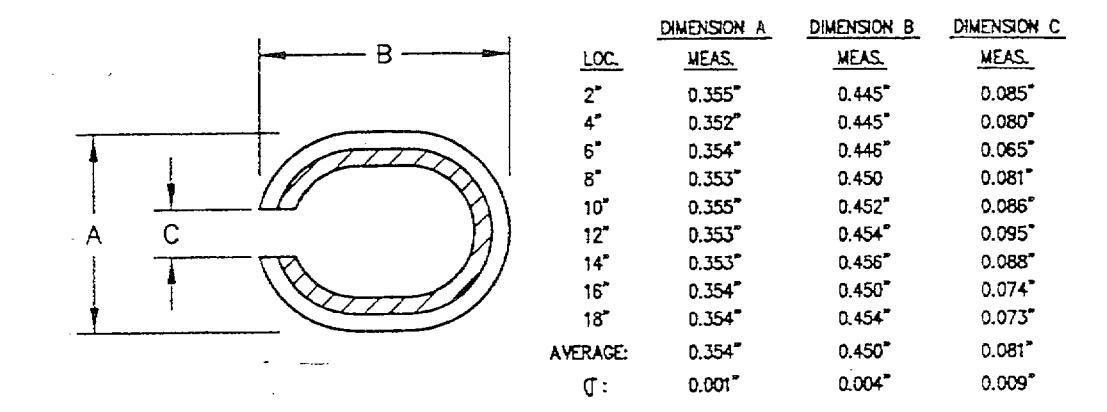
Figure 2-11. Primary lid metal O-ring crushed dimensional configuration.

The metal O-ring was also in good condition and was still ductile, as indicated by a few slight kinks, bends, and fresh surface scratches imparted by handling during removal from the lid. The metal showed no evidence of gross embrittlement such as cracks either in the body of the seal or at the handling defects. In general, the metal surface exhibited a metallic luster and showed no evidence of corrosion or extensive oxidation. The flattened contact surfaces bore the imprint of the machine marks of the O-ring groove and the mating seal surface of the cask body. The crushed dimensional configuration taken along a segment of the metal O-ring after removal (14 years of service) is presented in Figure 2-11.

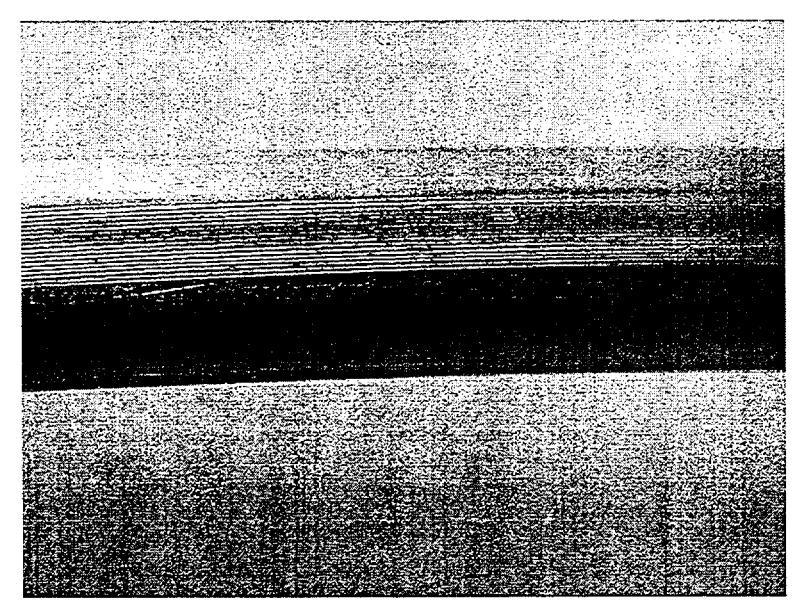
Figures 2-12. Primary lid metal O-ring.

The top surface of the metal O-ring, which was in contact with the seat of the O-ring groove, did not have any defects except for a few fresh (unoxidized) shallow scratches that have been attributed to handling damage during removal from the lid. The bottom surface as shown in Figure 2-12, which was in contact with the seal surface of the cask body, exhibited approximately 20 small pin-point indentations into the surface. The indentations were typically less than 1 mm (0.04 in.)in lateral dimension and did not appear to puncture the thickness of the metal O-ring. Because these were not spotted in the initial remote camera inspection, these features are being attributed to compression damage from environmental grit on the seal surface of the cask body. The grit was probably transfer from the bottom of the seal protector to the seal area during the fuel examination operations.

• Several pinpoint indentations, some on sealing surface; typically <0.5 mm dia, probably <0.5 mm deep

- Several light scratches, a few across the sealing surface; most have metal glint in scratch root, indicating fresh scratches
- No evidence of significant general corrosion, pitting corrosion, stains
- Sealing surface defined by the impression of the machining marks from the seal surface on cask
- No evidence of significant oxidation or spallation of these fine line features
- No deformation of the individual line impressions despite numerous cycles of lid removal/replacement during fuel inspection.

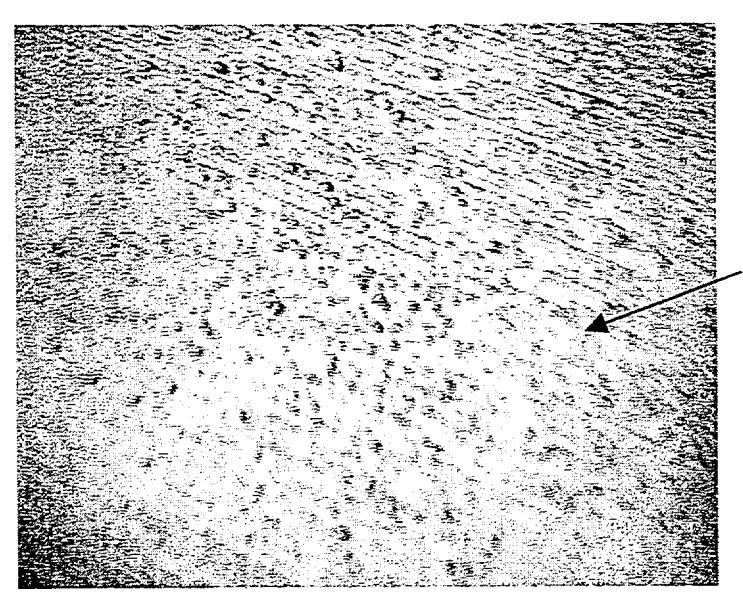
Figure 2-15. Cask wall below and between fuel tube A7 and A8—reflective surface free of corrosion—typical of cask wall condition without mineral stains.

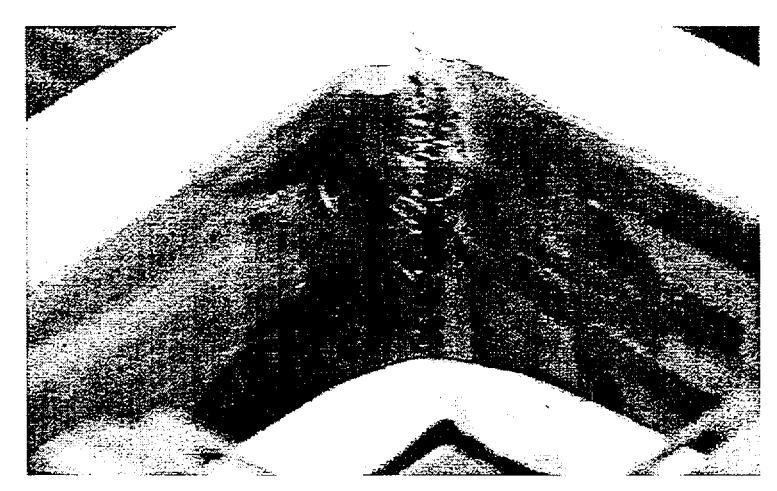
Figure 2-19. Crack in basket weld below weld crack 4 (120 degree side) identified in Figure 2-13.

The stitch welds in the triangular air channels appear to be nonstructural welds and were only intended to add additional stability for holding the fuel basket in place during 1985 fuel loading and vertical and horizontal thermal testing. The 1985 cask heat transfer performance testing (EPRI NP-4887) thermal analysis, concluded that the tightly fitted fuel basket expanded and came in contact with the basket barrel and the fuel barrel came in contact with the inner wall of the cask. The results of the thermal analysis indicated that thermal stresses in the weld joints at the eight crack locations identified in 1985 were well above yield stresses measured during tensile testing of applicable weld samples. Based on these results and speculations, it appears that all new cracks identified in 1999 occurred during the 1985 thermal testing. Further, it is concluded the cracks are not relevant to normal long-term storage and presents no adverse safety implications on the cask or components to perform their safety related function.

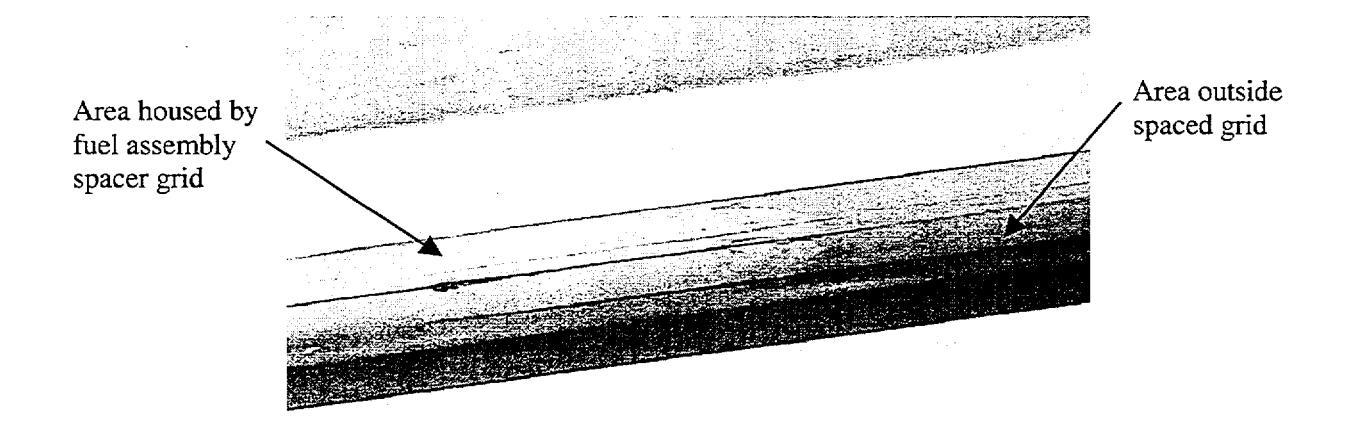
The twelve fuel rods were free of physical damage, except for long, continuous longitudinal scratches in the cladding from initial installation into the fuel assembly (Figure 2-23, 2-24 and Appendix E). The longitudial scratches were old scratches, for the roots of the scratches were thinly coated with oxide (crud). Several of the rods had many (6-12) parallel longitudinal scratches running most of the rod length; none of the scratches had perforated the cladding and are not caused by creep failure. There was no evidence on any of the rods of extensive corrosion, pitting, or creep failure.

Each rod was covered with a thin but uniform coating of oxide. The oxide coating seemed to comprise two layers, a light tan and a red-brown layer with sharp delineations between them, especially in the vicinity of the spacer grids (Figure 2-23 & Appendix E). These rods, drawn from within the bundle, appeared to have a more uniform oxide coating than the peripheral rods in the array. In general, the oxide layers appeared to be very thin and tenacious. On the upper portions of the rods, the incident lighting reflected diffusely from the thin oxide, imparting a pearly or vitreous satin sheen to the surfaces.

Figure 2-23. Close up of Fuel rod removed from fuel assembly T11 position 7H identified in Figure 2-22.

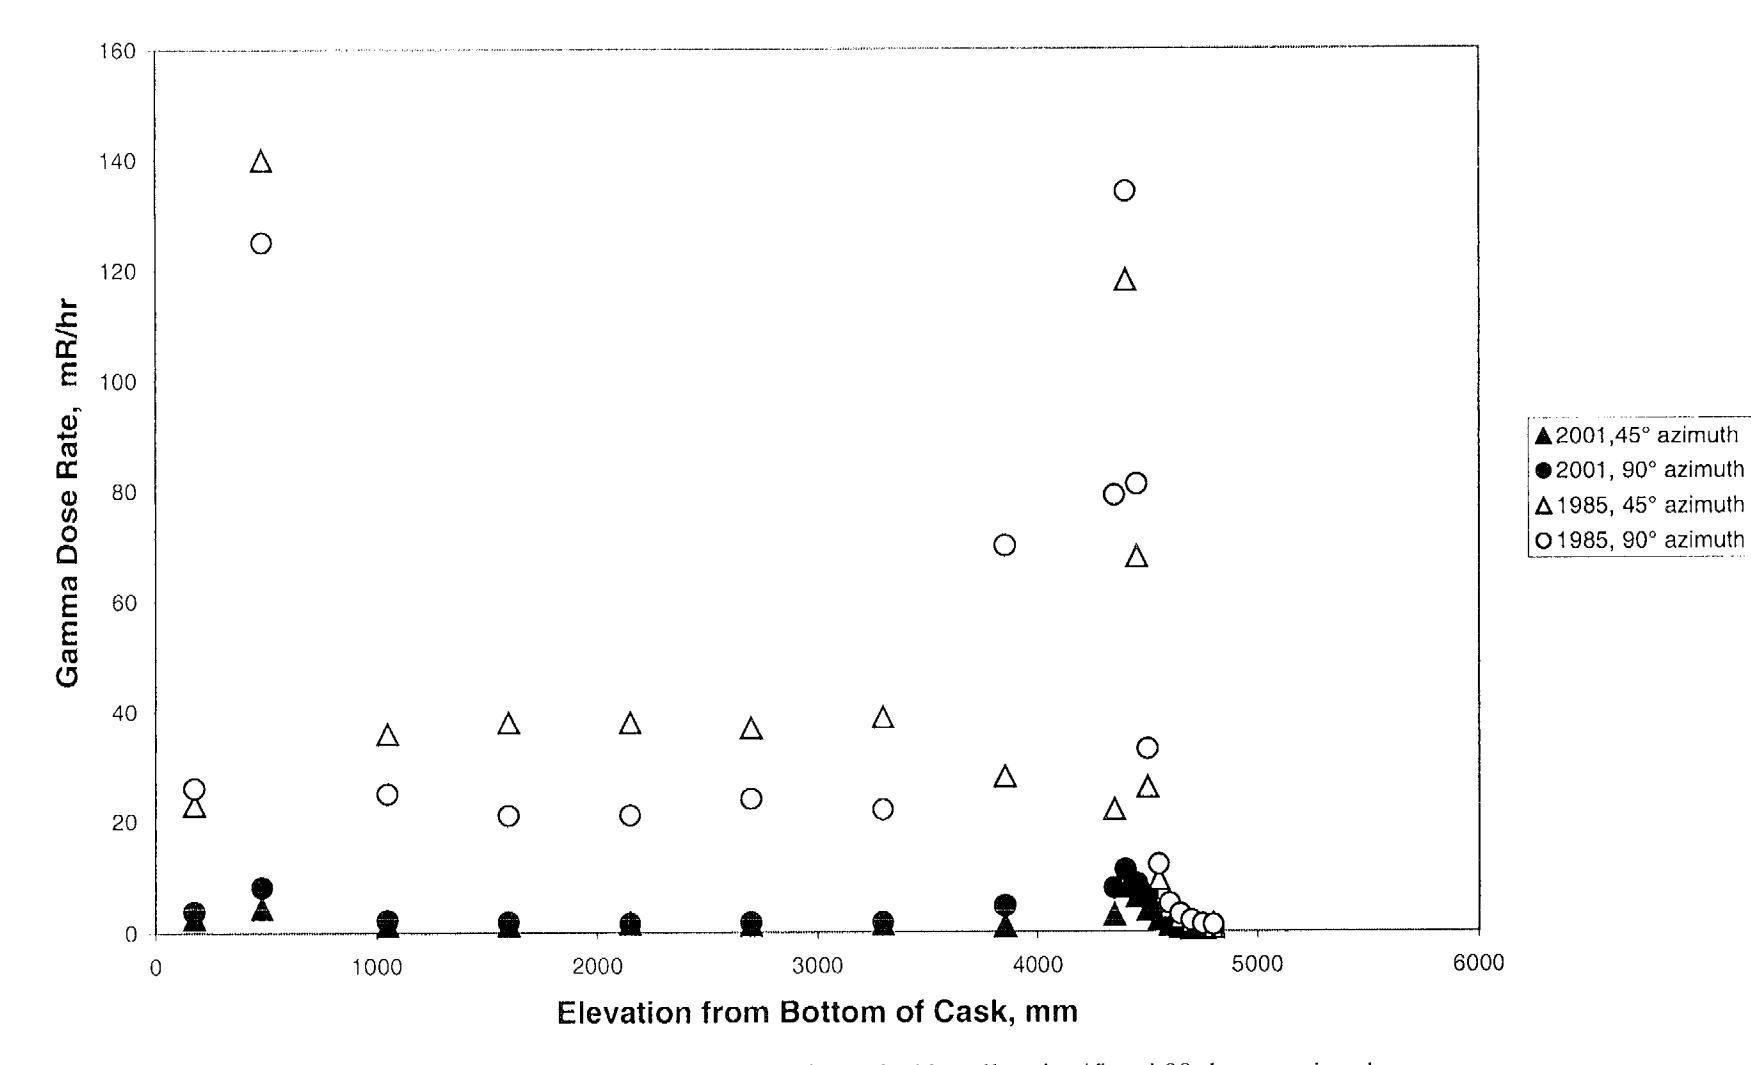
The gamma dose rates were acquired in 2001 at the same locations as the 1985 readings. The gamma results for 2001 and 1985 are summarized in Appendix A. As shown graphically in Figure 3-3, the 2001 gamma dose rate profiles for the 45 and 90-degree azimuths on the sidewall are qualitatively similar to the corresponding 1985 profiles, and show distinct gamma dose rate peaks near the bottom (480 mm elevation) and top areas (\approx 4400 mm elevation) of the side wall. The peaks correspond to the locations of the bottom and top flow nozzles of the PWR assemblies within the cask and are presumed to be due to ⁶⁰Co in the steel flow nozzles EPRI NP-4887, GNS Drawing 49001-E-01, GNS CASTOR SAR Figures 7.3-5 and 7.3-6).

The peak gamma dose rate (TLD) values decreased more than 90% from the 1985 values in agreement with the above decay-based projection. At the 480-mm elevation at the 45 and 90-degree azimuths, the peak dose rate dropped from 140 and 125 mR/hr in 1985 to 4.4 and 8.1 mR/hr, respectively, in 2001. At the 4400-mm elevation, the peak dose rates decreased from 118 and 134 (for the 45 and 90-degree azimuths) in 1985 to 8 and 11.1 mR/hr, respectively, in 2001. Similarly, the readings in the active fuel zone, corresponding to elevations of 1048 through 3850 mm, decreased approximately 95%, from 36.0 mR/hr (1 σ = 4.05) and 30.5 mR/hr (1 σ = 19.4) in 1985 to 1.32 (1 σ = 0.19) and 2.25 mR/hr (1 σ = 1.17) for the for the 45 and 90-degree azimuths, respectively, in 2001.

Figure 3-3. Comparison of the 2001 and 1985 gamma dose rates on the cask sidewall at the 45 and 90-degree azimuths.

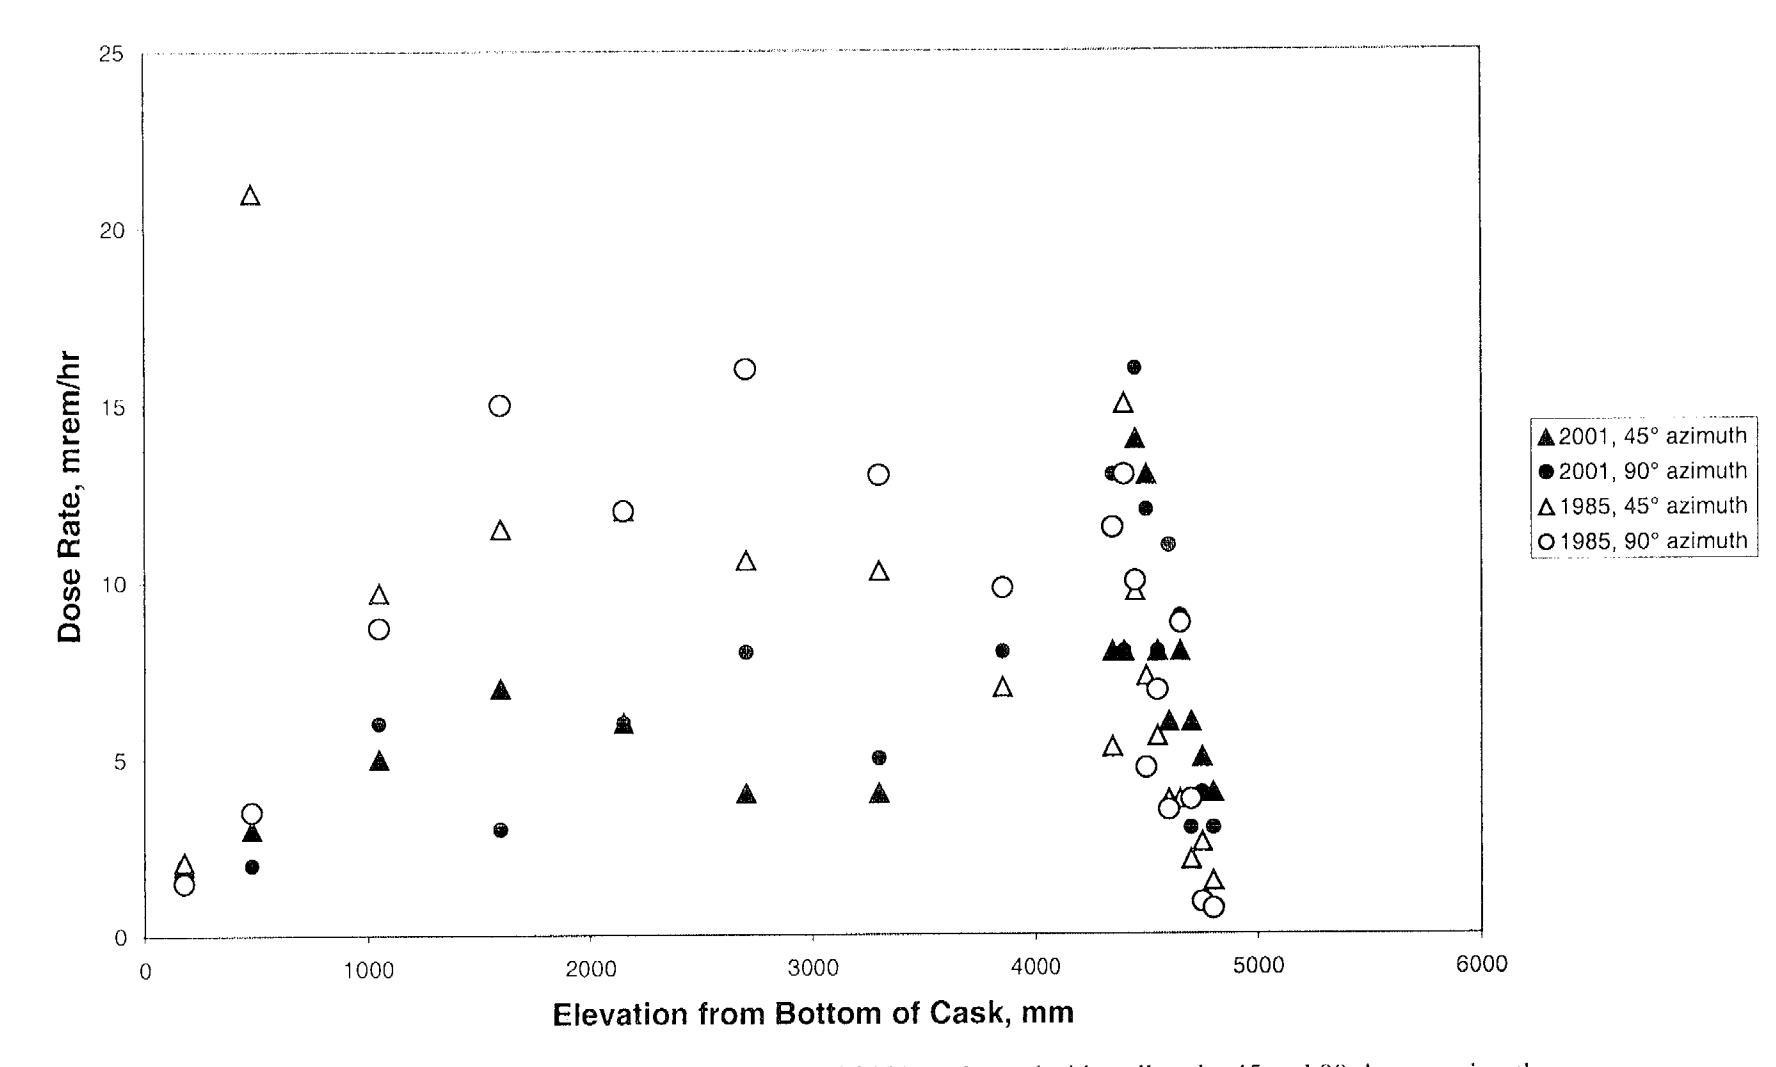
The neutron dose rate profiles for the cask sidewall in 1985 and 2001 are shown in Figure 3-6. The neutron dose rate data for both 1985 and 2001 show considerable scatter due to the measurement uncertainty of $\pm 30\%$. Because of the extremely long decay half-life of the fissile radionuclides in the fuel, the neutron dose rates for 1985 and 2001 should be comparable within the uncertainty of the measurements. The maximum neutron dose rates in 1985 and 2001 are comparable at approximately 16 mrem/hr. However, as indicated by Figure 3-6 and the summary in Table 3-2, much of the 2001 neutron dose rate data for the active fuel zone are approximately half the 1985 values. It is unlikely that the lower values in 2001 pertain to changes in shielding; the difference most likely is due to the use of two different methods for neutron dosimetry. The lower readings in 2001 were obtained with the Eberline E-600/NRD and suggest a lower response sensitivity to thermalized neutrons than the TED used in 1985. This possibility is suggested by the shape of the 2001 profile in Figure 3-5 in which the E-600/NRD readings are lower than the TED in the polyethylene-shielded fuel zone, yet comparable to the TED readings at elevations above 4400 mm, above the polyethylene rods within the cask wall. The manufacturer's response curve shows a decreasing sensitivity with decreasing neutron energy, from approximately 3 rem/n/cm² at 150 keV to 0.7 rem/n/cm² at 1 eV (Eberline). Depending on the extent of thermalization of the neutrons by the polyethylene shield rods, the E-600/NRD response for the neutrons from polyethylene-shielded zone of the side wall could easily be only 50% of the response for the less moderated neutrons above the polyethylene shield.

The 2001 data in Figure 3-6 do not show any increase in the neutron dose rate readings for sidewall elevations below 4400 mm, which corresponds to the top of the polyethylene shielding rods. This indicates that major degradation or slumping of the polyethylene shielding rods has not occurred.

Figure 3-6. Comparison of the neutron dose rates measured in 1985 and 2001 on the cask sidewall at the 45 and 90-degree azimuths.

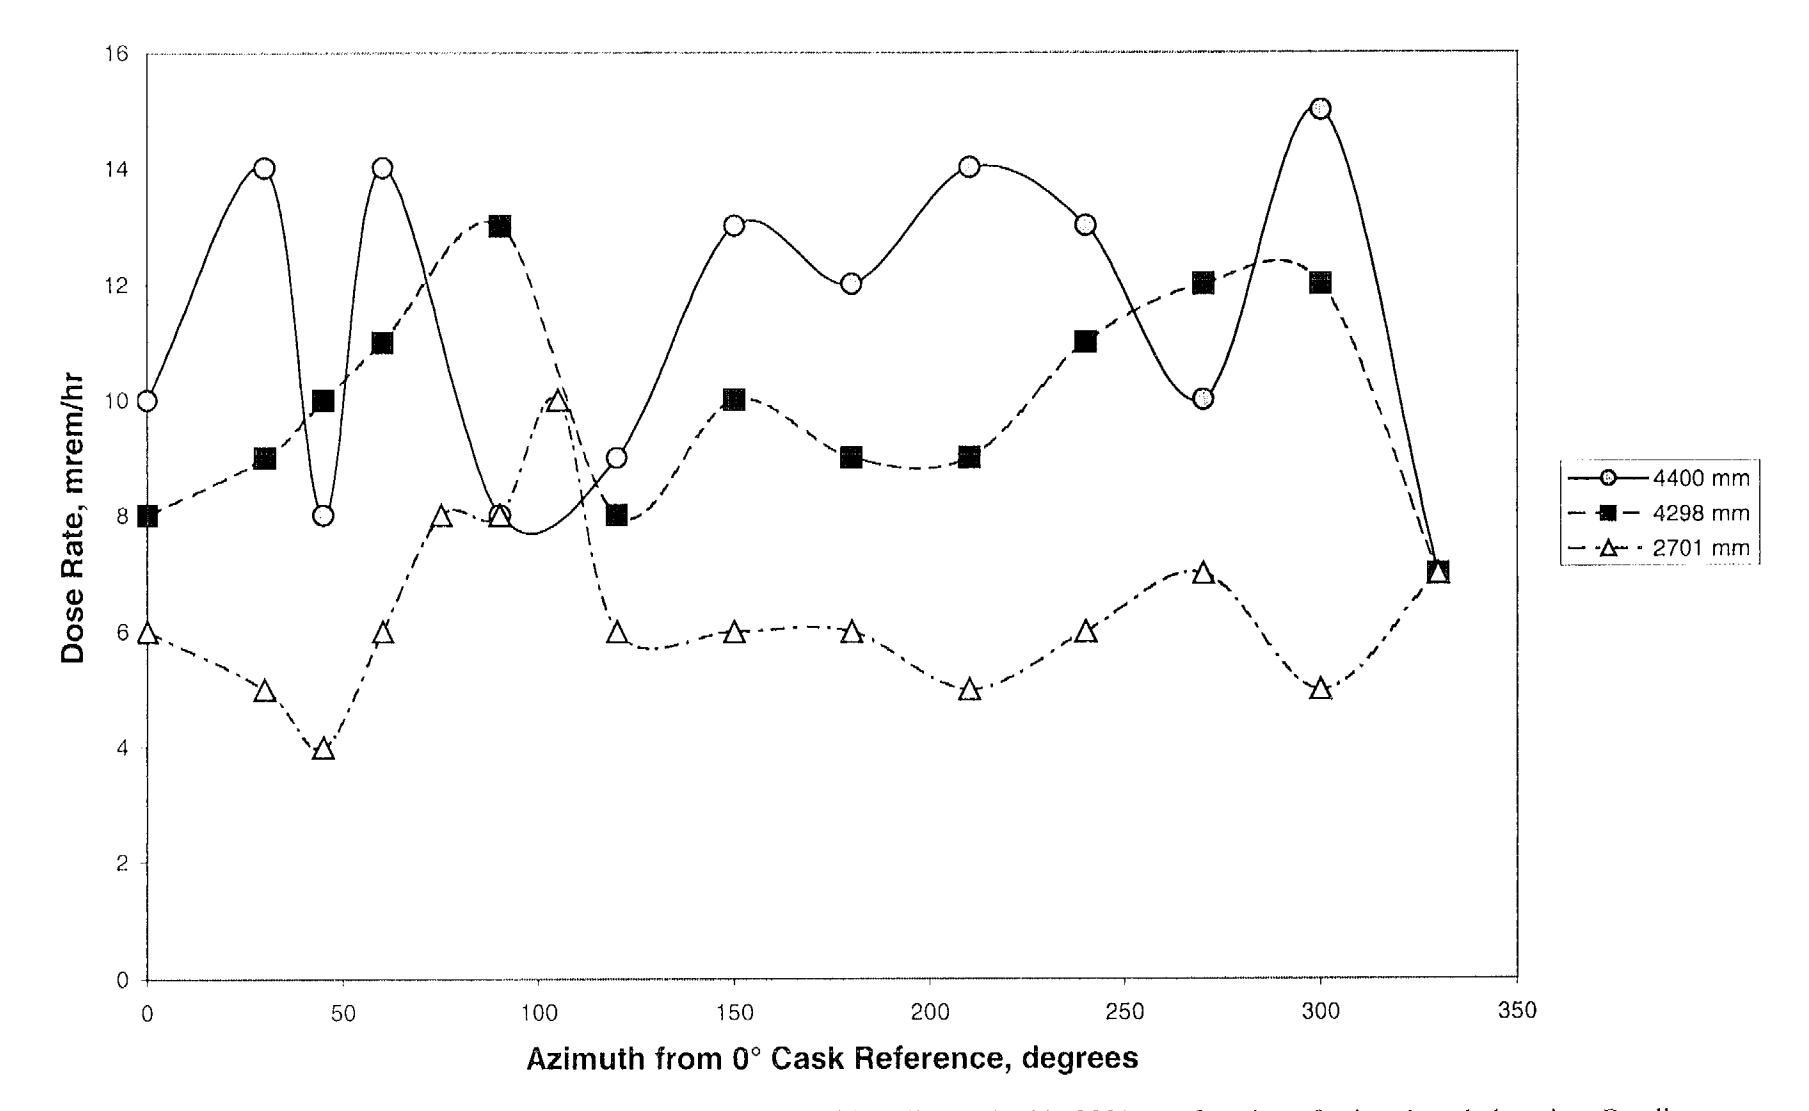
In 2001, 39 additional neutron dose readings were acquired at three sidewall elevations around the full circumference of the cask to determine the circumferential and axial uniformity of the cask shielding. The readings were obtained at the same locations as the circumferential gamma readings discussed above. The results for the neutron dosimetry are given in Appendix A and in Figure 3-7. The average circumferential readings at 4400, 4298, and 2701 mm are 11.3 mrem/hr ($\sigma = 2.8$ mrem/hr), 9.9 mrem/hr ($\sigma = 1.8$ mrem/hr), and 6.5 mrem/hr ($\sigma = 1.6$ mrem/hr) respectively. The readings at 4400 and 4298-mm elevation appear to be statistically identical and are in good agreement with the neutron dose rate data generated in 1985 as shown in Figure 3-8. The lower average at 2701 mm is most likely a function of the response curve of the NRD unit.

Figure 3-7. Circumferential profiles of neutron dose rates on the cask sidewall, acquired in 2001 as a function of azimuth and elevation. Readings were taken at the 4400, 4298, and 2701-mm elevations in 30-degree increments around the entire cask circumference.

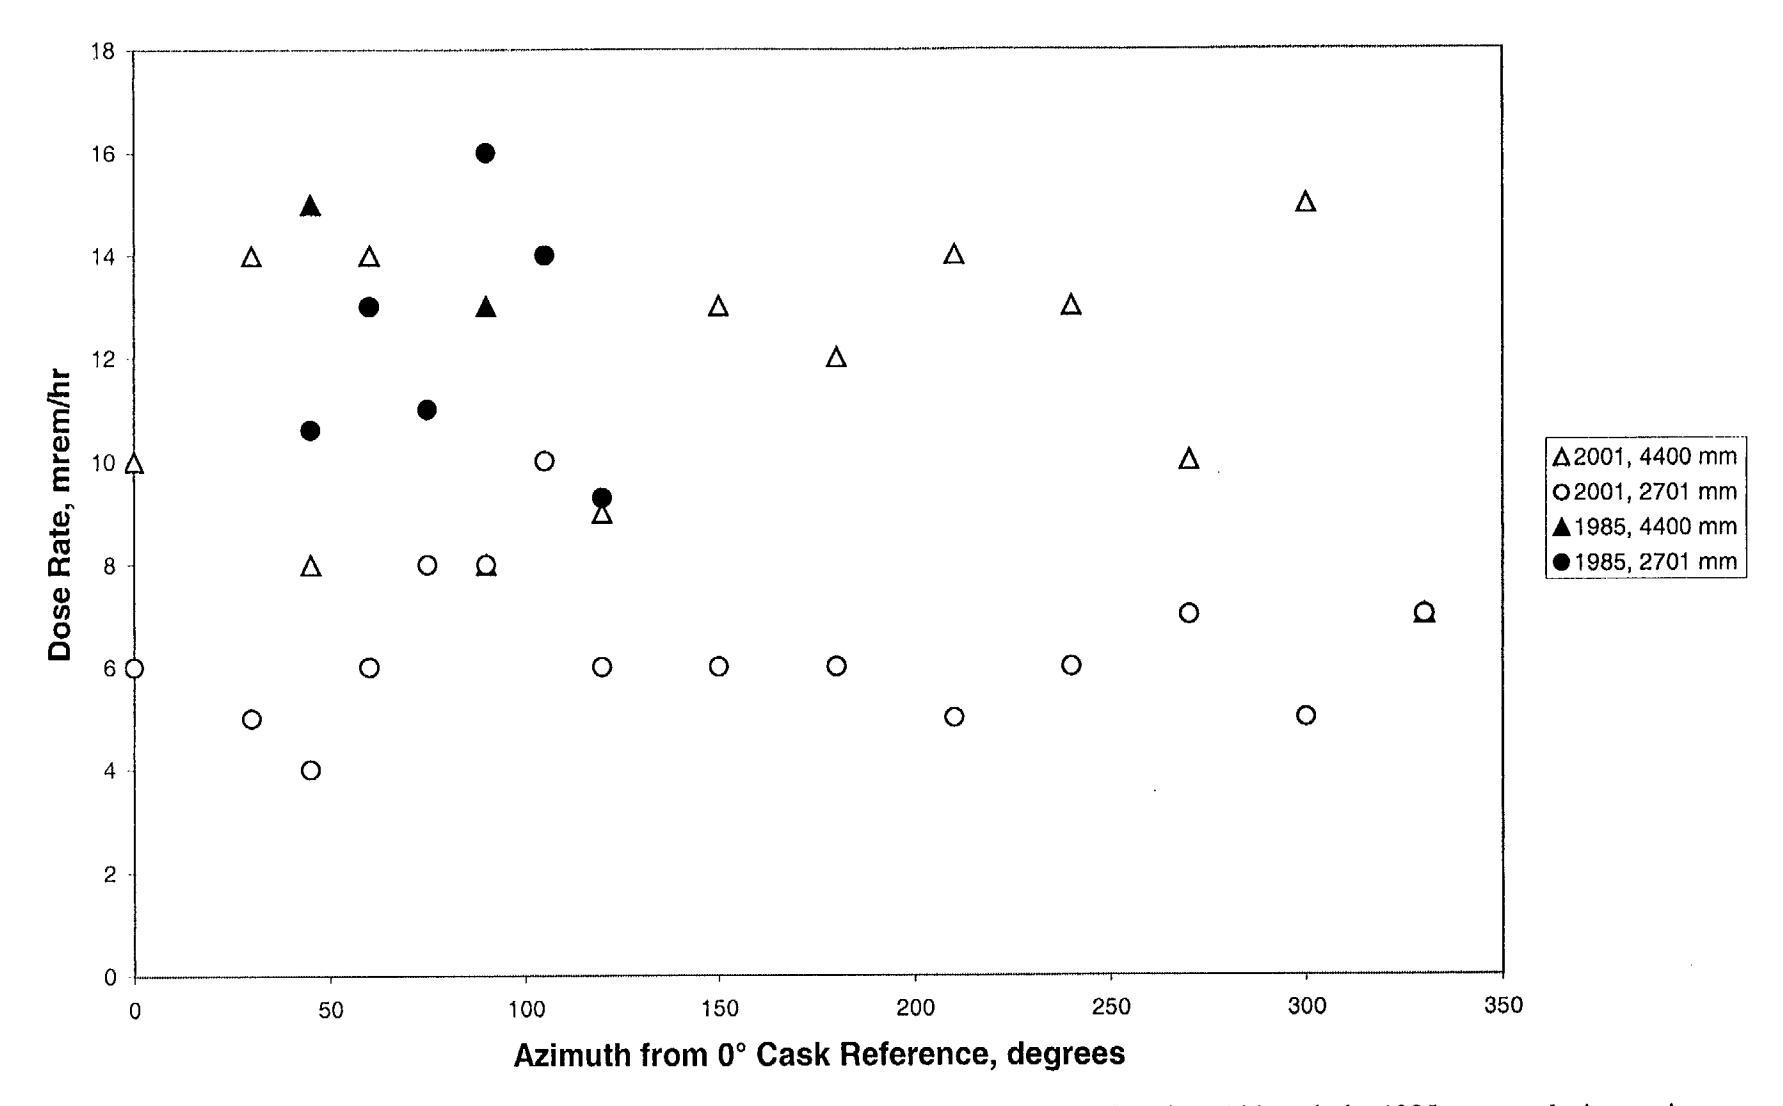
Figure 3-8. Comparison of the 1985 and 2001 neutron dose rates as a function of azimuth and elevation. Although the 1985 neutron dosimetry is limited to the 45–120-degree sector, the 2001 circumferential data compare favorably.

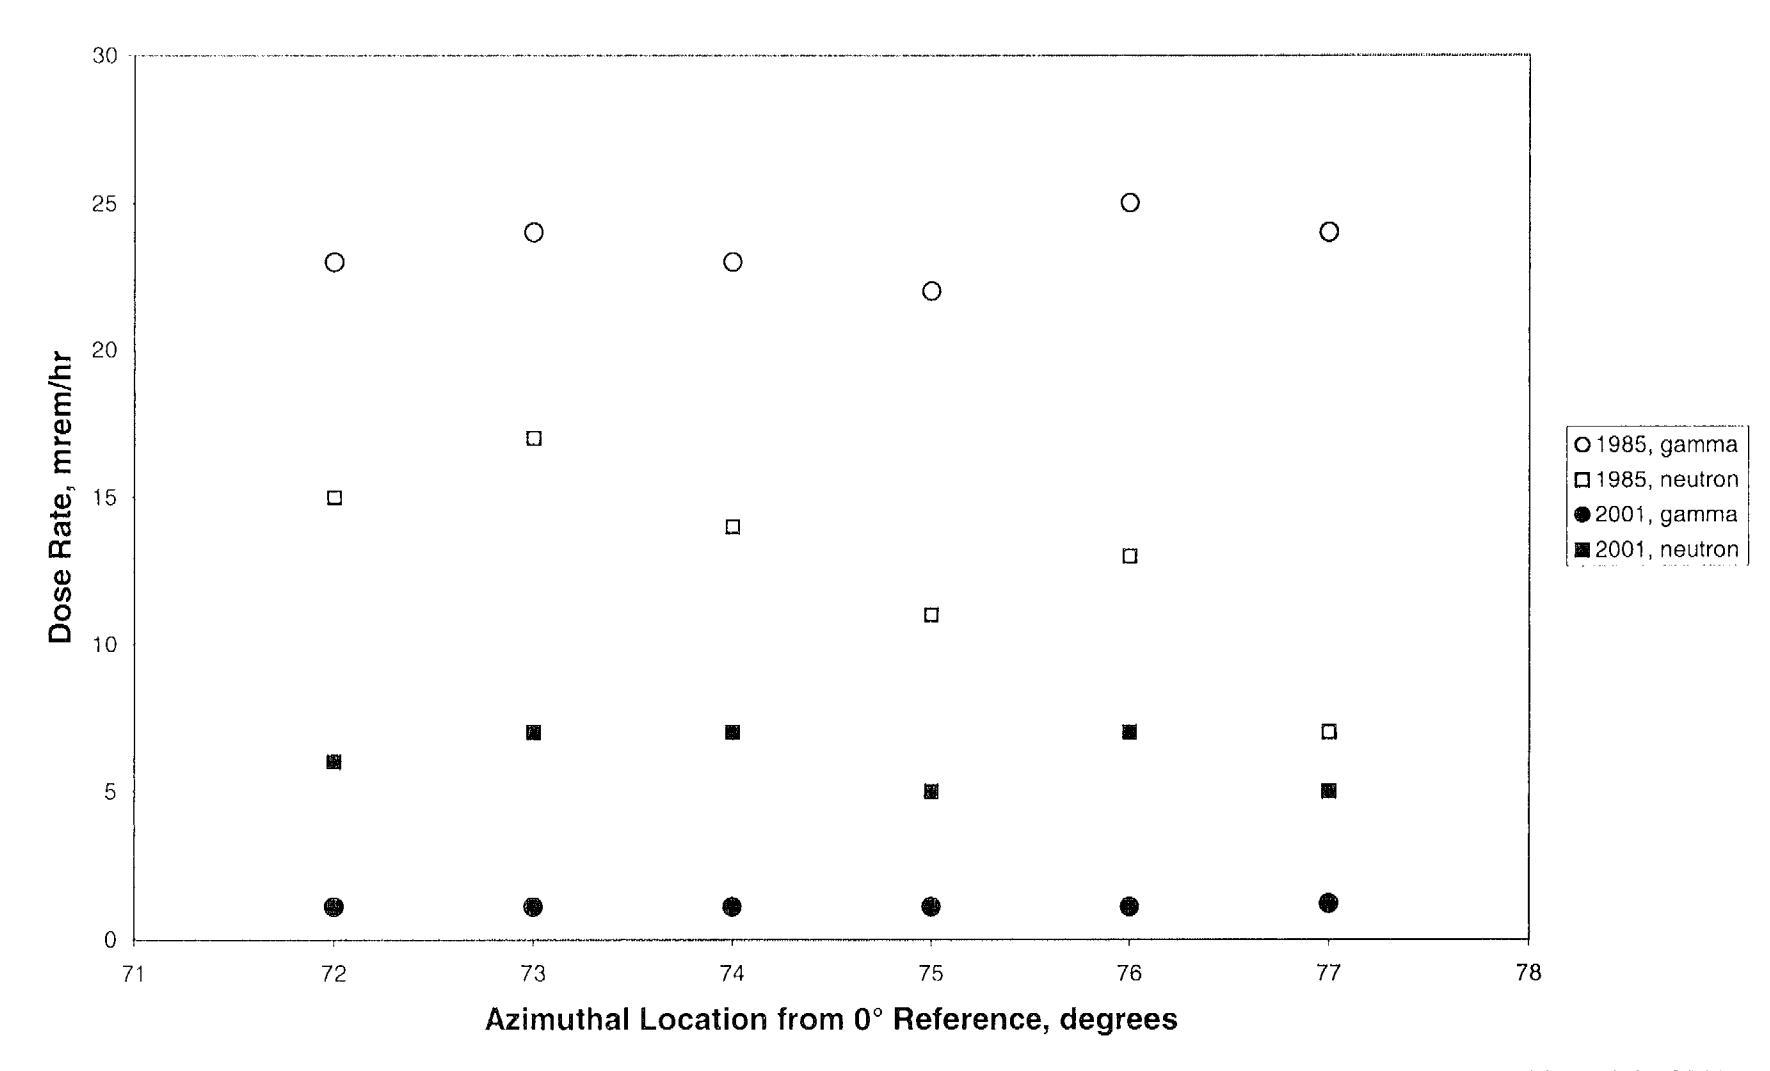
In 1985, neutron dose rate readings were made at 1-degree intervals from 72 to 77-degree azimuth (with respect to the 0-degree cask reference) at the 2149-mm elevation of the sidewall of the cask. The purpose of the original readings was to test for local nonuniformity of shielding due to the circumferential spacing of the cylindrical polyethylene shielding rods in the cask wall. At the time, no significant nonuniformity in neutron dose rate was observed. The test was repeated in 2001; the results are summarized in Figure 3-9 along with the 1985 results. Again, no significant nonuniformity was found in 2001. The measured neutron dose rates varied from 5 to 7 mrem/hr. However, as shown in Figure 3-9, the azimuthal profile of the 2001 neutron dose readings appears to duplicate the minor variations in the 1985 gamma and neutron dose rate profiles. The data do indicate that the stacking configuration of the polyethylene rods at this location has not changed between 1985 and 2001, and the effectiveness of the shielding has not diminished.

Figure 3-9. Local variations is shielding due to the stacking configuration of the cylindrical polyethylene rods. Plot compares the 1985 and the 2001 data for gamma and neutron radiation.

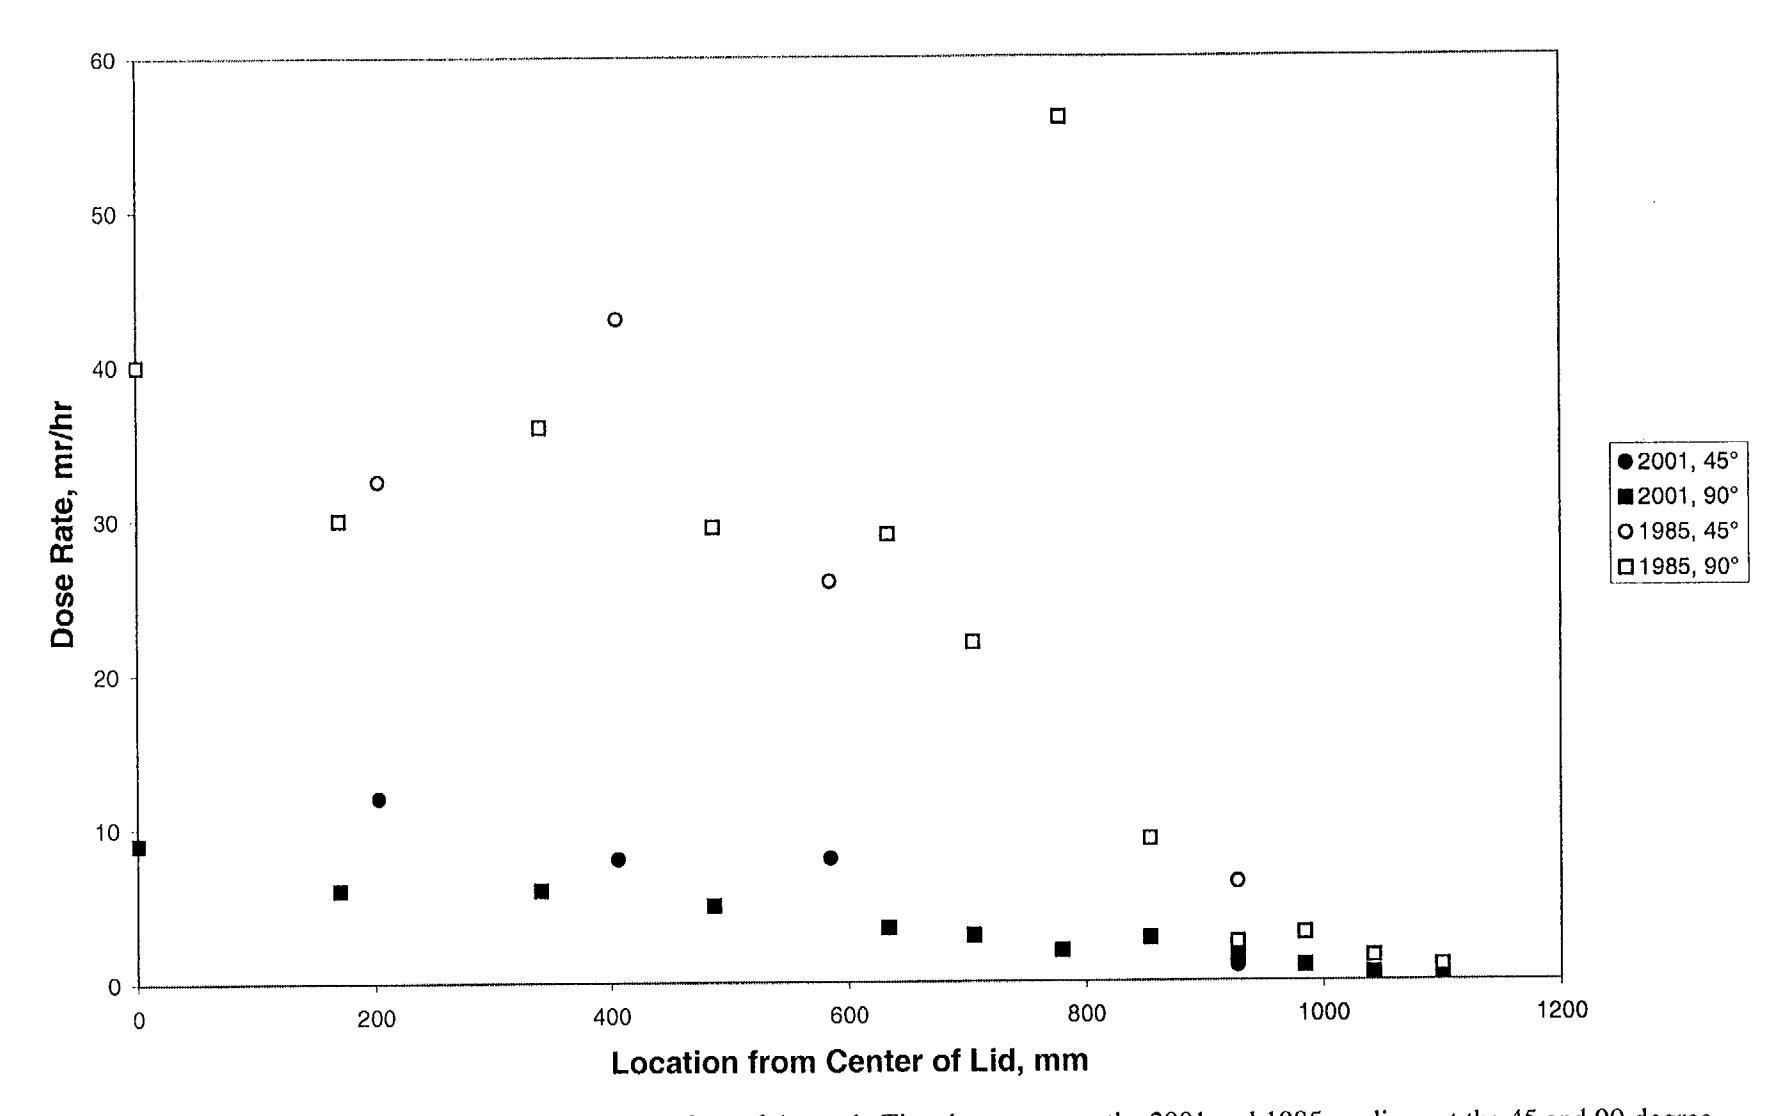
The gamma dose rate data for the top and bottom surfaces of the cask are summarized in Appendix A. Figures 3-10 and 3-11 graphically compare the gamma dose rate readings for the 45 and 90-degree azimuths in both the 1985 and the 2001 tests. The 2001 gamma dose rate values in the fuel region are approximately 15–20% of the corresponding 1985 values, consistent with ⁶⁰Co decay considerations. (Both the 1985 and 2001 measurements were taken with the secondary lid removed from the cask.) As shown by Figures 3-10 and 3-11, the dose rate profiles are fairly flat, with no spikes. The data for the 45 and 90-degree azimuths for the top and bottom are in very good agreement, within the uncertainty of the measurement.

Figure 3-10. Radial gamma dose rate profile on the top surface of the cask. The plot compares the 2001 and 1985 readings at the 45 and 90-degree azimuths.
