Dry Cask Storage Characterization Project—Phase 1: CASTOR V/21 Cask Opening and Examination

Idaho National Engineering and Environmental Laboratory

NUREG/CR-6745 INEEL/EXT-01-00183

Prepared by W.C. Bare, L.D. Torgerson

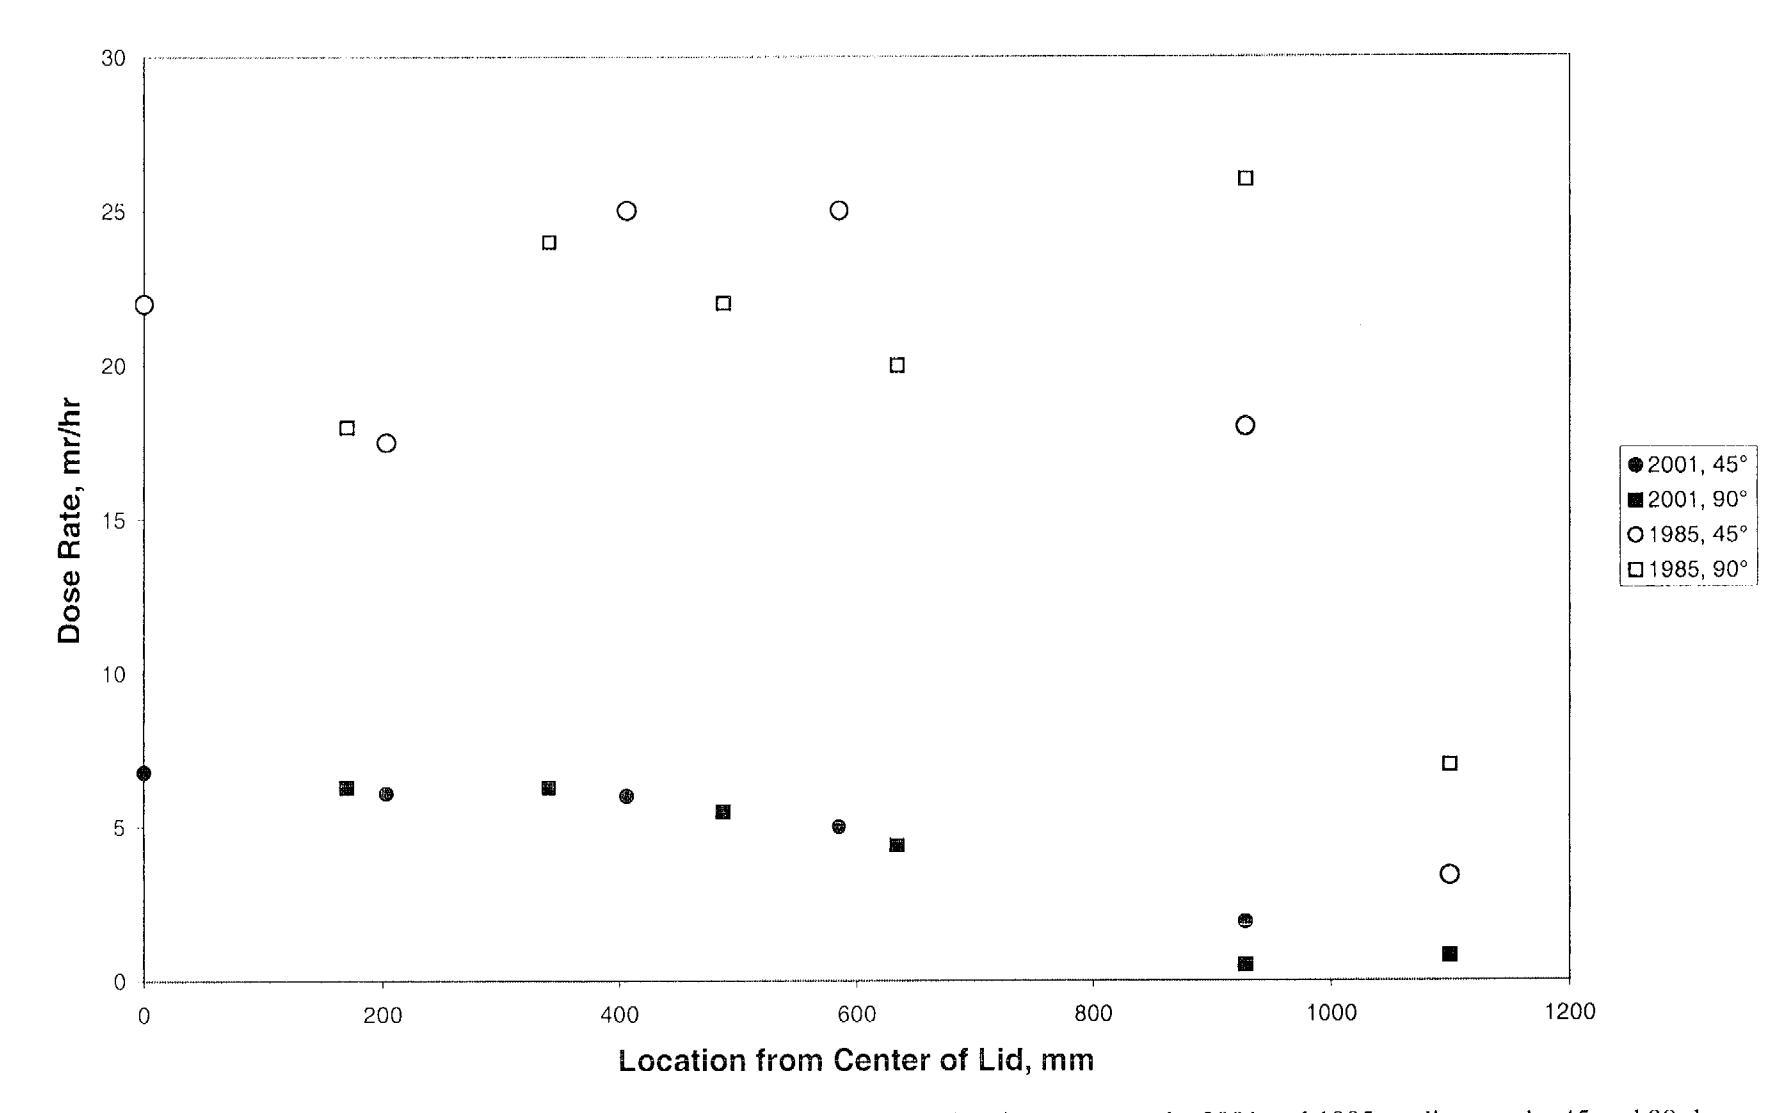
The gamma dose rate data for the top and bottom surfaces of the cask are summarized in Appendix A. Figures 3-10 and 3-11 graphically compare the gamma dose rate readings for the 45 and 90-degree azimuths in both the 1985 and the 2001 tests. The 2001 gamma dose rate values in the fuel region are approximately 15–20% of the corresponding 1985 values, consistent with ⁶⁰Co decay considerations. (Both the 1985 and 2001 measurements were taken with the secondary lid removed from the cask.) As shown by Figures 3-10 and 3-11, the dose rate profiles are fairly flat, with no spikes. The data for the 45 and 90-degree azimuths for the top and bottom are in very good agreement, within the uncertainty of the measurement.

Figure 3-11. Radial gamma dose rate profile on the bottom surface of the cask. The plot compares the 2001 and 1985 readings at the 45 and 90-degree azimuths.

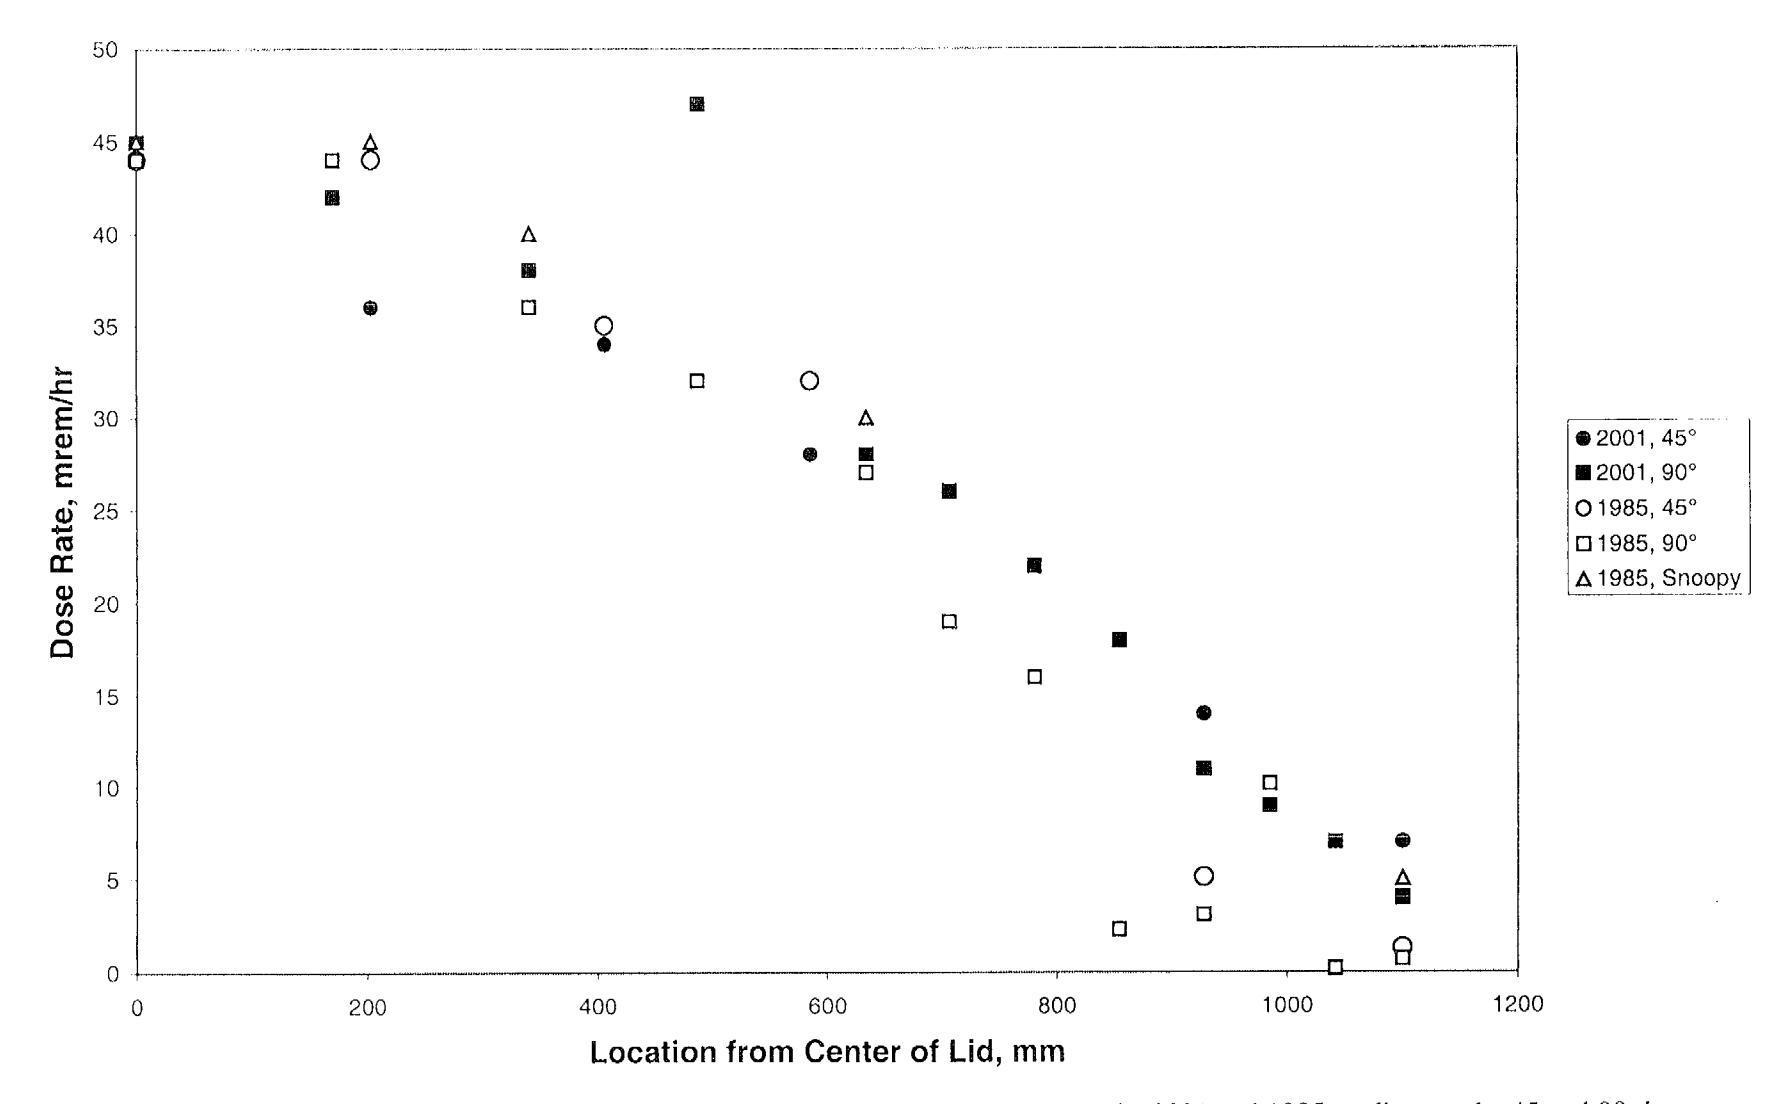
Figures 3-12 and 3-13 compare the 2001 and 1985 neutron dose rate data for the top and bottom surfaces of the cask. As shown in Figure 3-12, the 2001 and 1985 neutron dose rates for the cask top are identical both in profile shape and in magnitude. As in the 1985 measurements, the neutron dose rate peaks near the center of the cask lid at approximately 45 mrem/hr.

Figure 3-12. Radial neutron dose rate profile on the top surface of the cask. The plot compares the 2001 and 1985 readings at the 45 and 90-degree azimuths.

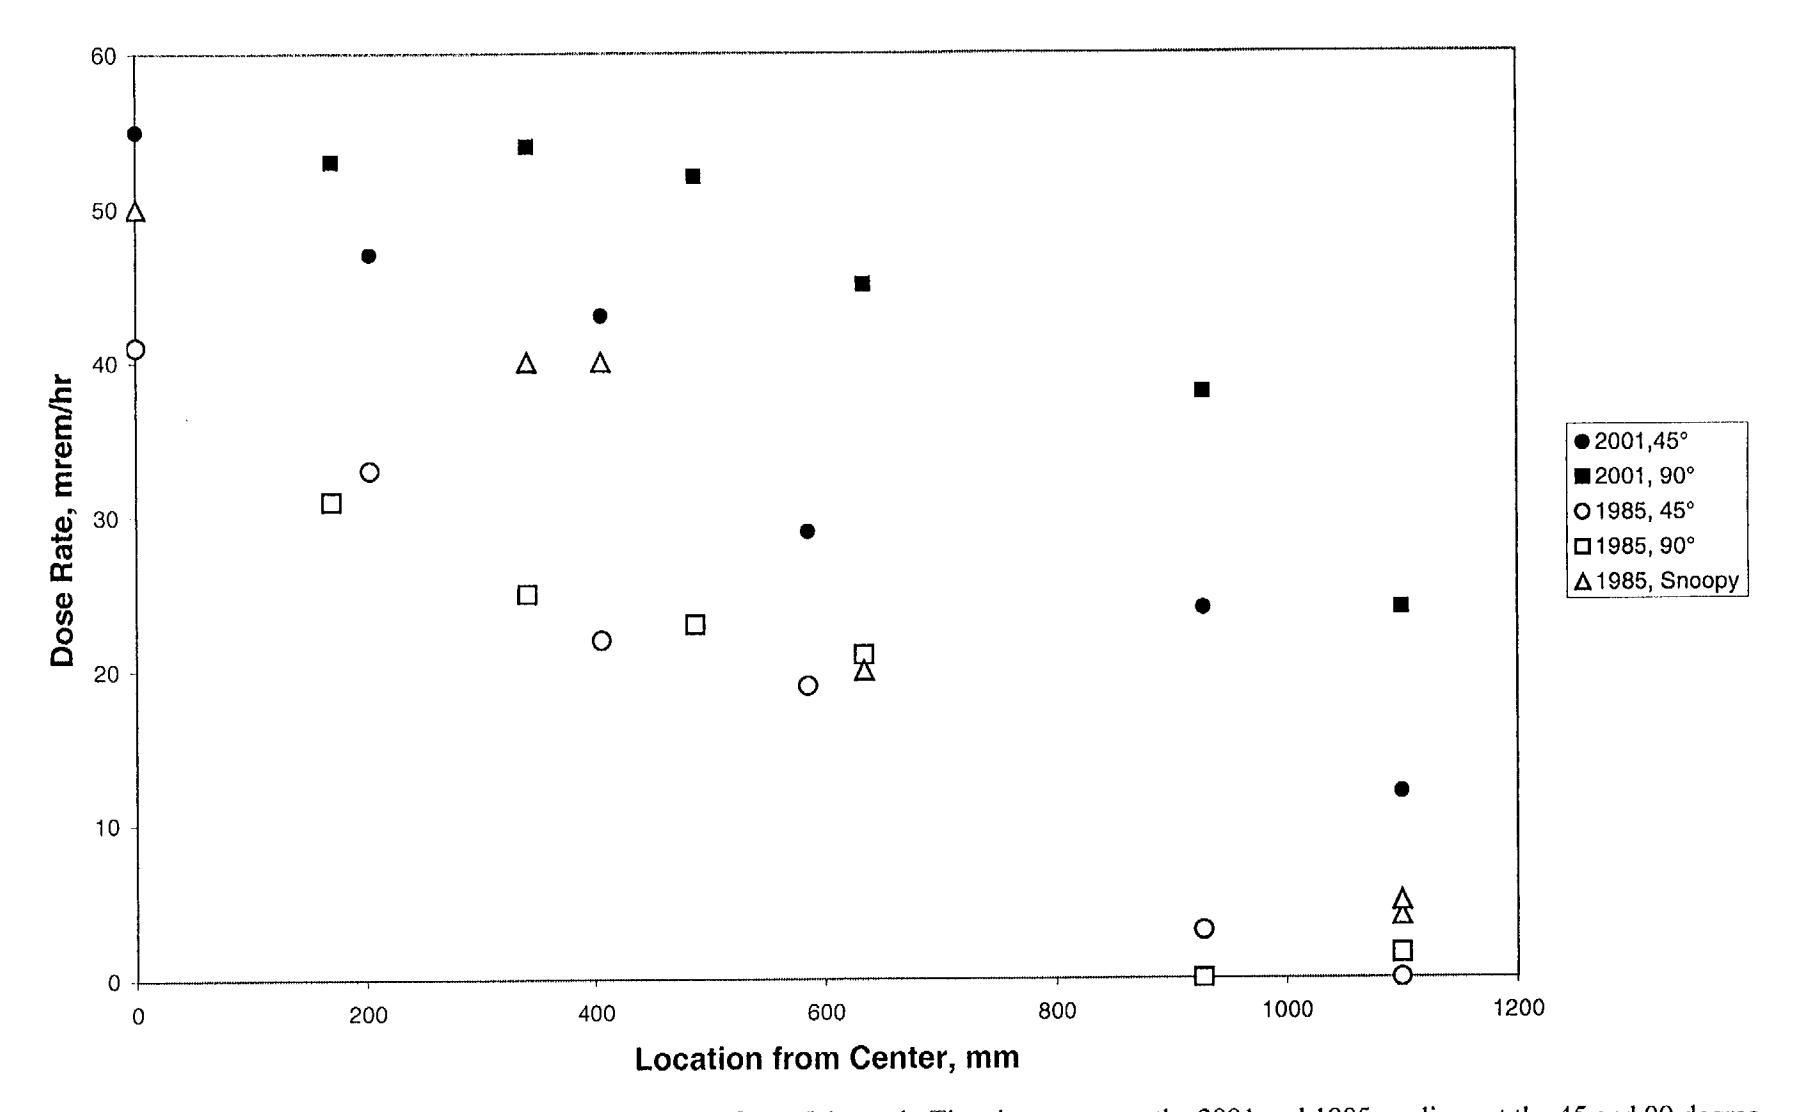
Figure 3-13 compares the neutron dose rate data for the bottom of the cask from the 2001 and 1985 tests. Unlike the top surface, the 2001 neutron dose rates are consistently higher than the corresponding 1985 data. Within the radius of the fueled area, the 2001 neutron dose rates are approximately twice as high as the 1985 values; the difference is even greater beyond the fueled area. The 2001 neutron dose rates at the 90-degree azimuth ranged from 53 mrem/hr near the center to 24 mrem/hr at the outer edge; whereas the 1985 readings ranged from 31 to 1.6 mrem/hr, respectively. In addition, unlike the top surface readings, the 45-degree azimuth readings are consistently lower than the readings at the 90-degree azimuth readings in 2001 ranged from approximately 55 mrem/hr in the center to 12 mrem/hr at the outer edge. By comparison, the 1985 neutron dose rates at the 45-degree azimuth ranged from 41 to 3 mrem/hr.

Figure 3-13. Radial neutron dose rate profile on the bottom surface of the cask. The plot compares the 2001 and 1985 readings at the 45 and 90-degree azimuths.

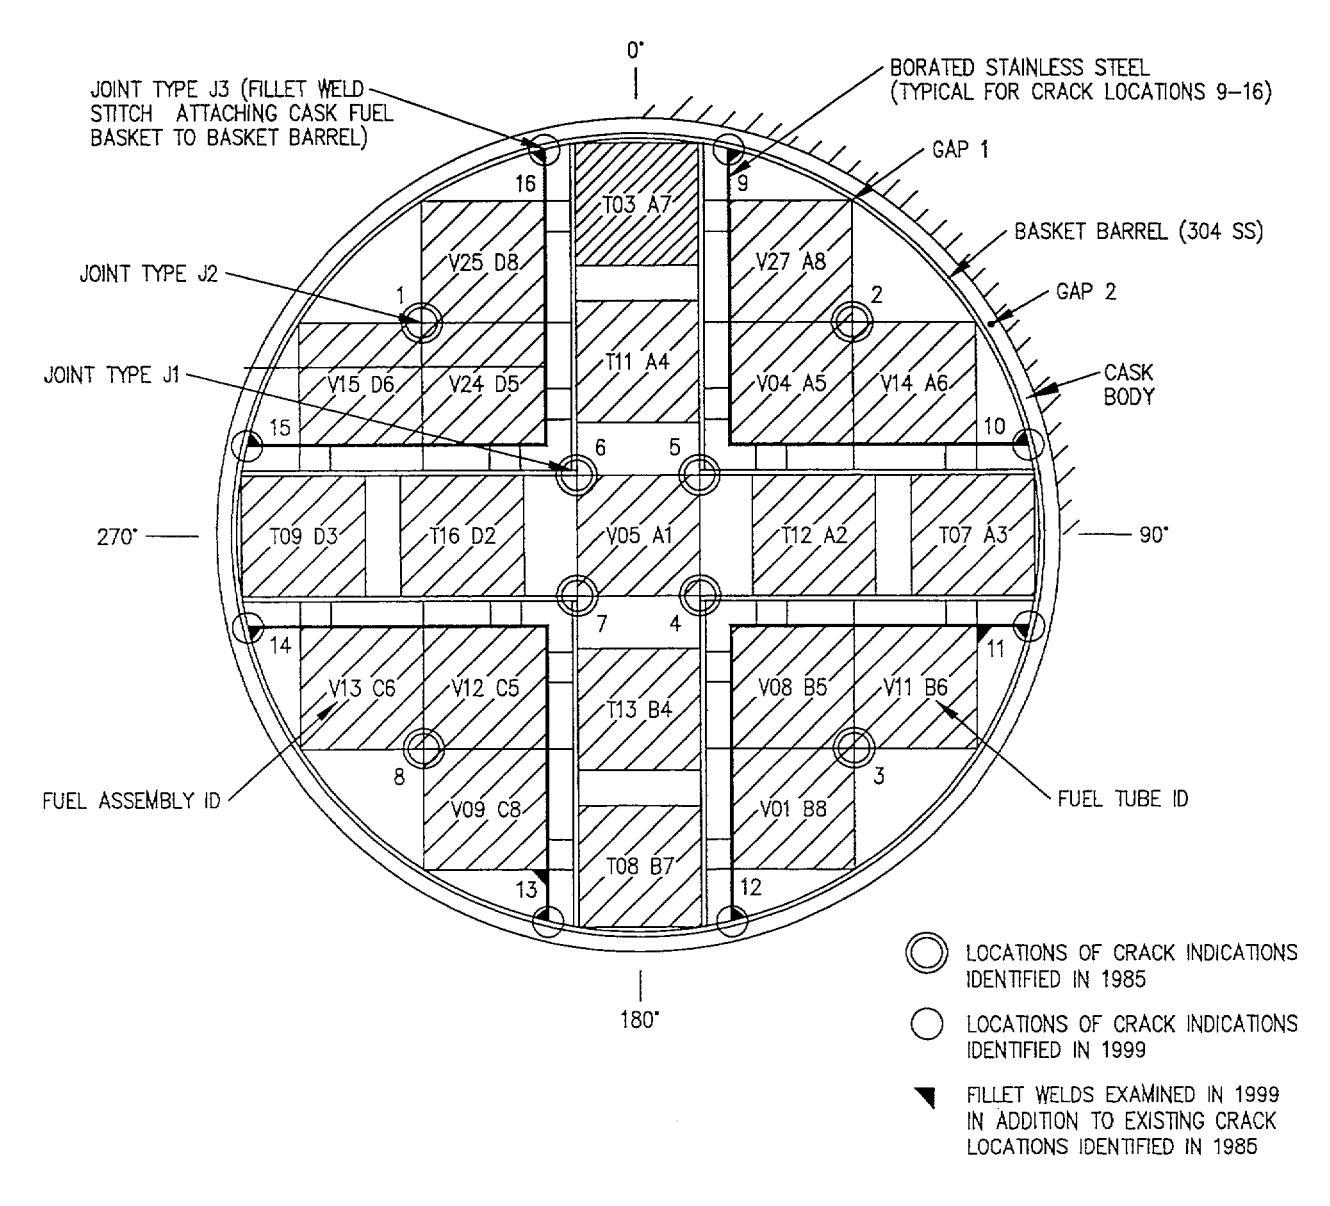
Figure B-19. CASTOR V/21 Basket Crack Indication Locations.

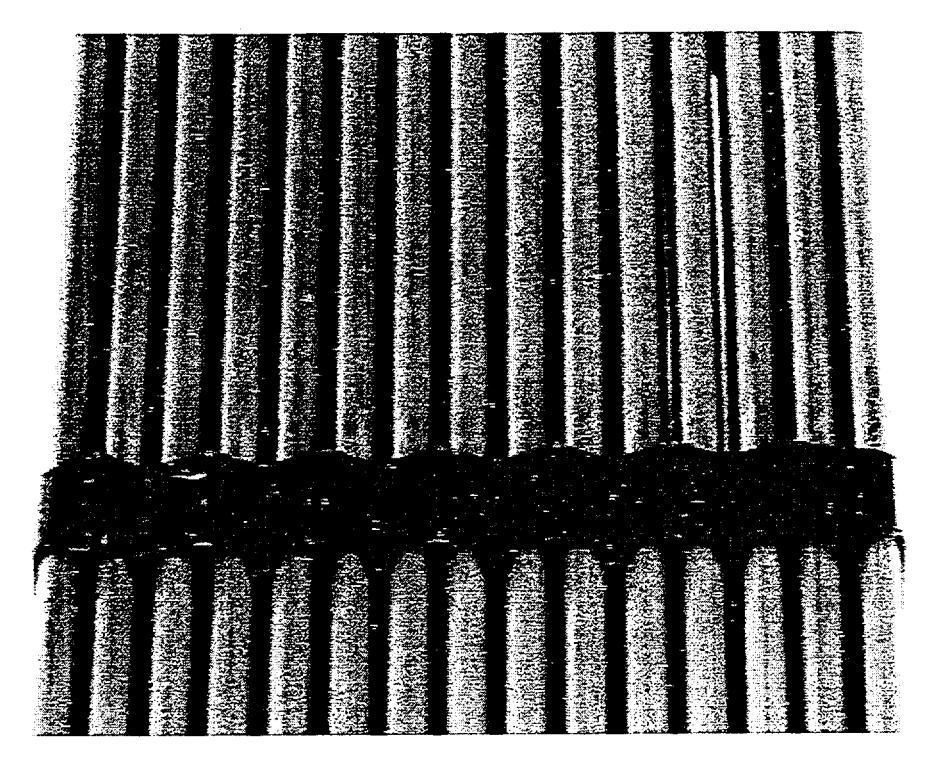
Figure C-5. Fuel assembly V-05-area around upper grid spacer-rods clean and minimal bowing noted.

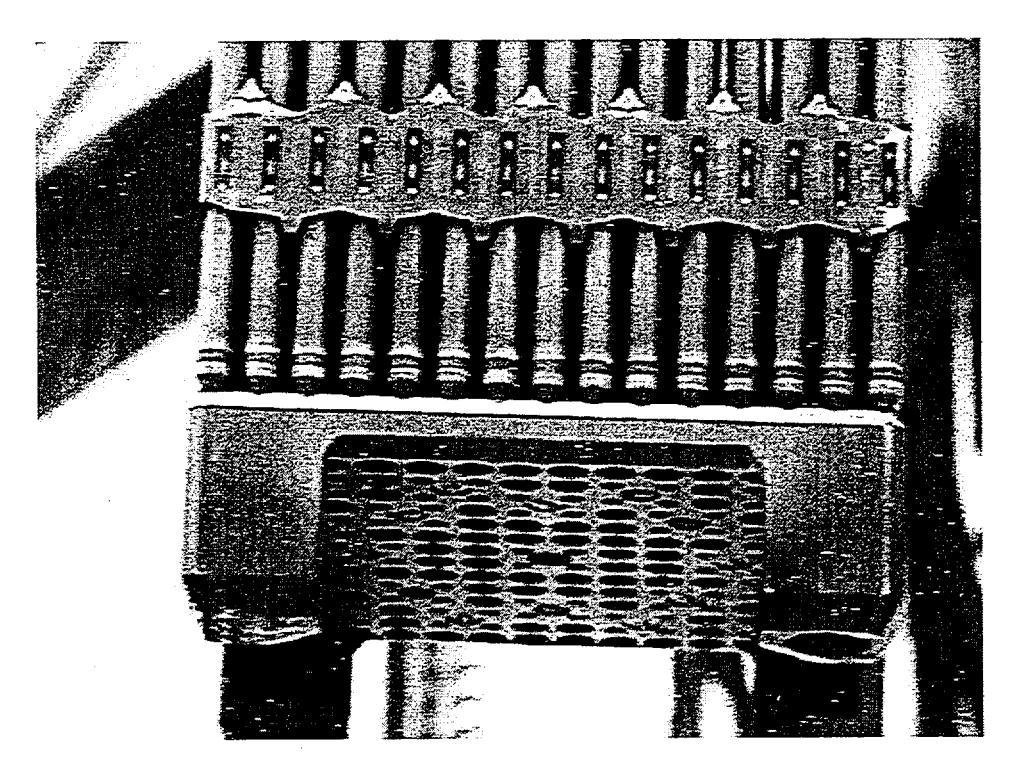
Figure C-12. Fuel assembly V-05-bottom left nozzle-noted mechanical fasteners searing guide tubes.

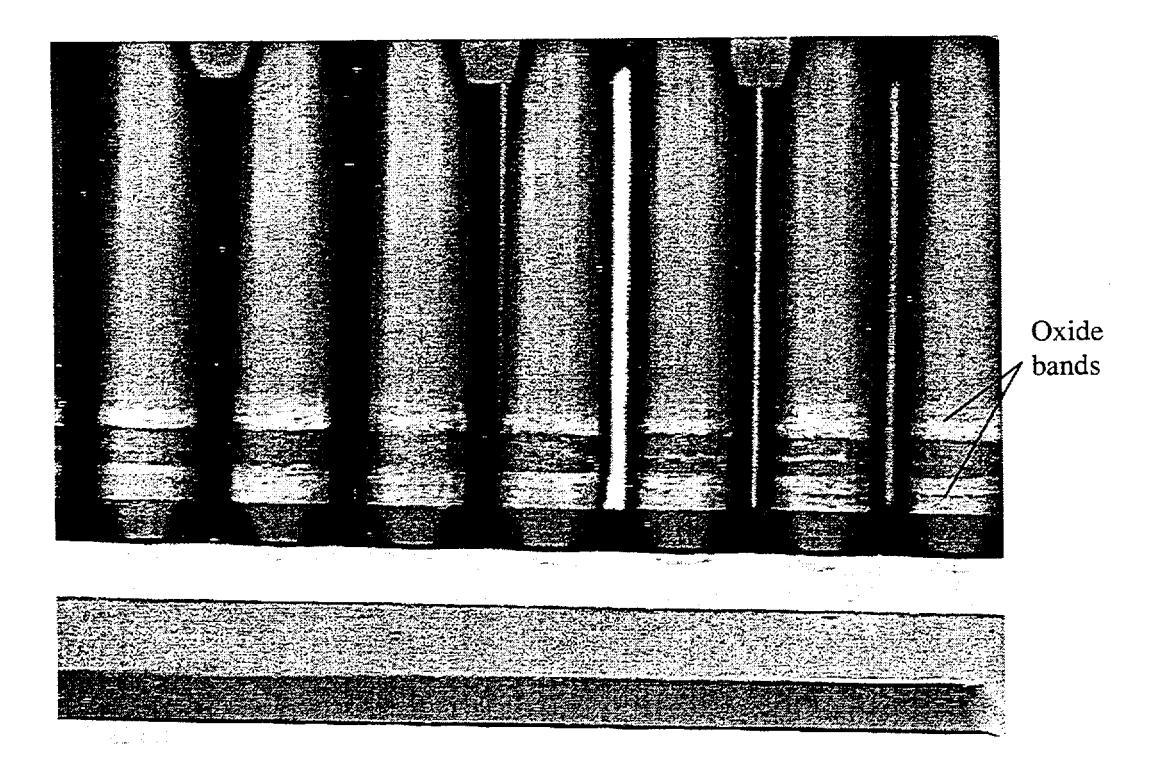
There was no evidence of major crud spallation from the fuel rod surfaces.

Figure C-13. Fuel assembly V-05 looking for loose "crud"---non was evident.

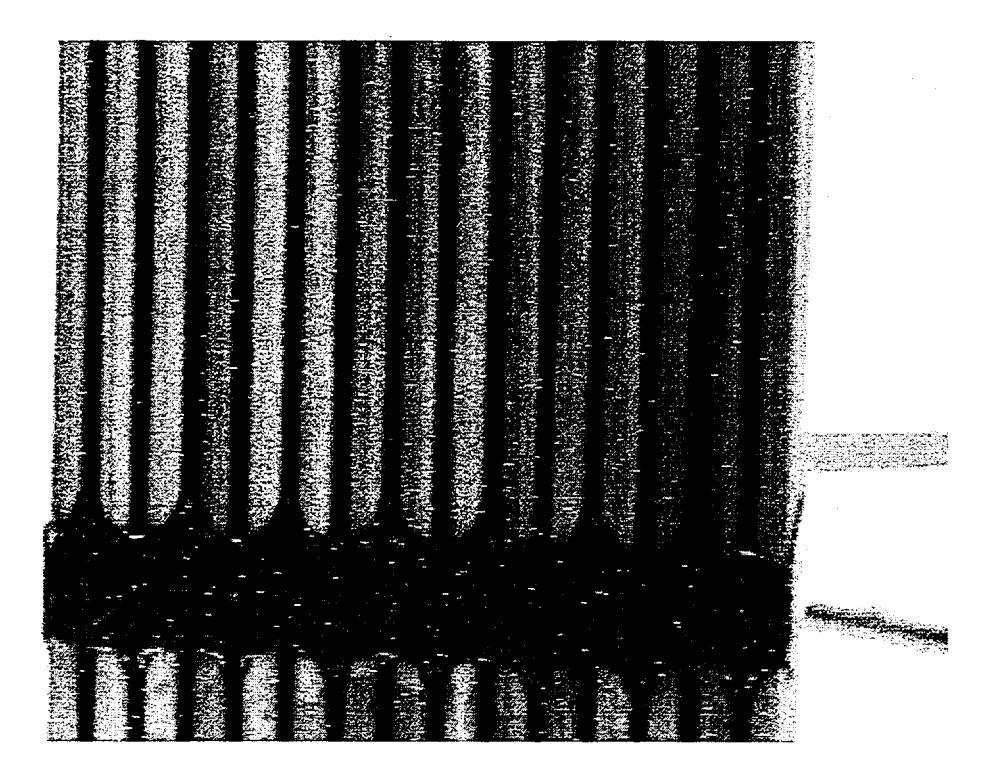
Figure C-15. Element T-03 at intermediate grid spacer—rods appear to be relatively clean with a light oxide coating.

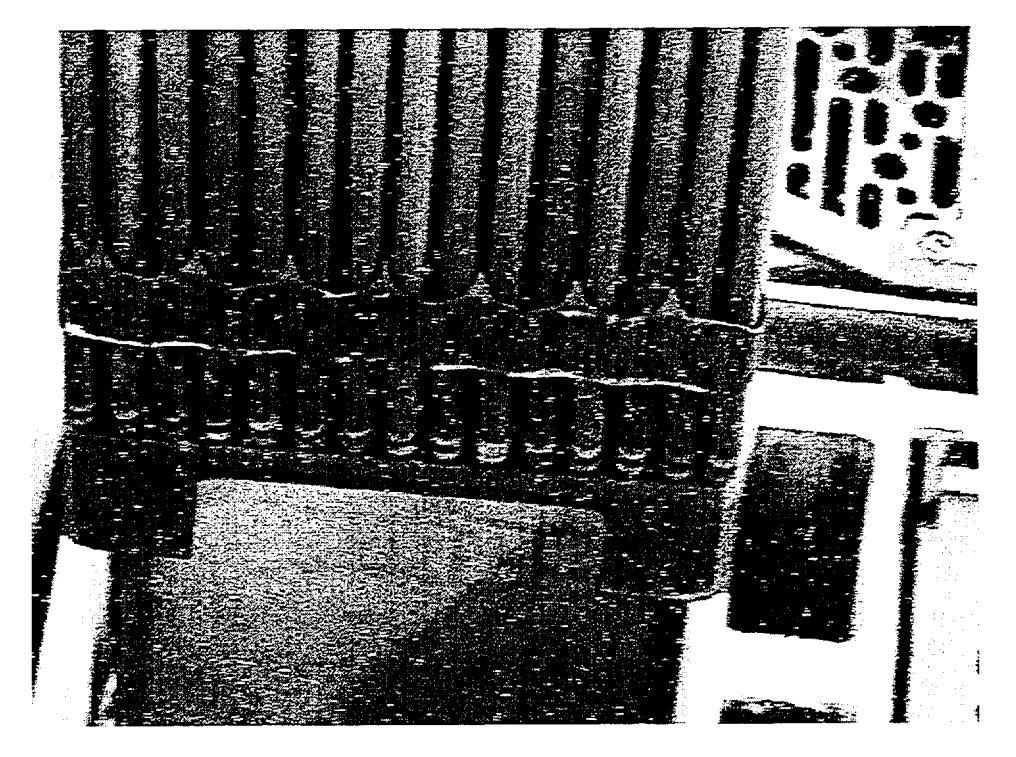
Figure C-18. Element T-03 bottom of fuel element-light oxide-no loose material obvious on surfaces.

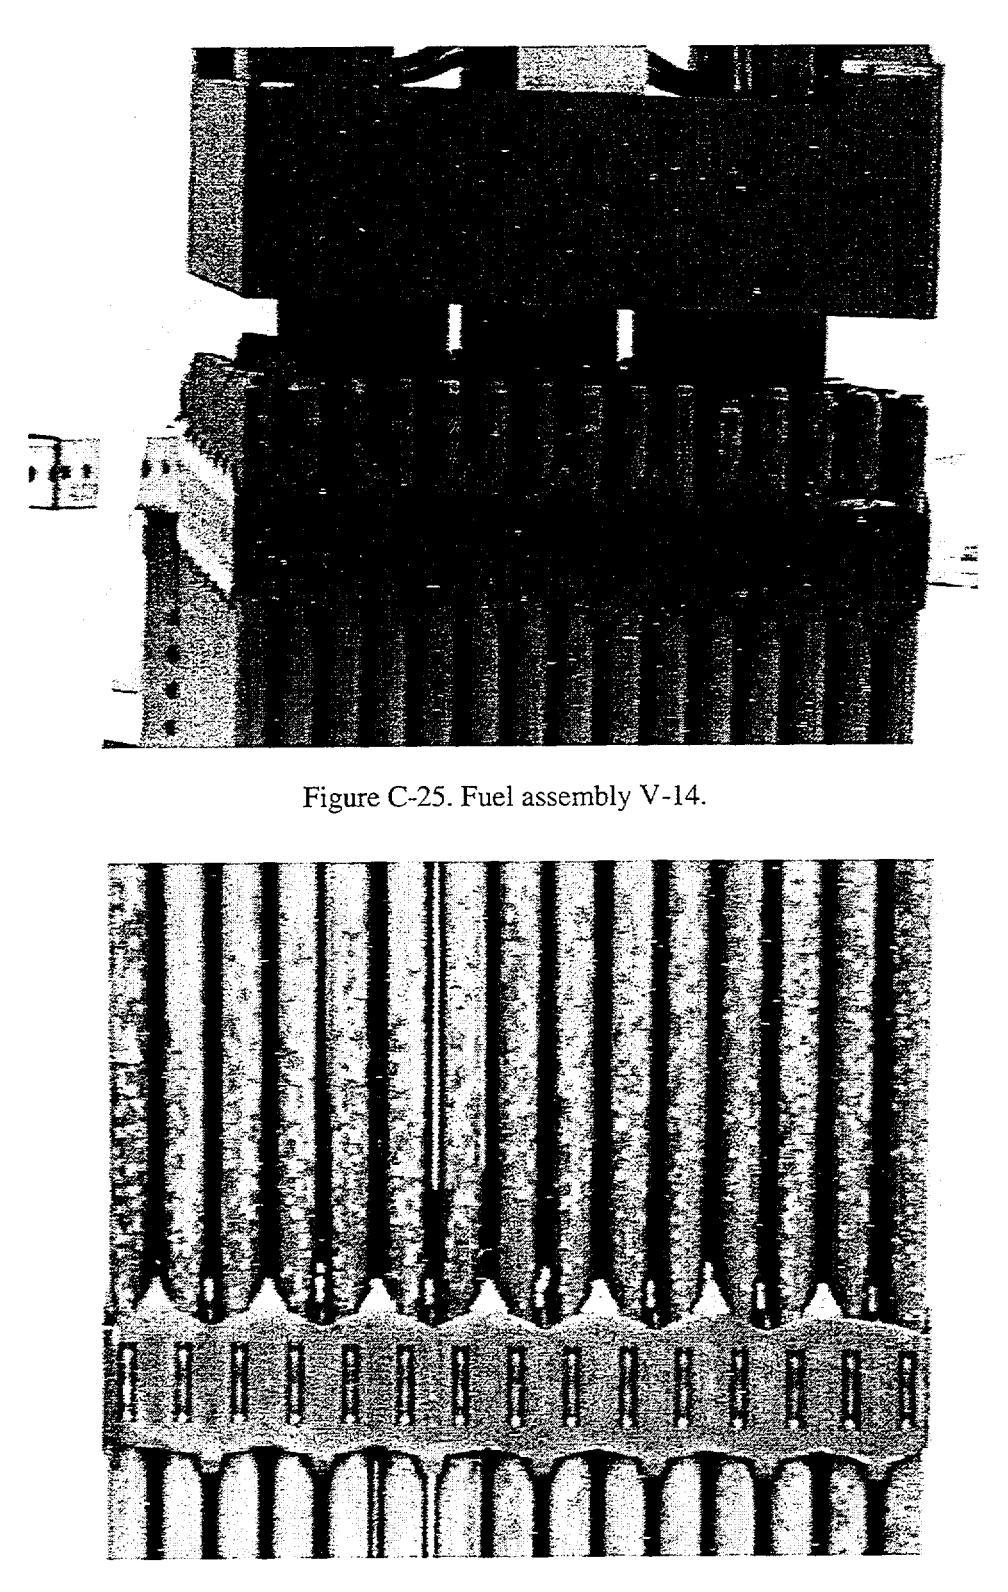
Figure C-26. Fuel assembly V-14 oxide mottling at fifth grid spacer.

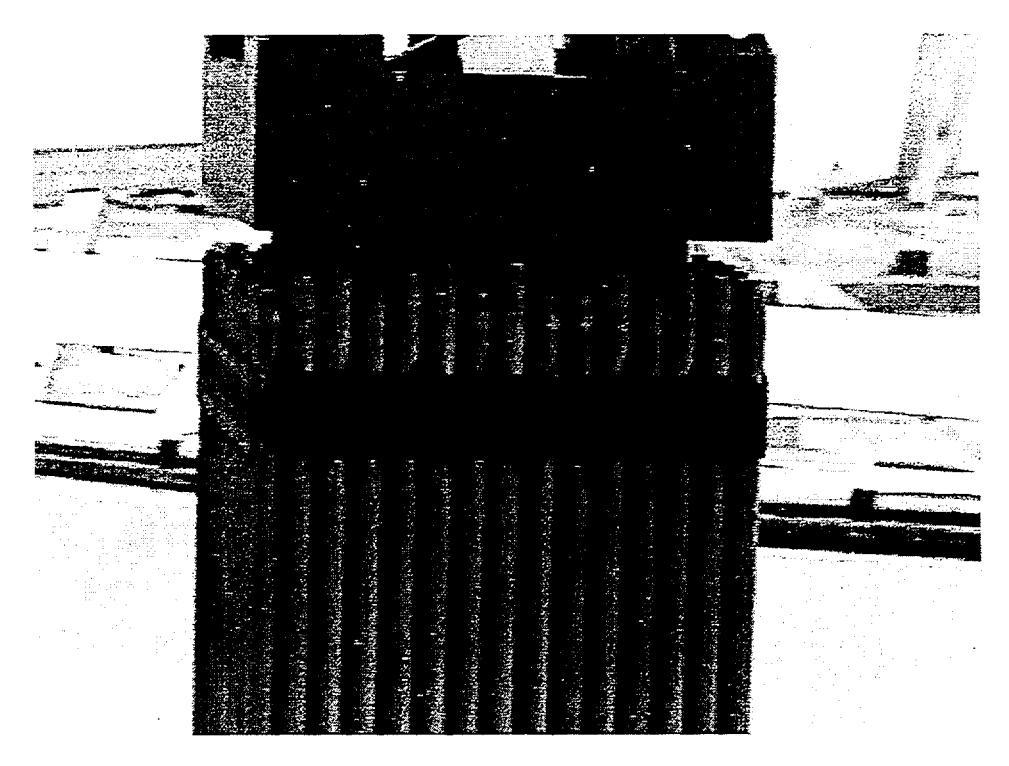
Figure C-27. Fuel assembly T-07 note difference in fuel rod growth.

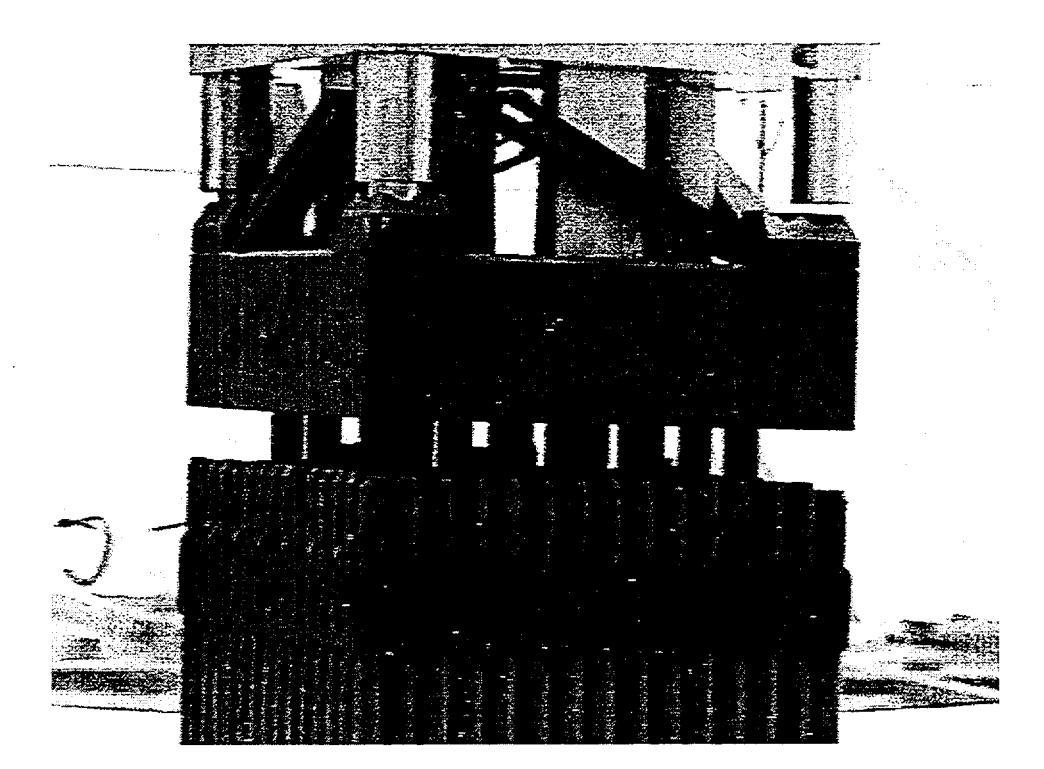
Figure C-33. Fuel assembly V-08 tops of fuel rods appear quite even.

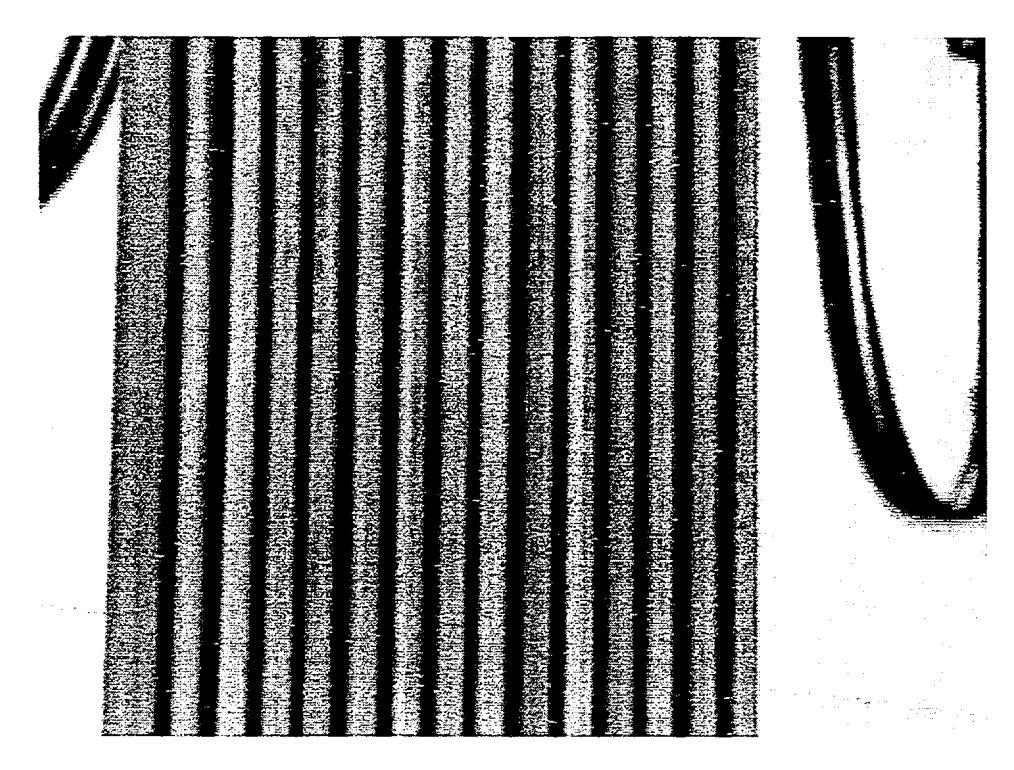
Figure C-43. Fuel assembly T-08 near sixth grid spacer.

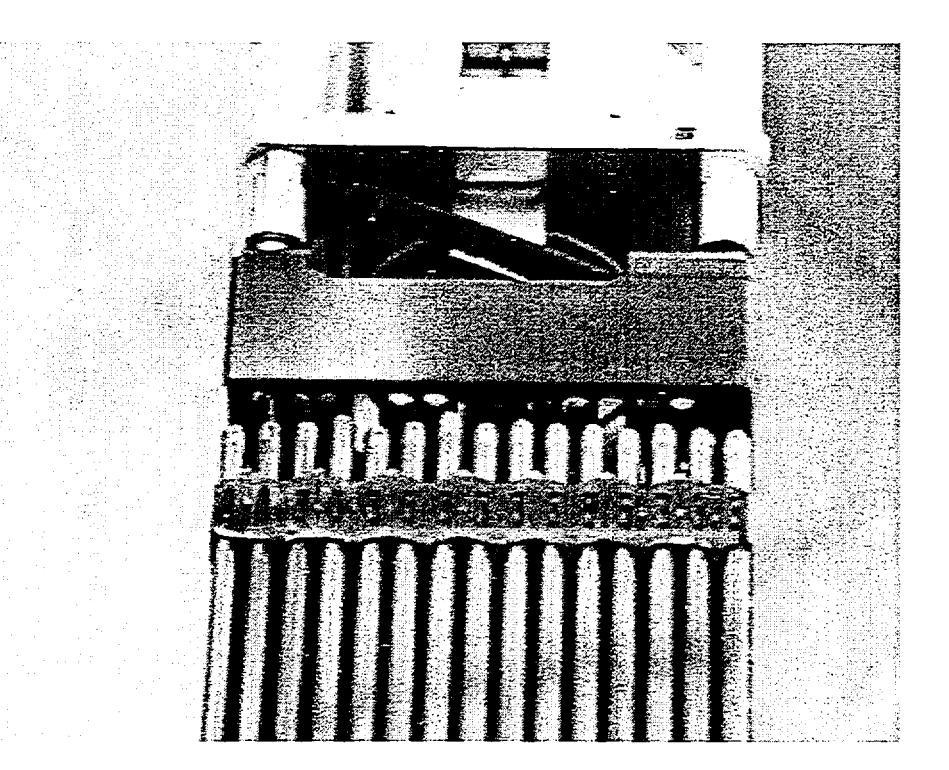
Figure C-44. Fuel assembly T-09---note uneven rods.

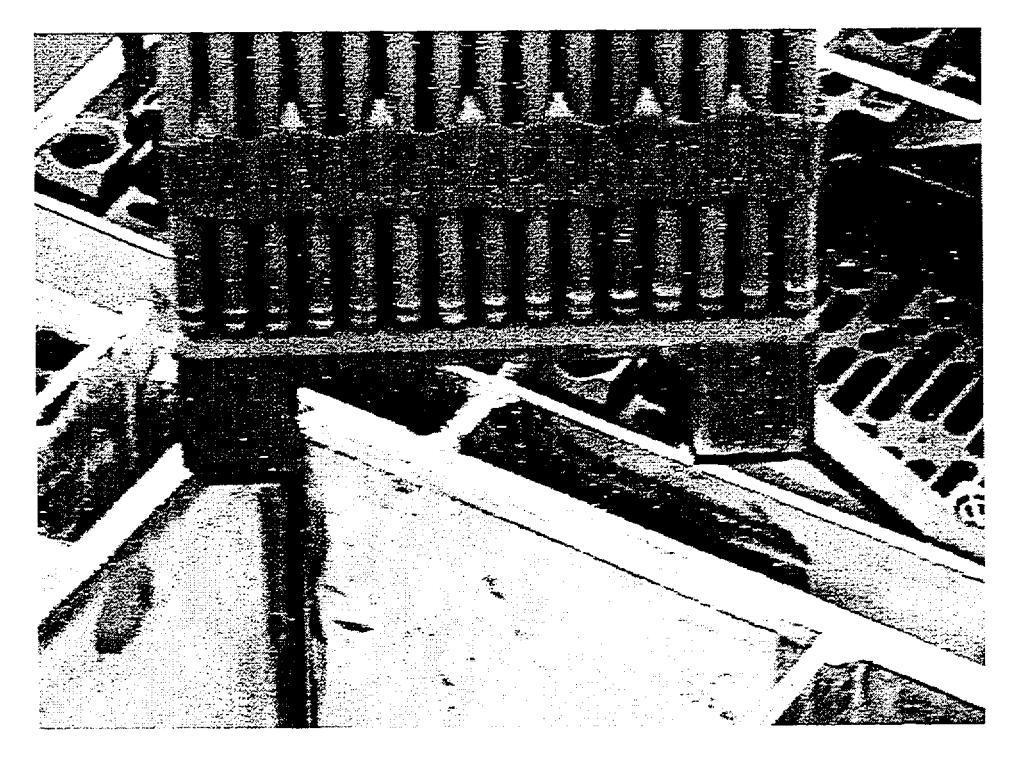
Figure C-52. Fuel assembly V-24 third spacer.

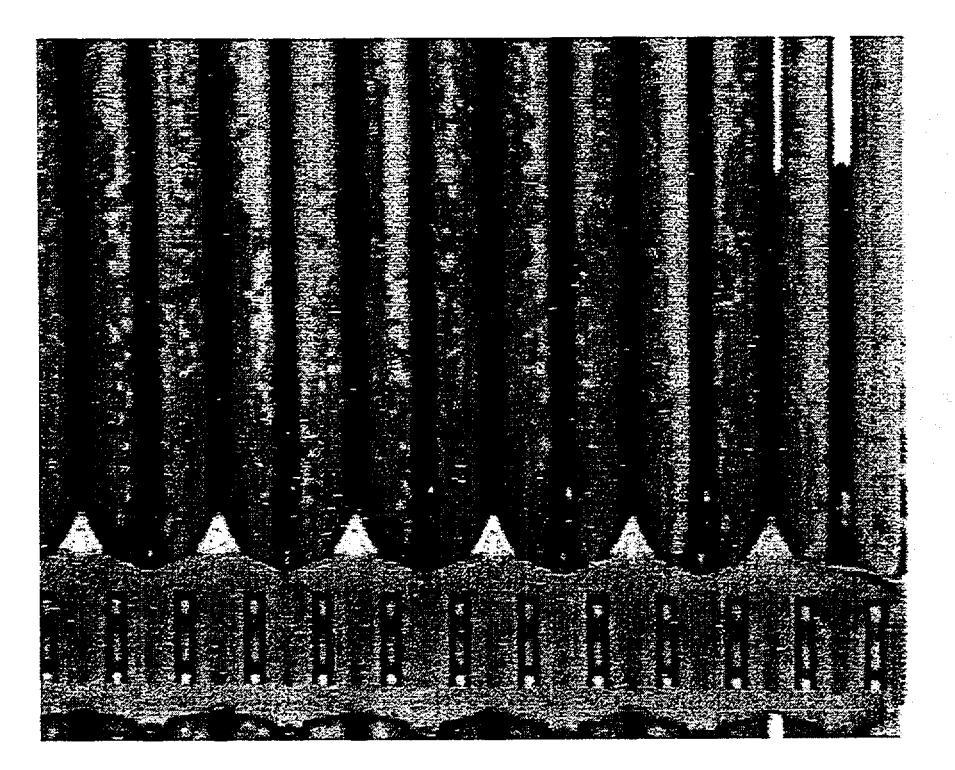
Figure C-53. Fuel assembly V-24 near fifth spacer.

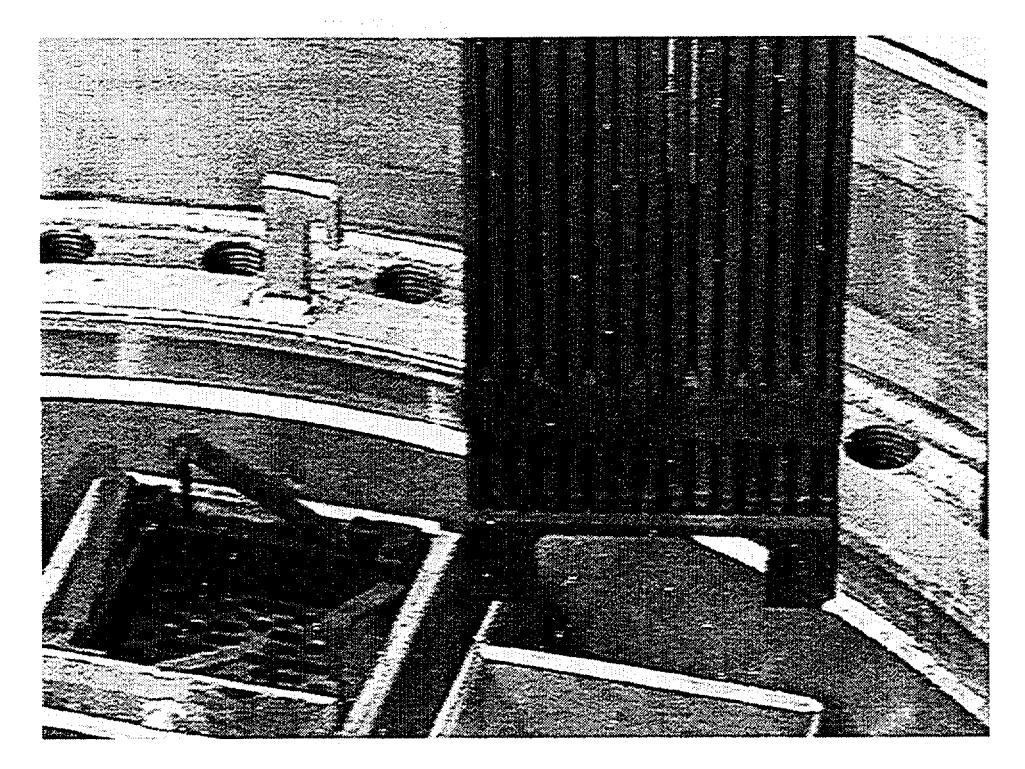
Figure C-57. Fuel assembly V-15.

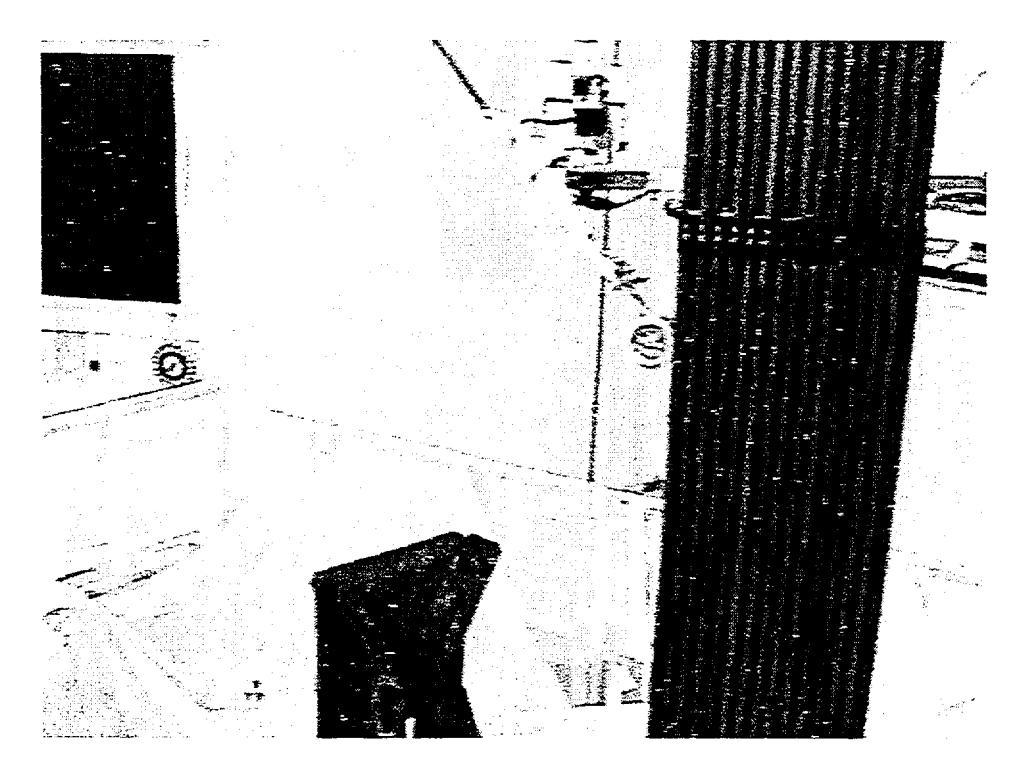
Figure C-64. Fuel assembly T-11 attempt to obtain loose material.

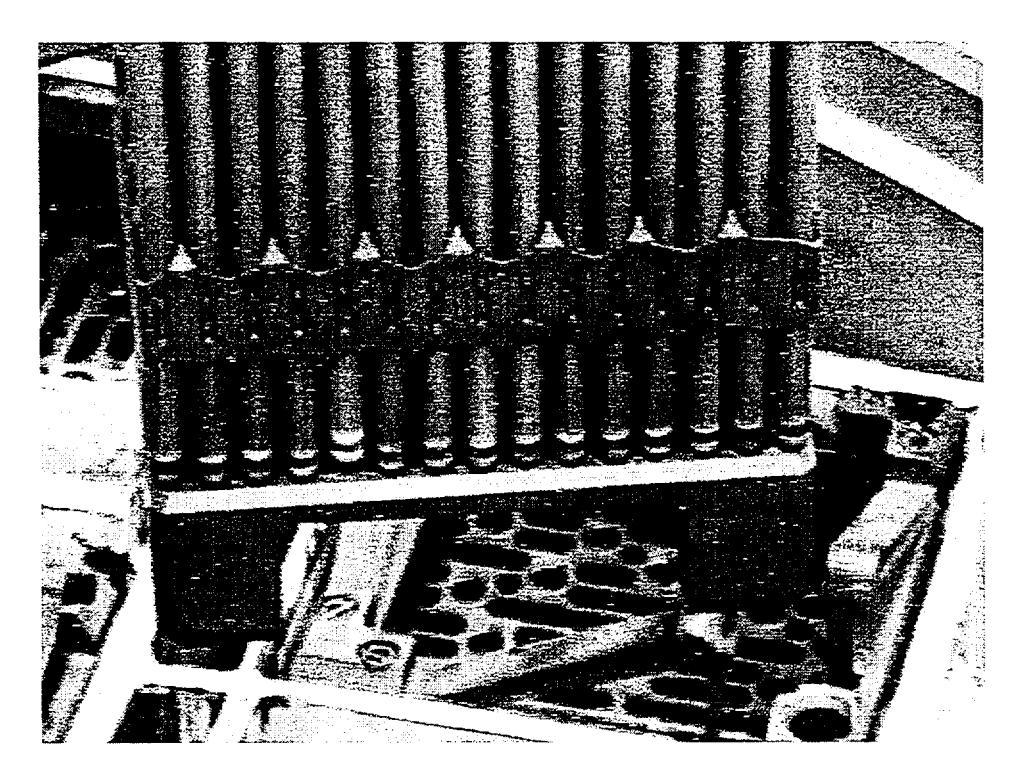
Figure 67. Fuel assembly V-04—bottom—rod having greatest indication of oxide appears to be slightly above the nozzle plate—no conclusion made.

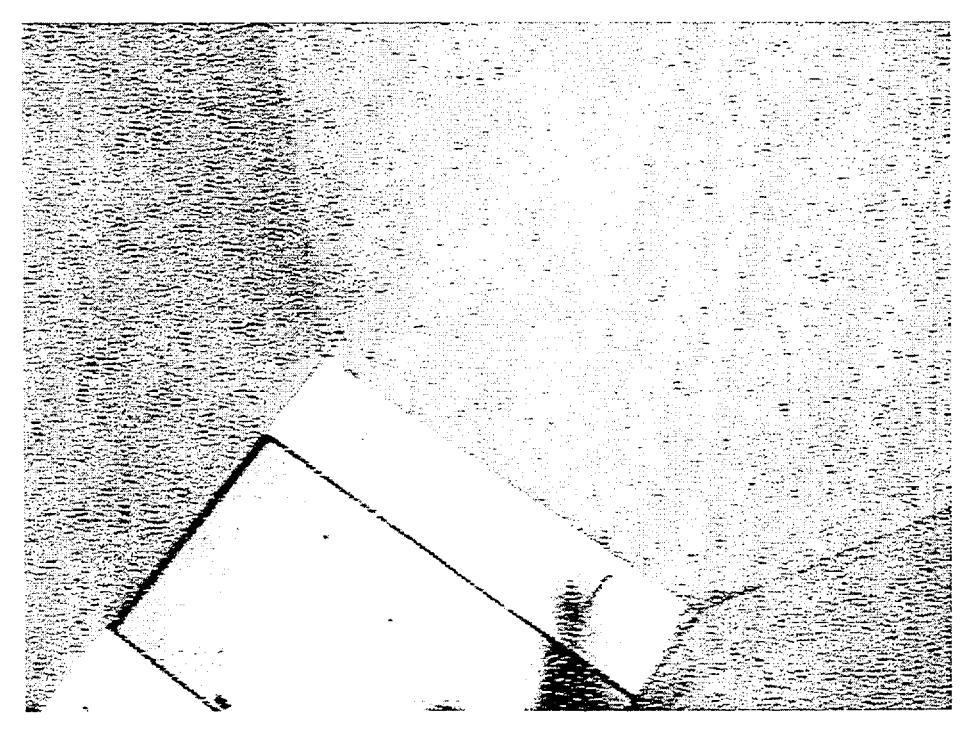
Figure D-4. Fuel tube A-5 bottom - Noted typical absence of quantities of loose material.

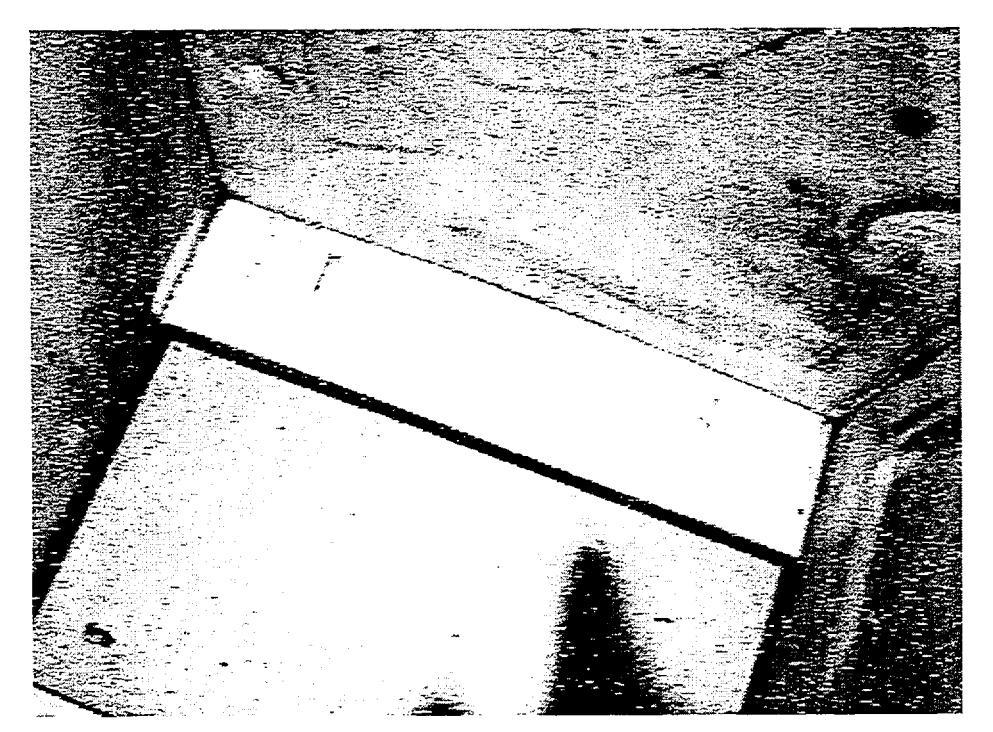
Figure D-6. Fuel tube A-3 bottom – Surfaces clean and bright.
