Dry Cask Storage Characterization Project—Phase 1: CASTOR V/21 Cask Opening and Examination

Idaho National Engineering and Environmental Laboratory

NUREG/CR-6745 INEEL/EXT-01-00183

Prepared by W.C. Bare, L.D. Torgerson

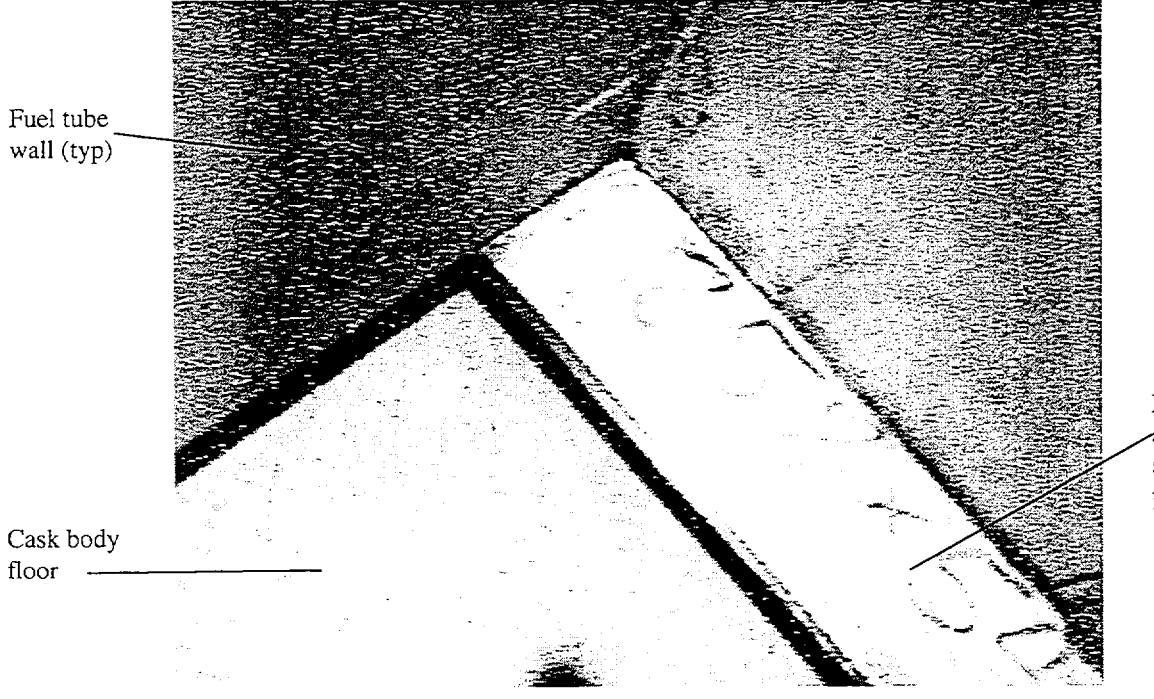
Fuel assembly support plate

Figure D-20. Fuel tube C-5 reflective surfaces and existence of original fabrication/layout characters.

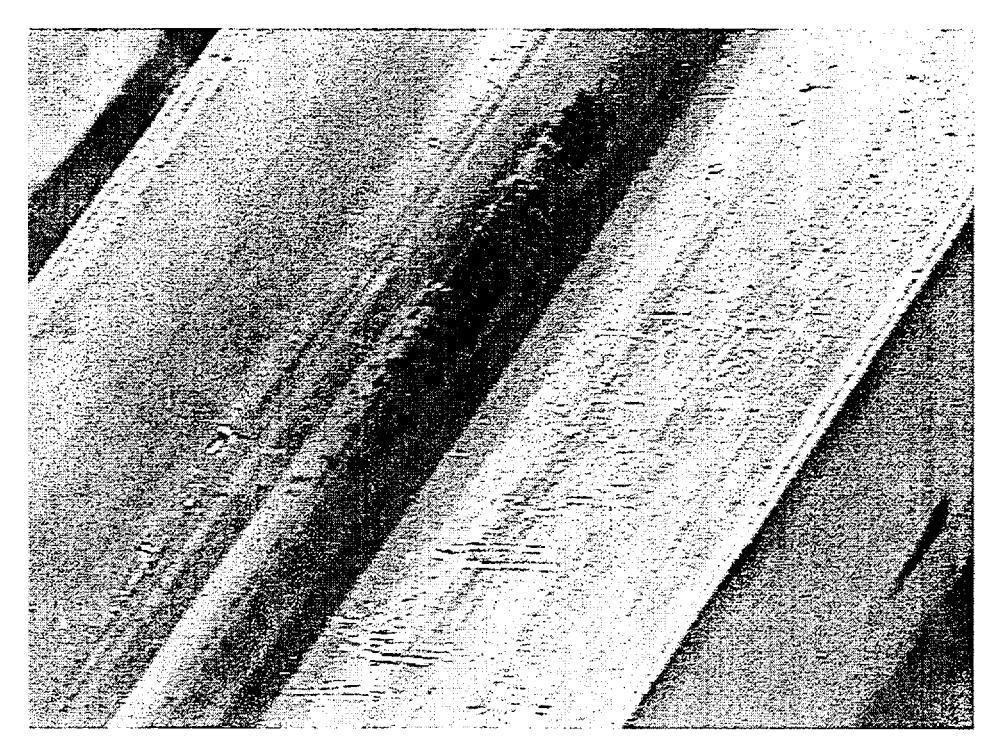
Figure E-6. Oxide mottling on fuel rod.

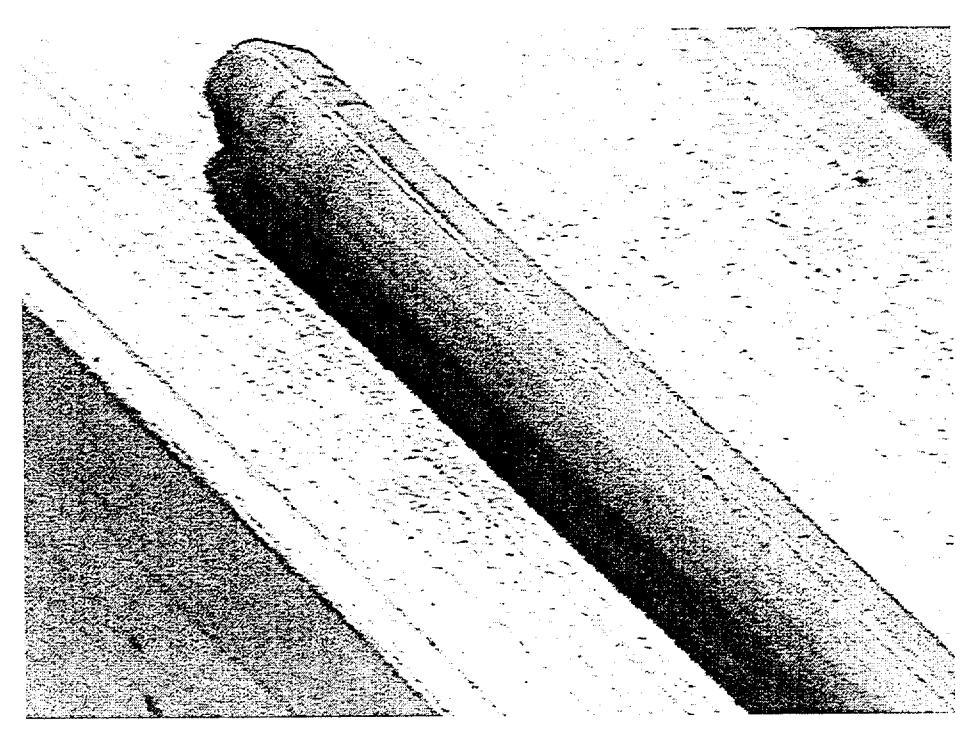
Figure E-9. Fuel rod-linear scratches believed from moving rod through spacer grid plates.

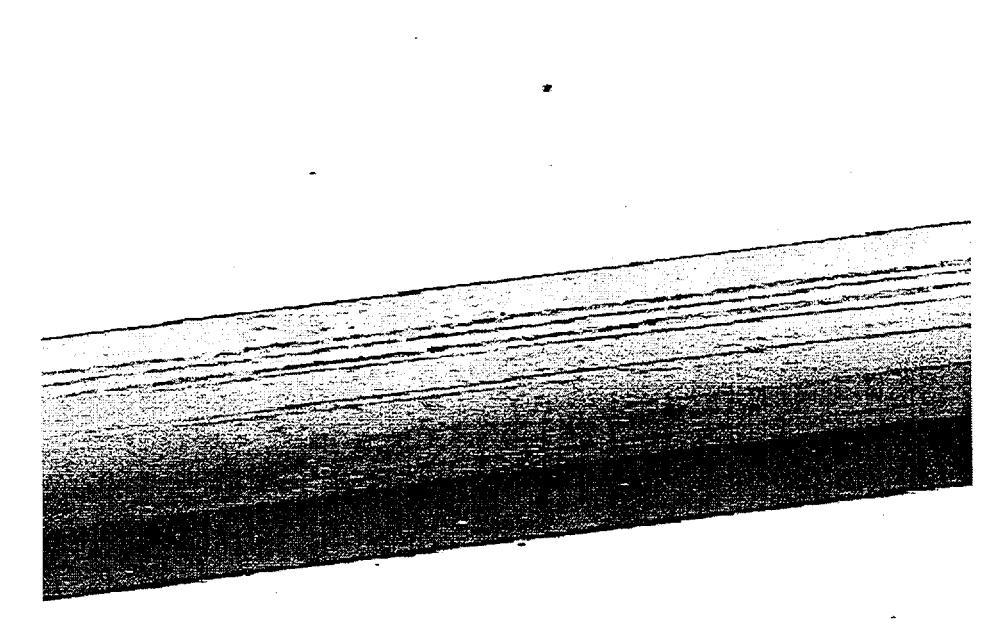
Figure E-10. Fuel rod with linear scratch.

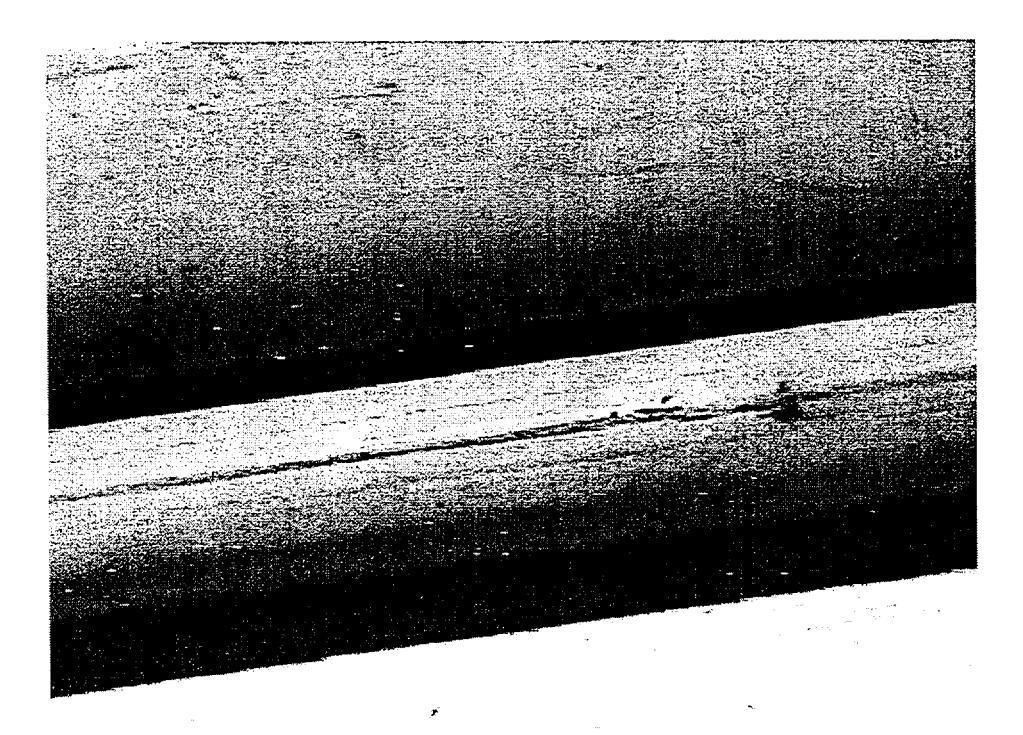
Figure E-11. Fuel rod with linear scratch.

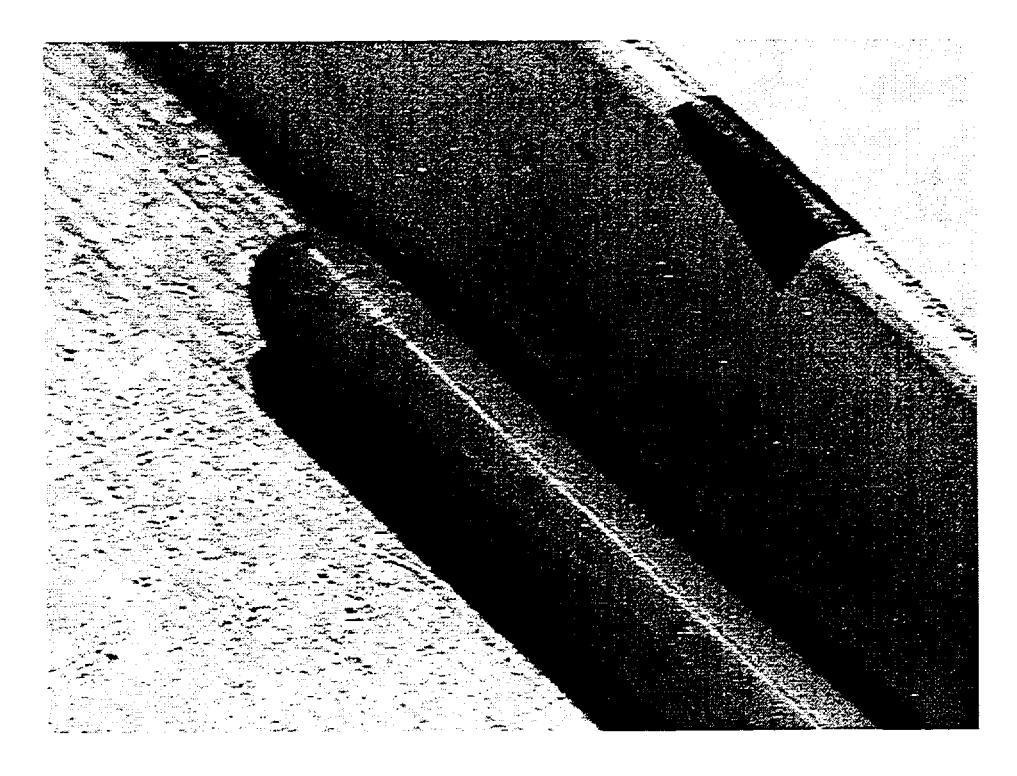
Figure E-12. Fuel rod with linear scratch.

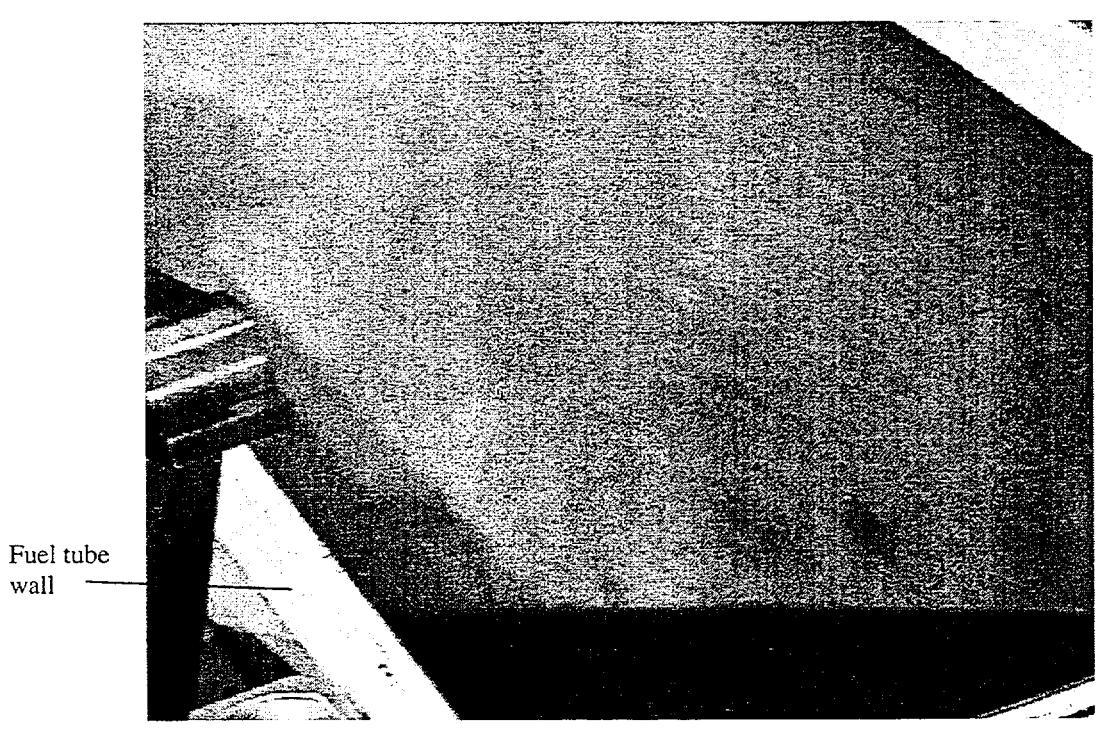
Figure F-2. Cask inner wall at top-typical surface condition.

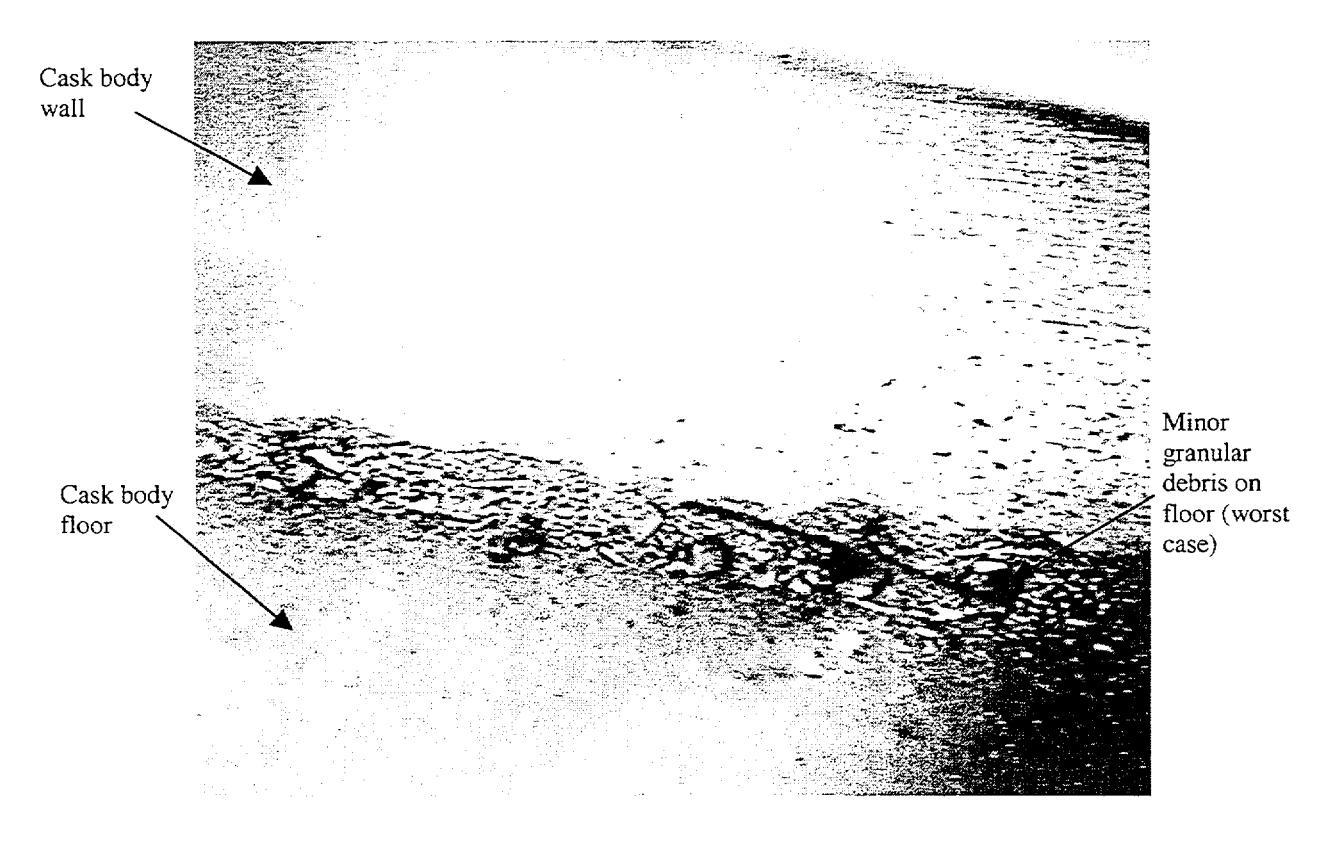
Figure F-4. Cask floor and wall below fuel tube C8-reflective surfaces free of corrosion.

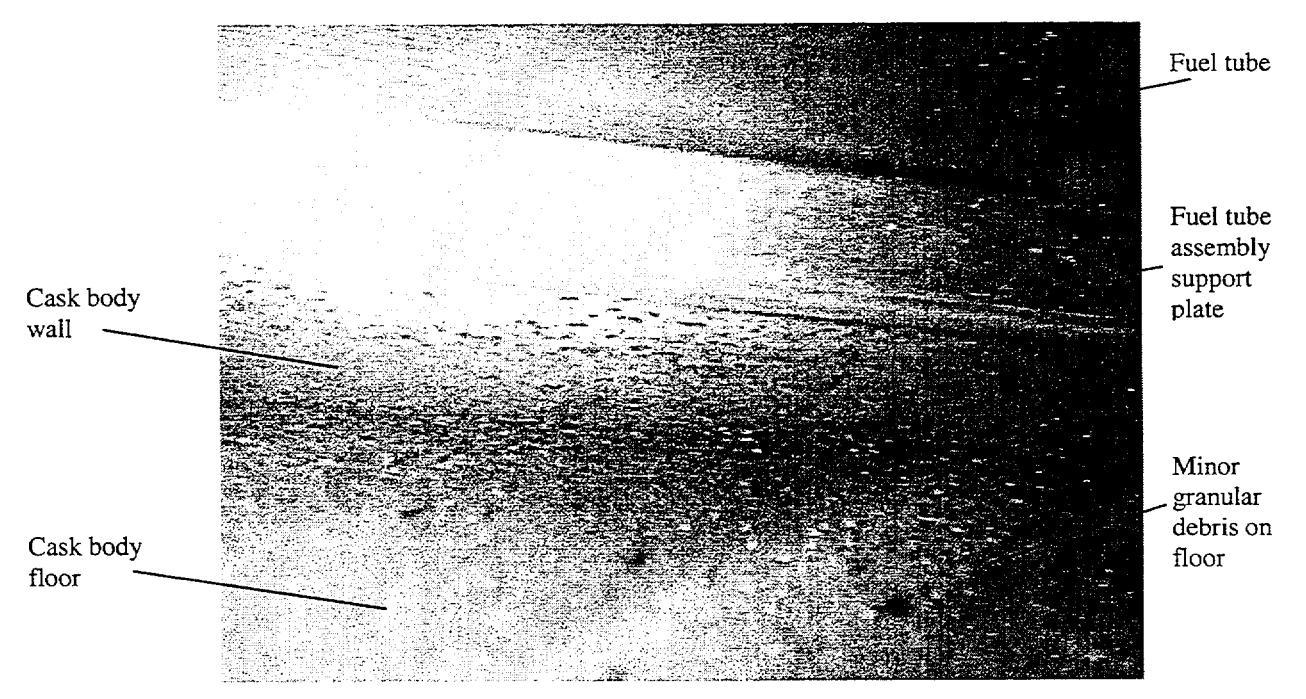
Figure F-5. Cask floor and wall below fuel tube D3-reflective surfaces free of corrosion.

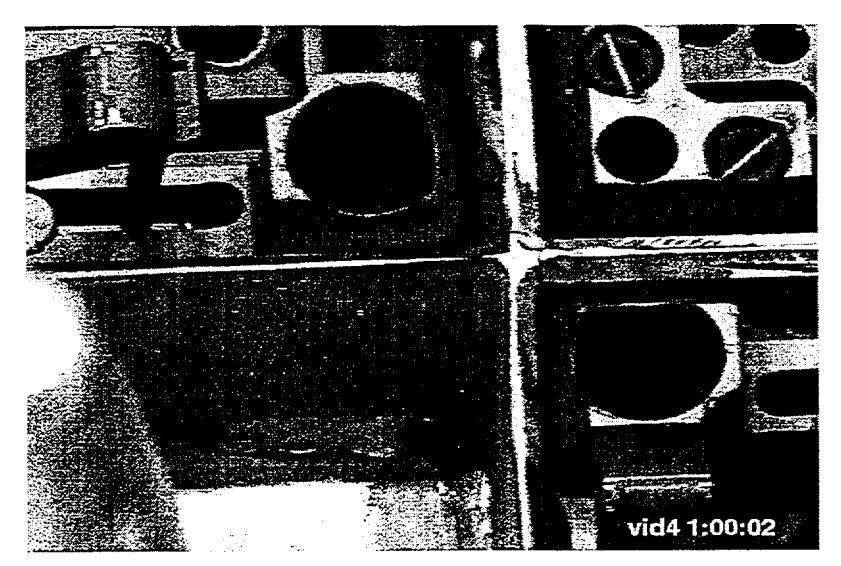
Figure G-1. Existing 1985 weld crack at location No. 1 identified in Figure G-9.

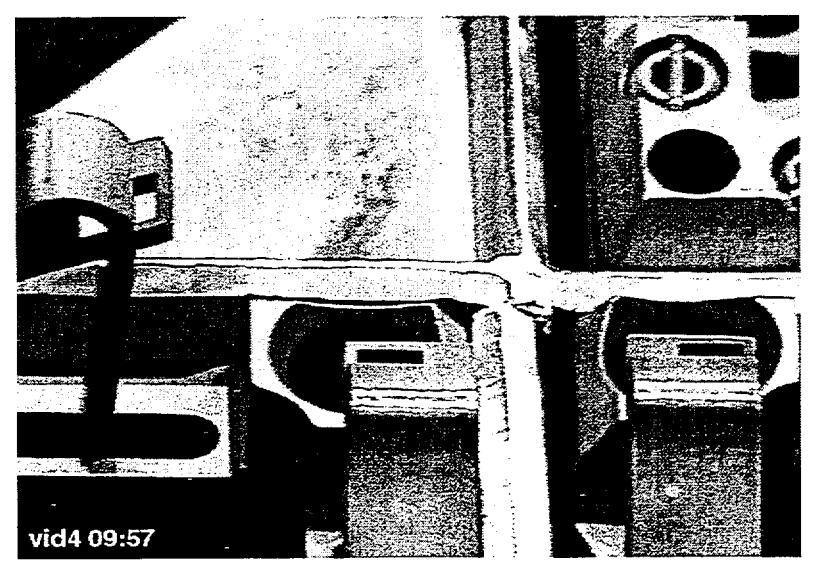
Figure G-2. Existing 1985 weld crack at location No. 2 identified in Figure G-9.

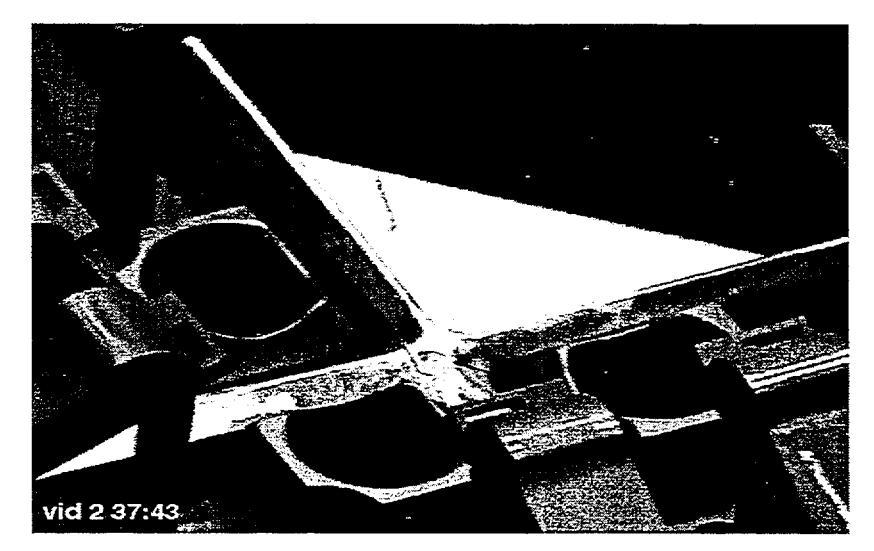
Figure G-3. Existing 1985 weld crack at location No. 3 identified in Figure G-9.

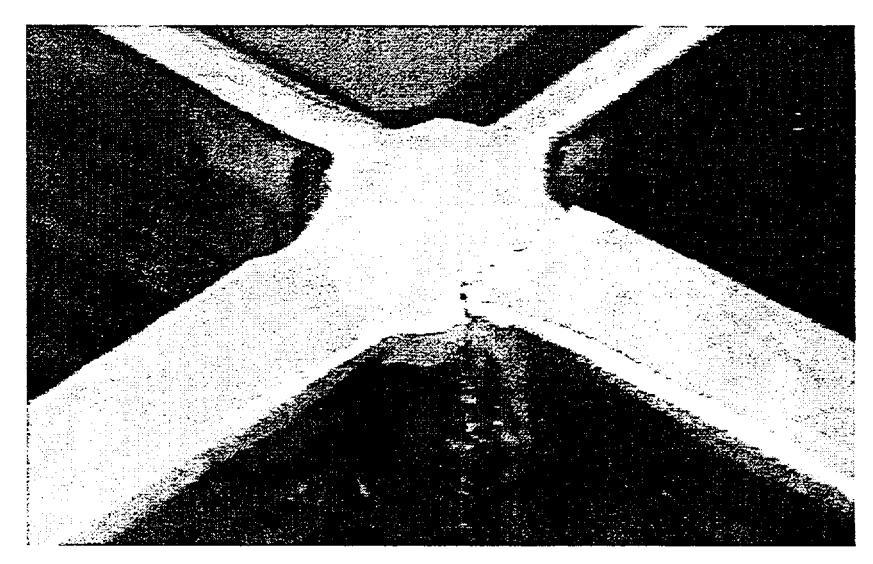
Figure G-4. Existing 1985 weld crack at location No. 4 identified in Figure G-9.

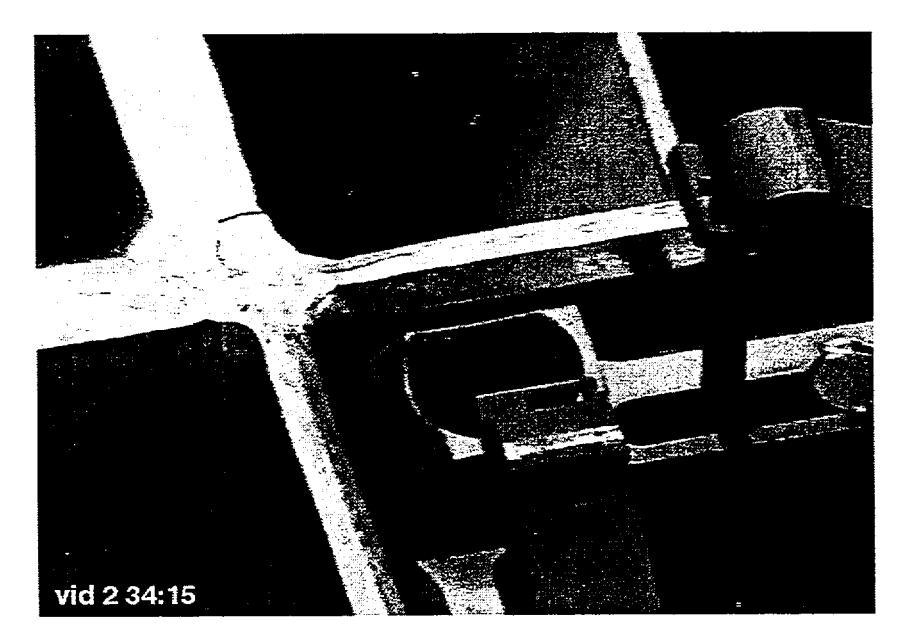
Figure G-5. Existing 1985 weld crack at location No. 5 identified in Figure G-9.

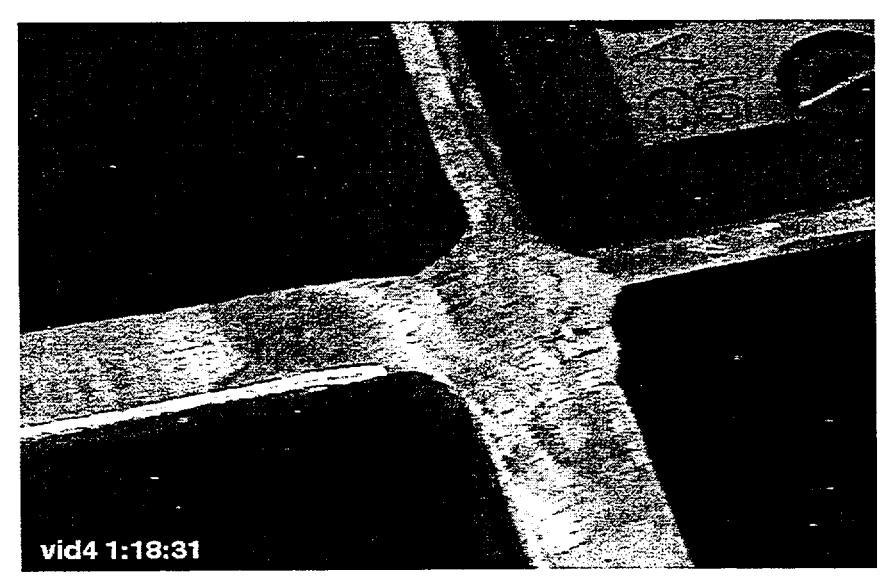
Figure G-6. Existing 1985 weld crack at location No. 6 identified in Figure G-9.

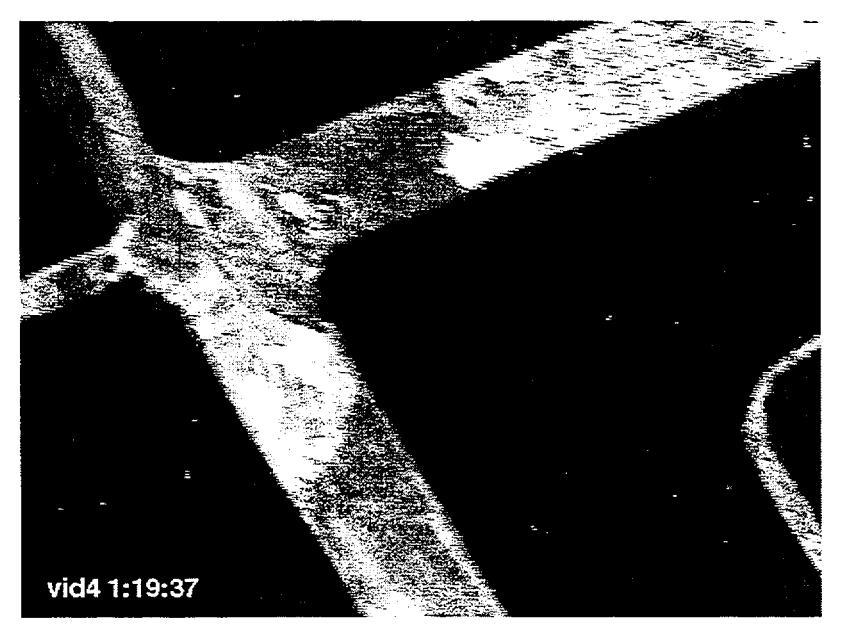
Figure G-7. Existing 1985 weld crack at location No. 7 identified in Figure G-9.

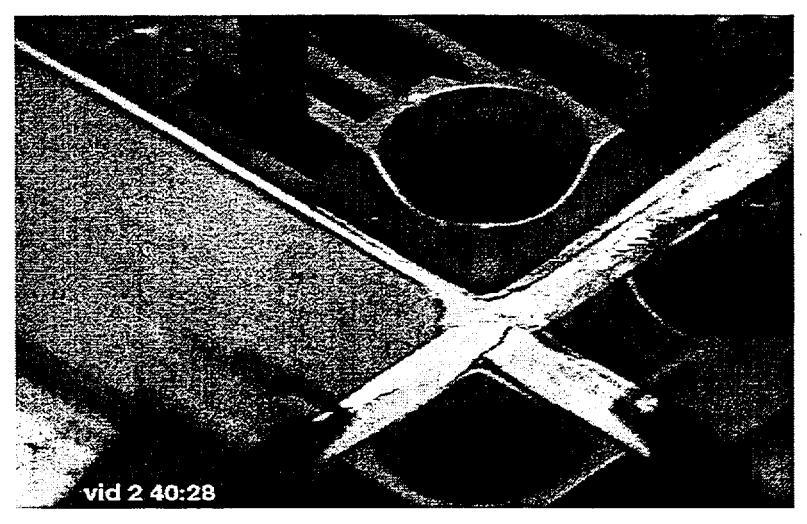
Figure G-8. Existing 1985 weld crack at location No. 8 identified in Figure G-9.

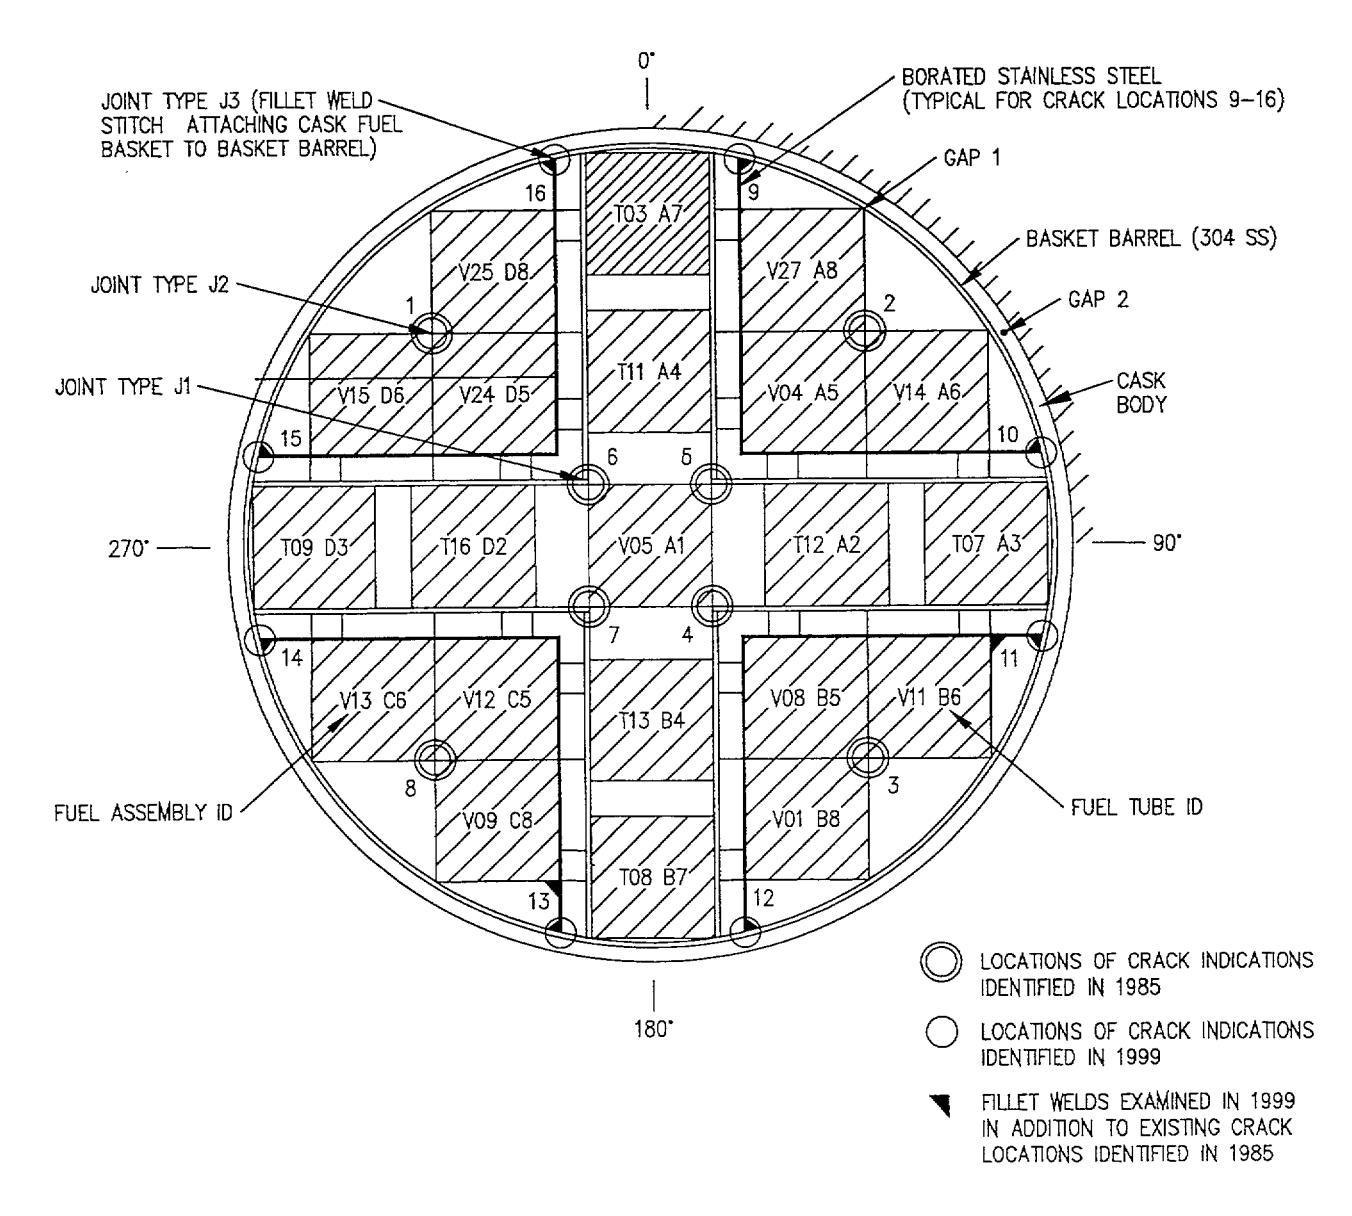
Figure G-9. Castor V/21 basket crack indication location.
